DRIVEABILITY—MALFUNCTION INDICATOR LAMP (MIL) ILLUMINATED—AND/OR DIAGNOSTIC TROUBLE CODES (DTC'S) P0442, P0455, P0456, P0457	Article No. 02-20-7

FORD: 2001 ESCAPE
2001-2002 WINDSTAR

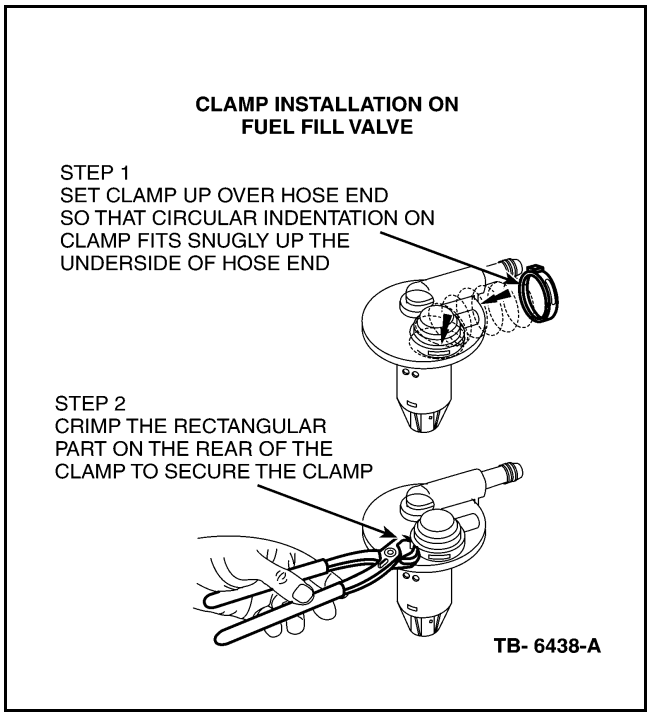
Figure 1 - Article 02-20-7

Some vehicles may exhibit an Malfunction Indicator Lamp (MIL) illuminated, and/or Diagnostic Trouble Codes (DTC's) P0442, P0455, P0456, P0457. This may be due to a small fuel vapor leak coming from the Fill Limit Vent Valve (FLVV) Over Pressure Relief (OPR) port area, of the Evaporative Emissions System (EVAP).

NOTE
IT IS RECOMMENDED TO DIAGNOSE THE LEAK WITH A ROTUNDA SMOKE LEAK DETECTION MACHINE (MODEL 218-00001) OR EQUIVALENT. IF THE (FLVV) (OPR) IS LEAKING, SMOKE IS TYPICALLY SEEN AT THE REAR TOP LEFT OF THE FUEL TANK. THE LEAK IS OFTEN REPORTED TO DISAPPEAR ONCE THE FUEL TANK IS LOOSENED.

2. Remove the fuel tank as outlined in the Workshop Manual Section 310-01.
3. Install a Clamp 1F2Z-9A064-AA on the (OPR) portion of the (FLVV) using a Rotunda Keystone Clamp Installer (part number T63P-9171-A), see Figure 1.
4. Re-install the fuel tank per Workshop Manual.
5. Leak test the (EVAP) system to confirm all leaks have been repaired.
6. Using the NGS or WDS tool clear the (DTC's) as related to the repair.
