LIFTGATE GLASS BALL STUD BRACKET

AFFECTED VEHICLES: **CERTAIN 2002 MODEL YEAR EXPLORER AND MOUNTAINEER**

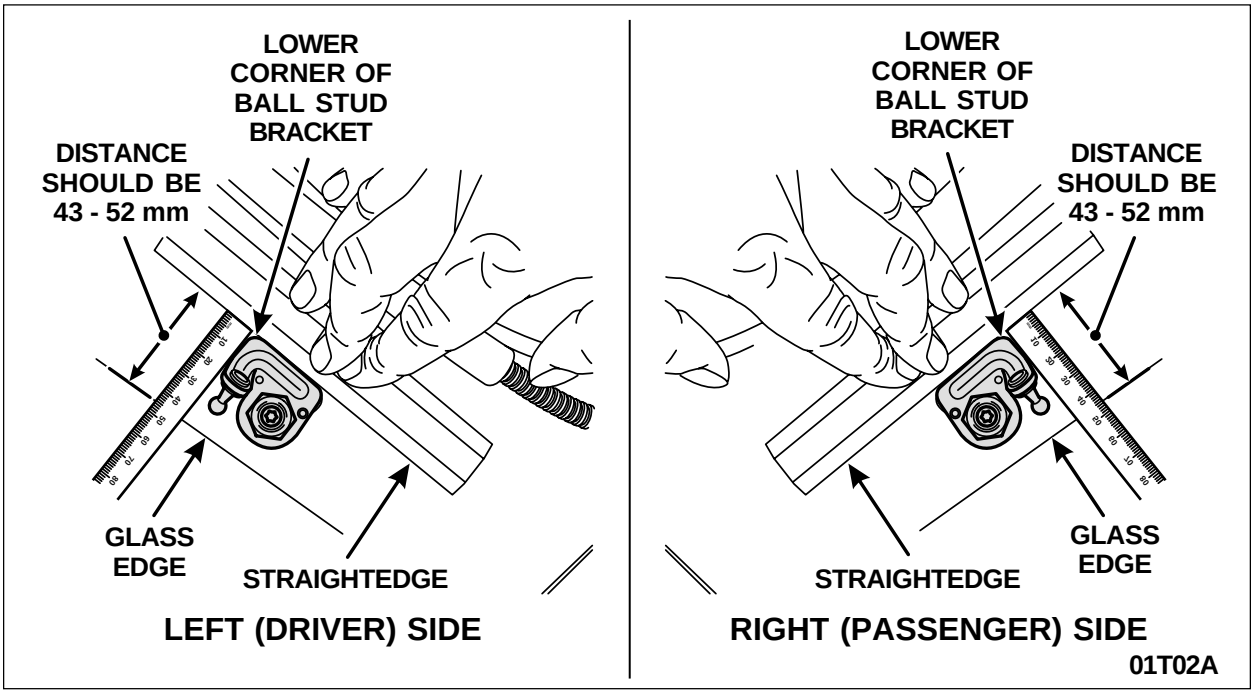
FIGURE 1

1. Open liftgate glass.
2. Place a straightedge against the inner edge of each ball stud bracket. Measure the distance between the edge of the glass and the straightedge at the lower corner of each ball stud bracket. See Figure 1.
   A. If the distance measured is between 43 and 52 mm, the bracket is positioned properly and will only require the following tightening procedure:
      - Tighten **(counterclockwise)** the attachment bolt with a T-30 Torx® bit to 25 Nm (18 lb-ft), placing a 17 mm wrench on the nut attachment of the ball stud bracket while holding the bracket in place.
      - **CAUTION: To maintain the proper torque, the ball stud bracket bolt MUST be retightened after a minimum of thirty (30) minutes.**

B. If the distance measured is less than 43 mm or greater than 52 mm, go to Ball Stud Bracket Relocation.

Wait a minimum of thirty (30) minutes, then retighten the bolt to 25 Nm (18 lb-ft).
