ELECTRICAL—MOISTURE OR CONDENSATION IN FOG LAMPS—VEHICLES PRODUCED BEFORE 6/25/2001	Article No. 01-14-3

FORD: 2001 RANGER

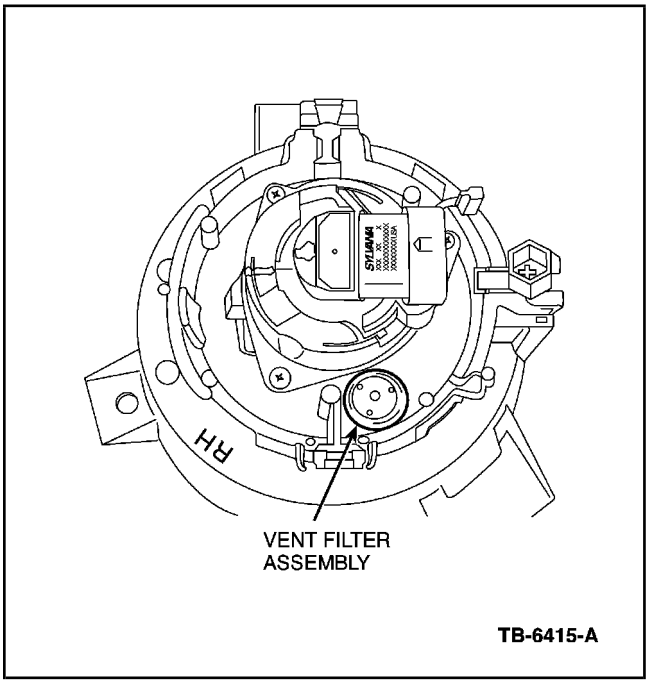
Figure 1 - Article 01-14-3

Some vehicles may exhibit condensation and/or water accumulation within the fog lamp assembly. If not serviced, the fog lamp could eventually become inoperative. This may be caused by the fog lamp vent-filter becoming contaminated.

6. Install new vent filter assembly, cap colored “black” (1L5Z-13B216-AA). Refer to Figure 1.

NOTE
IF OBTAINING A NEW FOG LAMP, VERIFY THAT THE VENT FILTER CAP IS COLORED “BLACK” AND CONTAINS A “NITTO DENKO” TEXT STAMPED IN AND ON-TOP OF THE “BLACK” CAP PRIOR TO INSTALLATION. THIS WILL ENSURE YOU HAVE OBTAINED THE CORRECT COMPONENT.
