ELECTRICAL—SIDE AIR BAG DIAGNOSTIC CODES (DTC) B1994 AND/OR B1998—VEHICLES BUILT BEFORE 2/18/02 ONLY	Article No. 02-13-7

LINCOLN: 2000-2002 LS

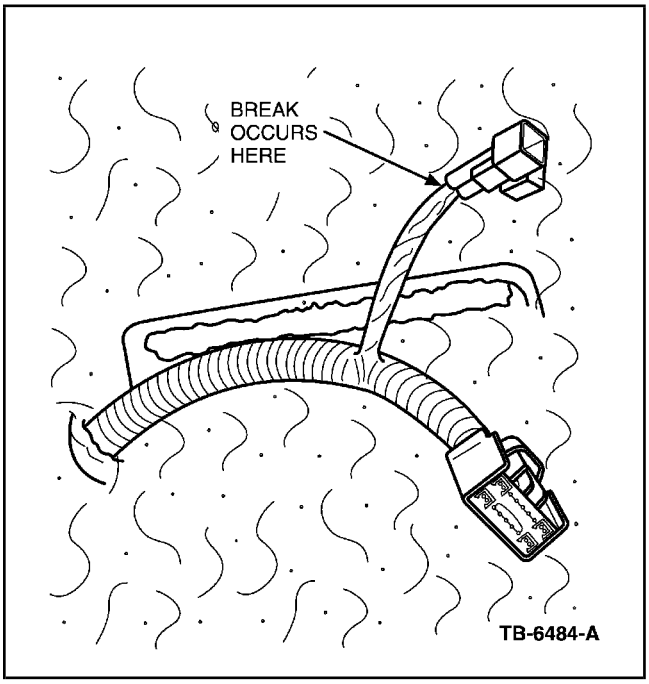
Figure 1 - Article 02-13-7

2. The suspect circuits are part of the 14A005 vehicle electrical harness that enters the passenger compartment through an opening in the carpet below each front seat. The break may occur slightly above or inside the end of the protective conduit near the Air Bag connector for the seat (Figure 1).
