WATER LEAKS—WATER LEAK AT FRONT PASSENGER FLOOR AREA—SERVICE TIPS	Article No. 02-25-1

FORD: 2000-2003 FOCUS

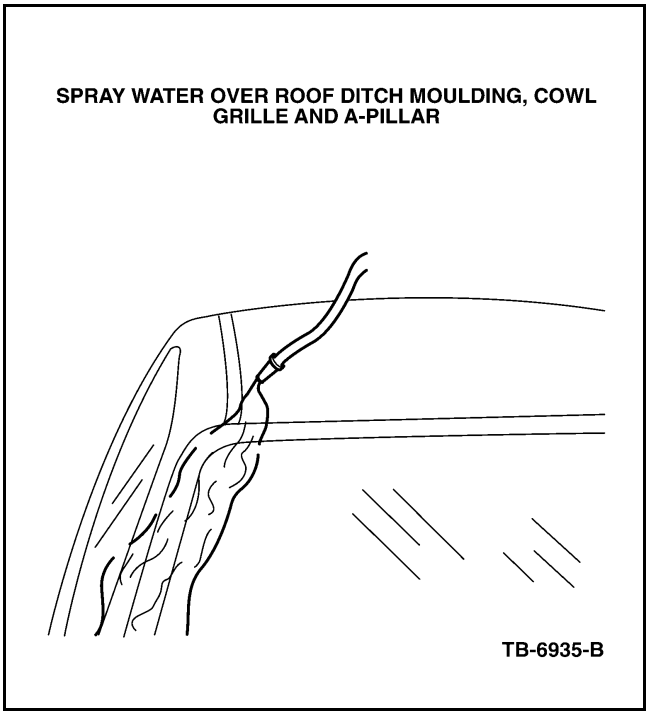
Figure 1 - Article 02-25-1

Using a high-pressure water hose or a pressure washer, run water over the roof onto the windshield being sure to direct water over the roof ditch mouldings, and down onto the cowl (Figure 1). From the side of the car with the hood open, direct water into the base of the A-pillar in the hood hinge area (Figure 2). With the right inner fender splash shield removed, direct water into the back of the right front wheel well area (Figure 3).

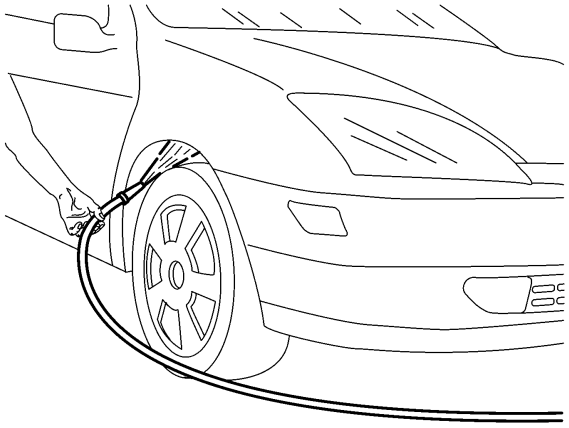
SPRAY WATER IN REAR OF FRONT WHEEL WELL
(SPLASH SHIELD REMOVED)

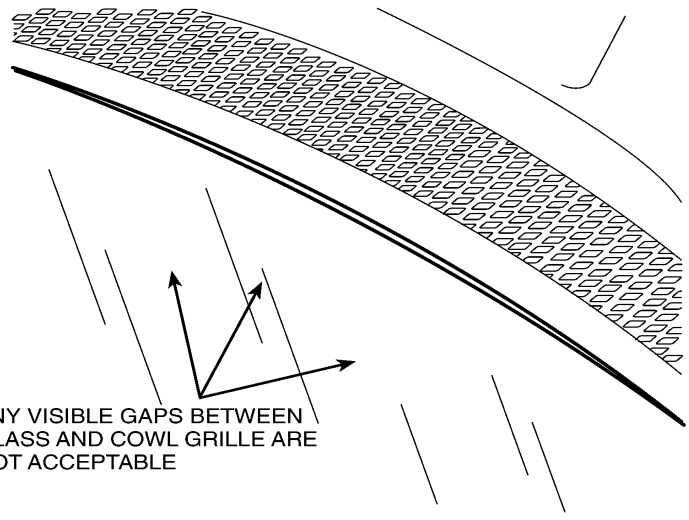
Figure 4 - Article 02-25-1

NOTE: OBSERVE WATER'S PATH AS IT RUNS ALONG THE COWL/GLASS INTERFACE

NOTE: CHECK FOR ANY OBSTRUCTIONS THAT MAY BE BETWEEN THE COWL AND THE GLASS

NOTE: CHECK FOR AREAS WHERE WATER IS SEEPING UNDERNEATH THE COWL

1. Inspect for visible gaps between the windshield and the cowl grille (Figure 4). If gaps are present remove and replace the cowl grille, (1S4Z-5402228-CA) per Workshop Manual Section 501-02.
2. Remove cowl panel, inspect for gaps between pollen filter housing gasket and sheet metal plenum. If present, inspect for studs bent or off center. If off center, use a drill to slot the housing (Figure 5).
3. Inspect for bent plenum sheet metal flanges - repair as necessary.
4. Inspect Pollen Filter Housing gasket for damage. If damaged, replace Pollen filter housing (YS4Z-19N619-EA).

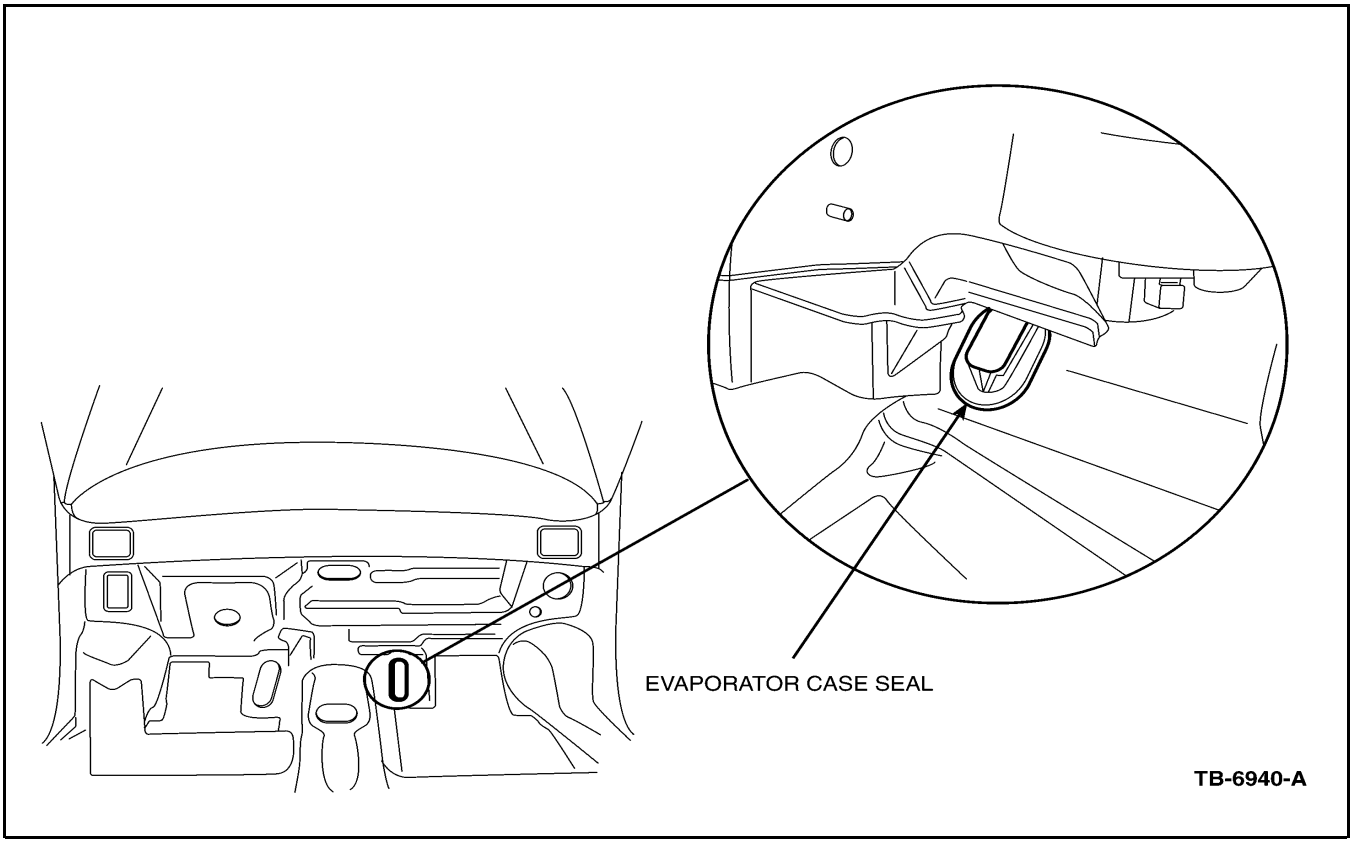
Figure 6 - Article 02-25-1

If Water Is Visible On Evaporator Case Seal At The Heater Core Inlet/Outlet (Figure 6):

1. Inspect for a mis-positioned evaporator case seal at the heater core inlet/outlet. Repair as necessary.
2. Inspect for loose evaporator case housing nuts. Repair as necessary.
