WATER LEAKS—WATER LEAK FROM TRUNK/LIFTGATE AREA—SERVICE TIPS	Article No. 02-15-6

FORD: 2000-2003 FOCUS

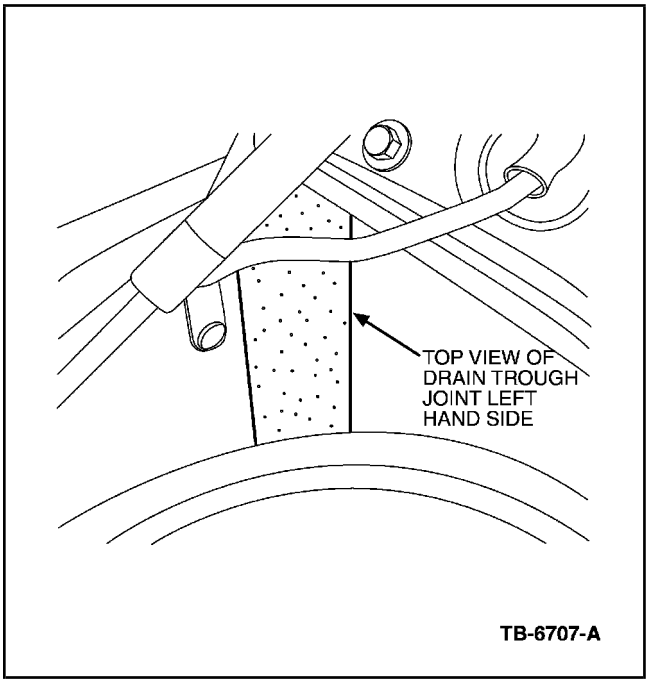
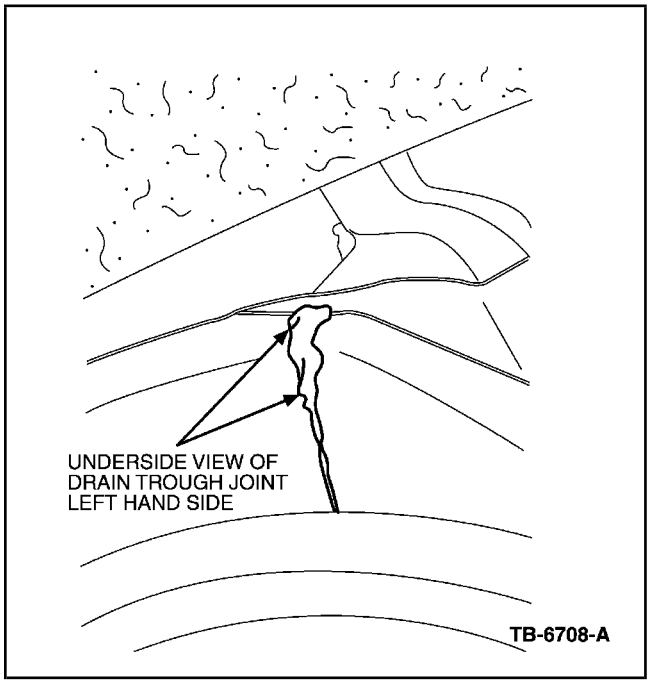
Figure 1 - Article 02-15-6

1. IF WATER IS FOUND ON SEDAN TRUNK CARPET NEAR LEFT/RIGHT CORNERS.

a. Pin holes in decklid drain trough sealer. **Refer to Figures 1 and 2.**
      - Locate pin holes in the sealer on the drain trough (check both top and underside of drain trough joint for leaks)
      - Caulk in area of missing sealer using silicone-based caulk

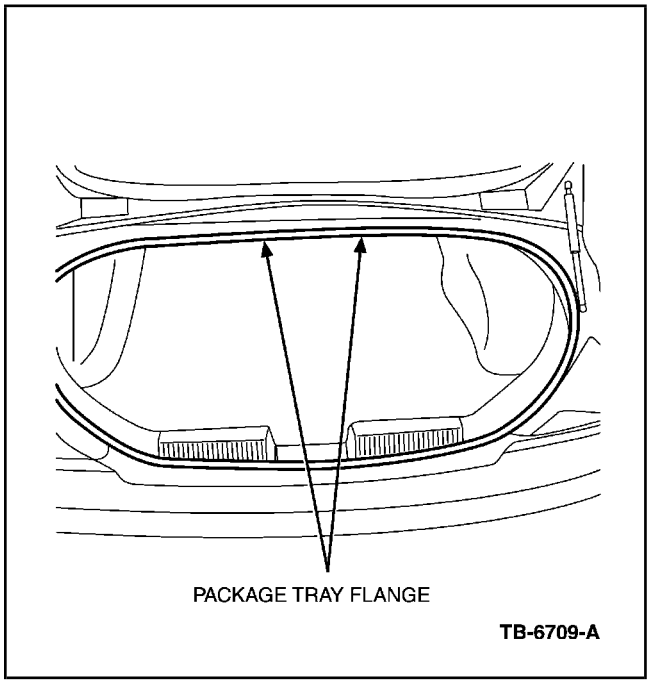
Figure 3 - Article 02-15-6

2. IF WATER IS FOUND ON SEDAN TRUNK CARPET NEAR MIDDLE.

a. Decklid package tray sheet metal flange too low (weatherstrip not sealed against decklid). **Refer to Figure 3.**
      - Perform chalk test along package tray flange area to confirm areas of lost contact with weatherstrip
      - Move the flange upwards in areas where low
      - Perform chalk test again to verify contact with weatherstrip

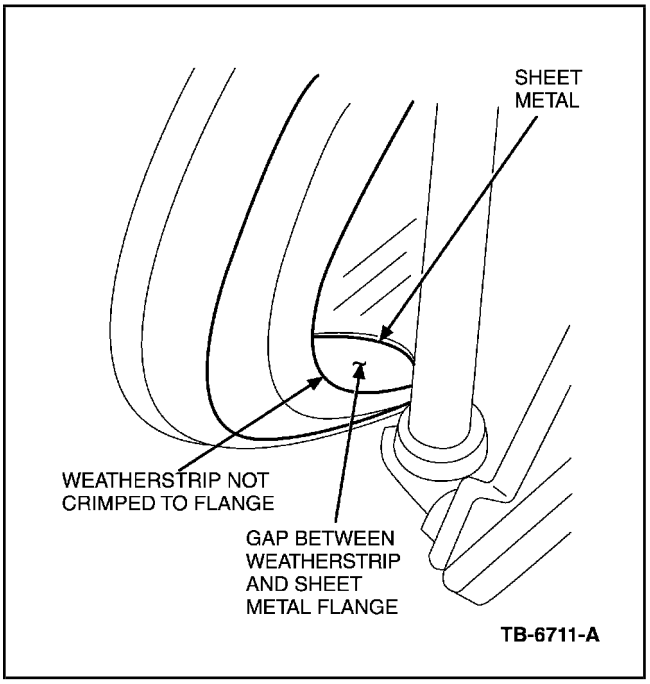
Figure 4 - Article 02-15-6

5. IF WATER IS FOUND IN SEDAN SPARE TIRE WELL.

a. Weatherstrip not crimped to sheet metal flange (loose or gapping) **Refer to Figure 4.**
   - Check if loose by pulling on weatherstrip bulb lightly (it should be tight to sheet metal flange)
   - Visually inspect weatherstrip for gaps between weatherstrip carrier and sheet metal flange
   - Reseat/re-crimp weatherstrip to flange

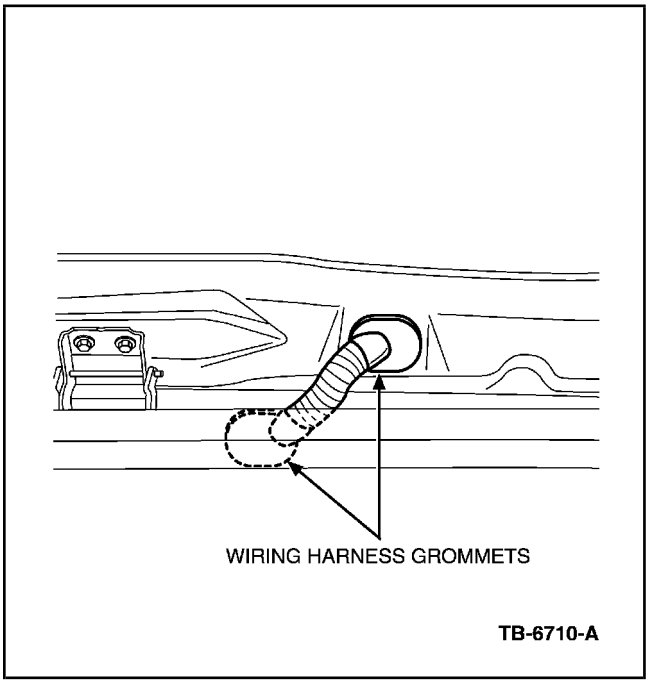
Figure 5 - Article 02-15-6

6. IF WATER IS FOUND ON WAGON REAR HEADLINER.

a. Wiring harness grommet not seated/loose **Refer to Figure 5.**
   - Pull on both ends (body-side and liftgate-side) of wiring harness to check retention of grommet to sheet metal
   - If grommets are loose, snap into place

a. Wiring harness grommet not seated/loose. **Refer To Figure 5.**
   - Pull on both ends (body-side and liftgate-side) of wiring harness to check retention of grommet to sheet metal
   - If grommets are loose, snap into place

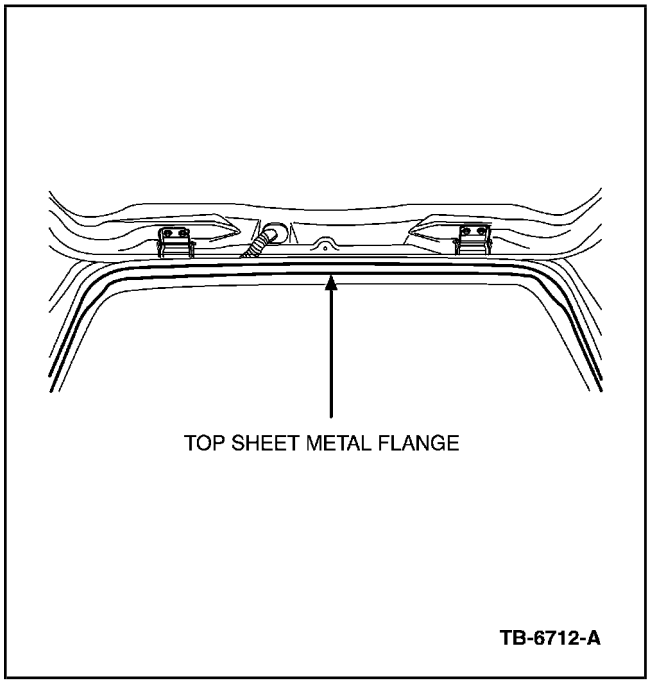
Figure 6 - Article 02-15-6

7. IF WATER IS FOUND ON WAGON CARGO AREA CARPET.

b. Top sheet metal flange too low. **Refer to Figure 6.**
   - Perform chalk test along top flange area to confirm areas of lost contact with weatherstrip
   - Move flange upwards in areas where low
   - Perform chalk test again to verify contact with weatherstrip

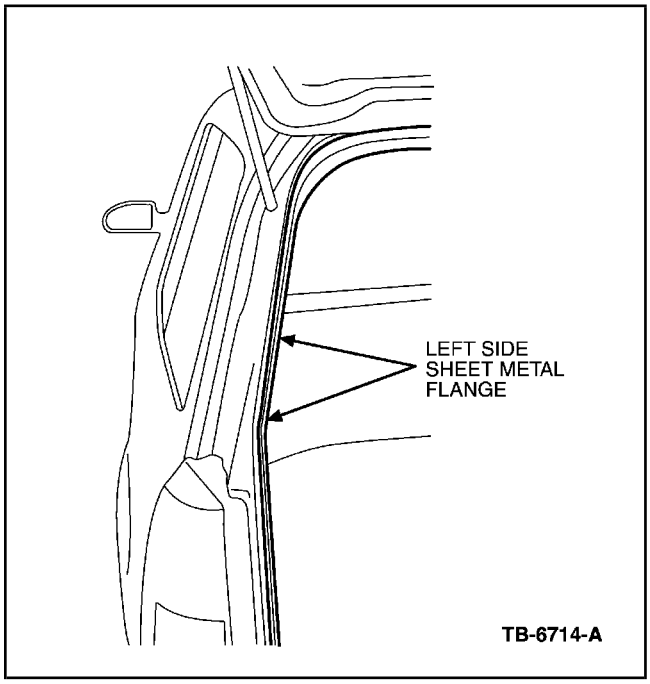
Figure 7 - Article 02-15-6

8. IF WATER IS FOUND ON WAGON PLASTIC TRIM AROUND LIFTGATE STRIKER.

b. Left/right sheet metal flanges inboard. **Refer to Figure 7.**
   - Perform chalk test along flange area to confirm areas of lost contact between weatherstrip and liftgate
   - Move flange outward in areas where inboard
   - Perform chalk test again to verify contact with weatherstrip
