## Permit Fact Sheet

Permit Number	WI-0067569-01-0
Permittee Name and Address	Gilbert Farms Ltd. 5186 Country Road T, Sturgeon Bay, WI 54235
Permitted Facility Name and Address	Gilbert Farms Ltd. 5186 Country Road T, Sturgeon Bay
Permit Term	October 01, 2025, to September 30, 2030
Discharge Location	5186 County Rd T, Sturgeon Bay, WI 54235, S ½ of the SW ¼ of the SW ¼ of S35 T28N R26E, Township of Sevastopol, Door County, WI
Receiving Water	Unnamed tributaries within the Door Peninsula-Frontal Lake Michigan Watershed, Lake Michigan Drainage Basin, and groundwaters of the state

December 4, 2024, Conditional Nutrient Management Plan Approval

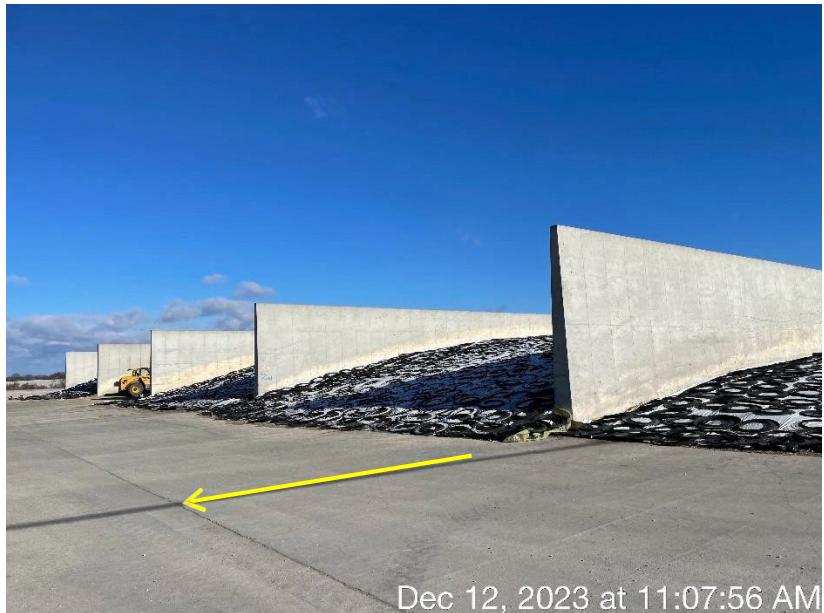
**Photo 39.** Feed storage bunkers located on the east side of the feed storage area. Runoff flows west to the middle, where it then flows north.
