# Check It Out Property Inspections

## CONFIDENTIAL INSPECTION REPORT

1194 Highbluff Avenue, San Marcos, CA  92078

5/6/2019  12:30 pm to 3:30 pm

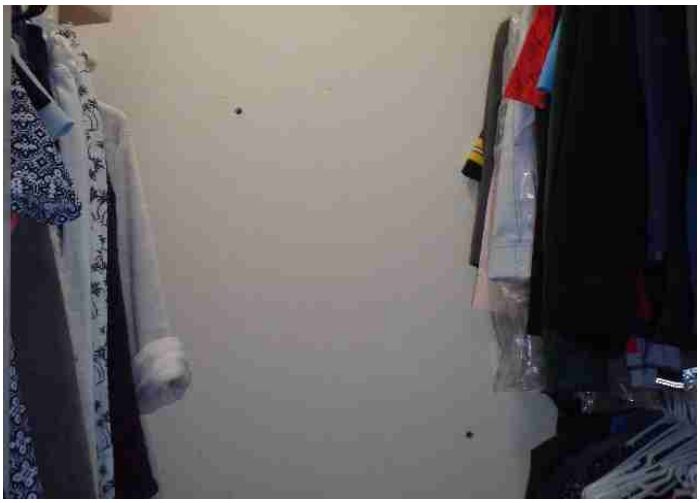
v Holes and dents in the walls of the master bedroom closet are in need of repair.
