Inspection Report

Property Address:
1213 Columbus Way
Vista CA 92081

Insight Property Inspections of San Diego

Date: 1/7/2021	**Time:** 01:30 PM	**Report ID:** 210107-12
Property: 1213 Columbus Way Vista CA 92081	**Customer:** Jeremy Steiding	**Real Estate Professional:** Niko Argeres

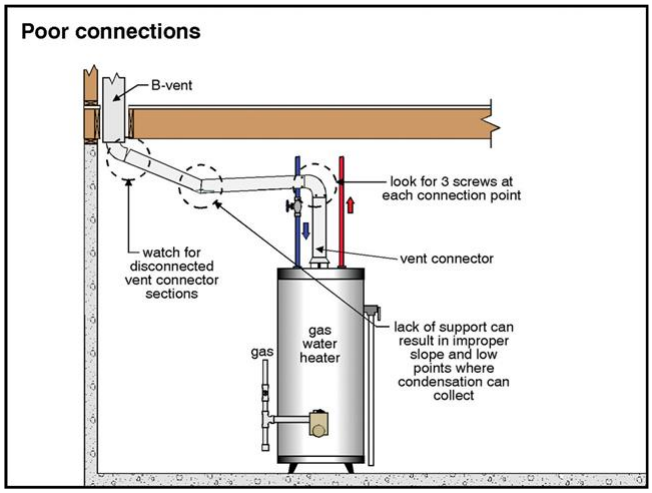
2.4 Item 1(Picture)

The water heater vent flue is not properly supported. Single wall vents require screw fasteners or other approved product. Advise correction by a licensed plumber.

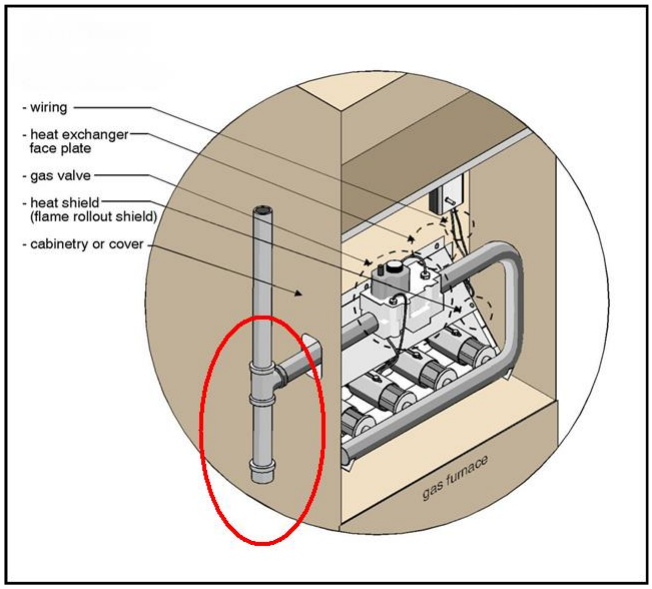
2.9 Item 2(Picture) water heater

IN	NI	NP	RR	Items
				A sediment trap is a small "Tee" pipe assembly installed in the gas line just before the appliance. The idea is that any debris/sediment in the gas will fall into the trap before it reaches the appliance gas control. The gas control valve is a sensitive device. Any debris that contaminates the control can cause the system to operate unsafely. Most gas furnace and gas water heater manufacturers have required them for years. The manufacturer's warranties will more than likely be void or invalid if these trap(s) are not installed. Sediment traps were not observed at the water heater or furnace. It is recommended to have a licensed plumber further evaluate to install sediment trap(s) as necessary.

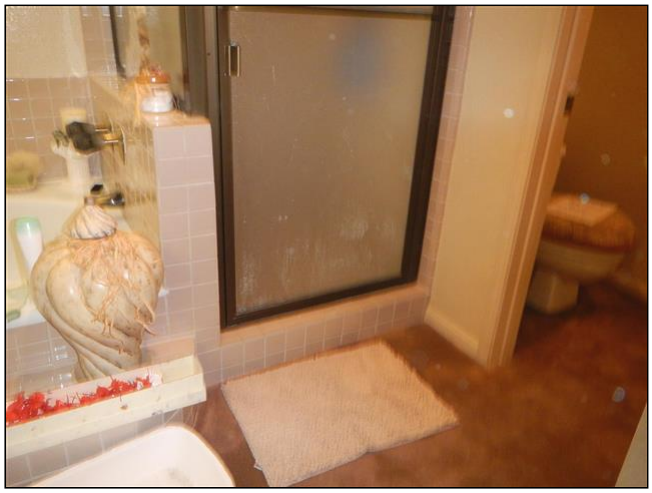
3.0 Item 1(Picture)

Carpet is installed in the master bathroom. This is not a good standard of installation. Carpet retains water, can cause deterioration and conditions which fosters mold. Installing a hard surface materials like tile, vinyl or stone in wet locations is advisable. The inspector cannot see under the carpet to verify if there is water damage.

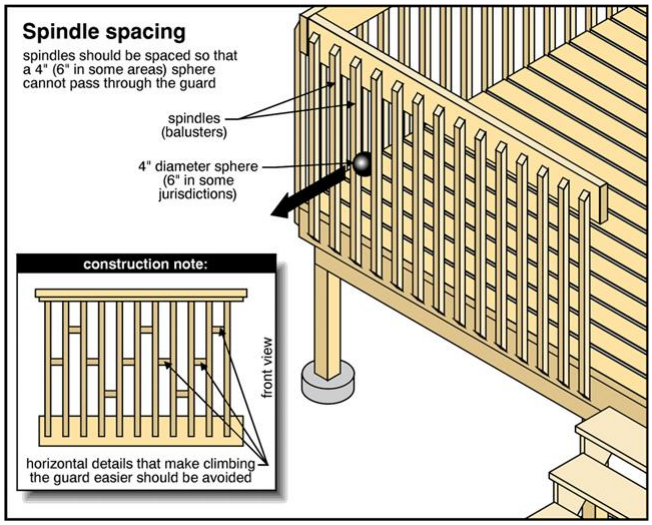
3.3 Item 1(Picture)

The rail spacing does not comply with the current safety standards of 4". It is recommended to install a form of barrier to assure safety.

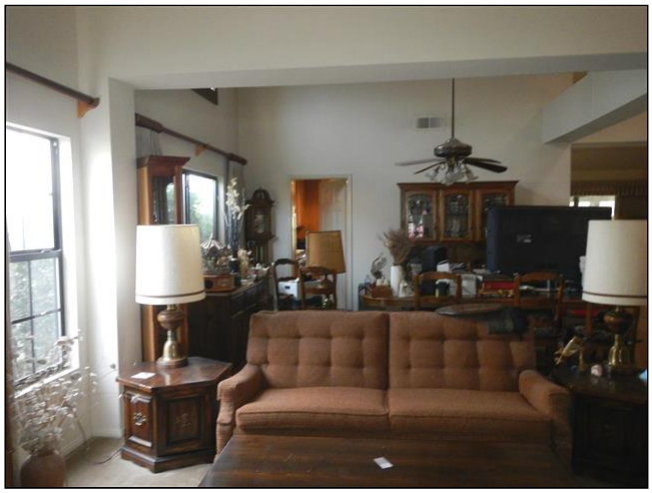
3.8 Item 2(Picture)

Due to personal property, some of the interiors were not visible. We recommend a careful evaluation before the close of escrow.

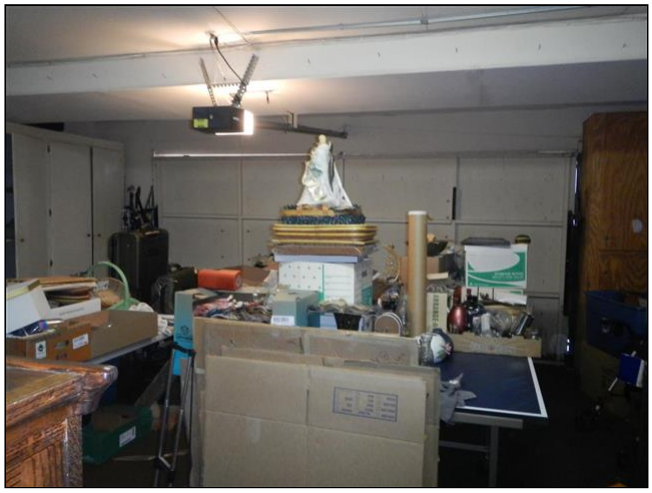
5.1 Item 1(Picture)

(1) Some of the walls were not visible due to personal property. Recommend reviewing this area before the close of escrow.

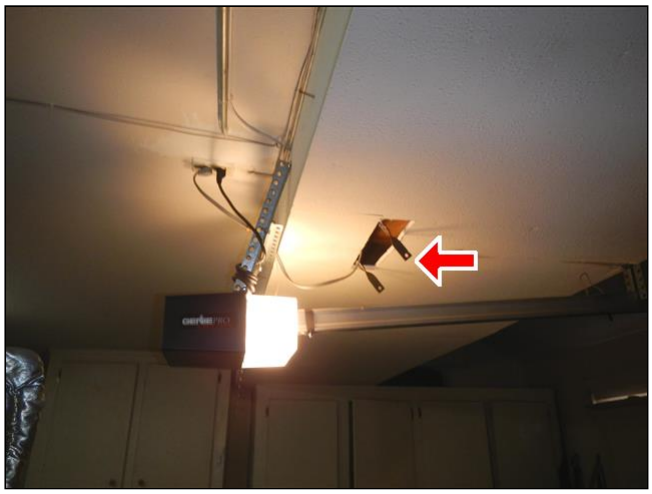
5.1 Item 2(Picture)

(2) Hole damage noted in the firewall ceiling. The wall and ceiling between the living quarters and garage is the "fire wall" which provides protection in case of a fire in the garage. The firewall must be intact for safety. Recommend repair by a licensed contractor.

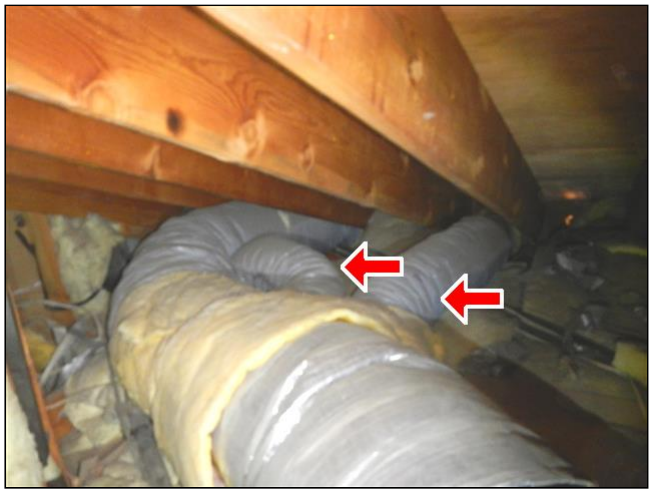
6.3 Item 1(Picture)

(1) Note: Grey flex ducting is installed in the home. This type of ducting is known to be defective; the plastic wrap can deteriorate due to hot attic conditions and UV/light exposure. The ducting also compresses over time and becomes less efficient. The ducting appeared to be intact at the time of the inspection. Longevity of the ducting is unknown. New ducting is more efficient than older ducting of this type.

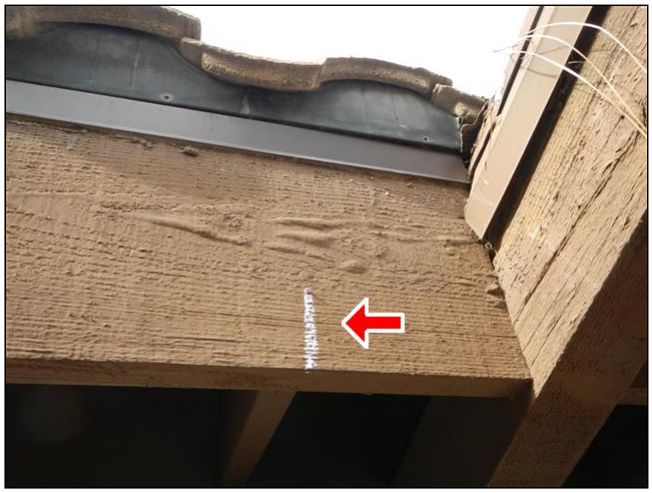
7.3 Item 1(Picture)

Deterioration noted at the roof eave. Refer to the pest control report.

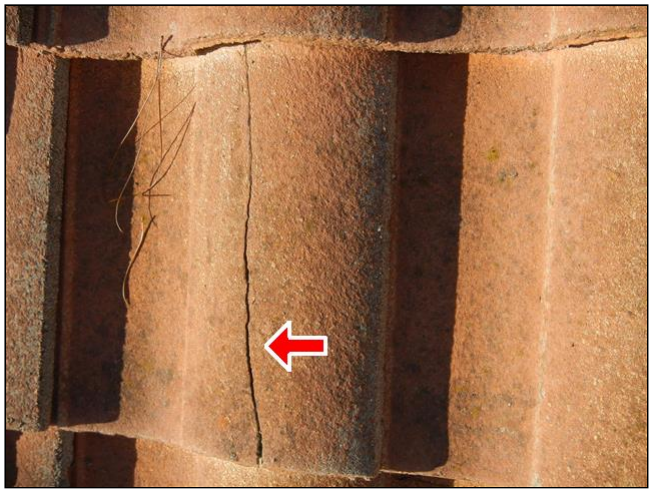
Cracked and missing roof tiles noted. It is recommended to have a general roof evaluation of the entire roof and repair as necessary by a licensed roofer.

8.0 Item 1(Picture) cracked tile

8.0 Item 2(Picture) missing tile

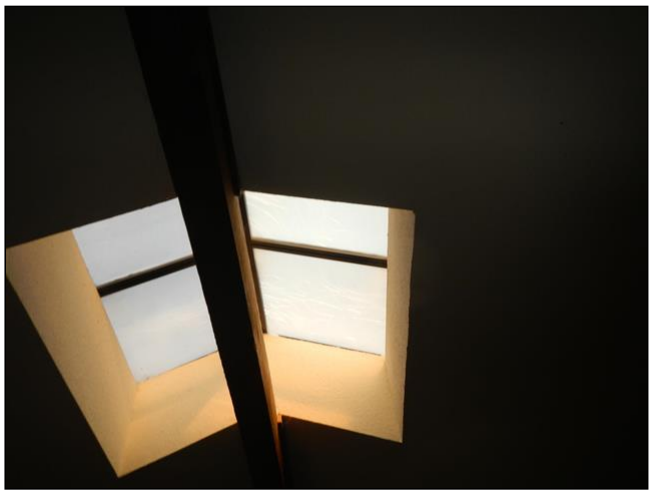
8.2 Item 1(Picture)

(3) The upper hallway skylight cover is cracked. Recommend necessary correction by a licensed roofer.

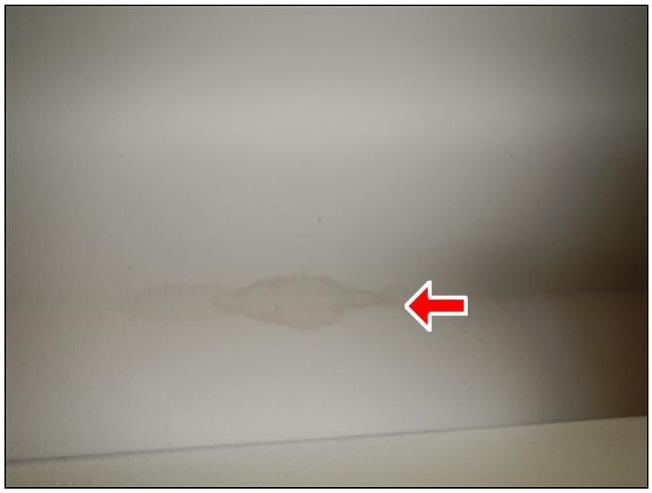
8.4 Item 1(Picture)

Water stains noted in the attic and living room. Advise inquiry with the seller for more information on any leak. It is recommended to have a licensed roofer further evaluate the roof.
