TOYOTA **TECHNICAL SERVICE BULLETIN**

REF.: HEATING & AIR
CONDITIONING
NO.: AC93-004
DATE: APRIL 09, 1993
MODEL: ALL MODELS

HFC-134A REFRIGERANT OIL HANDLING PRECAUTIONS

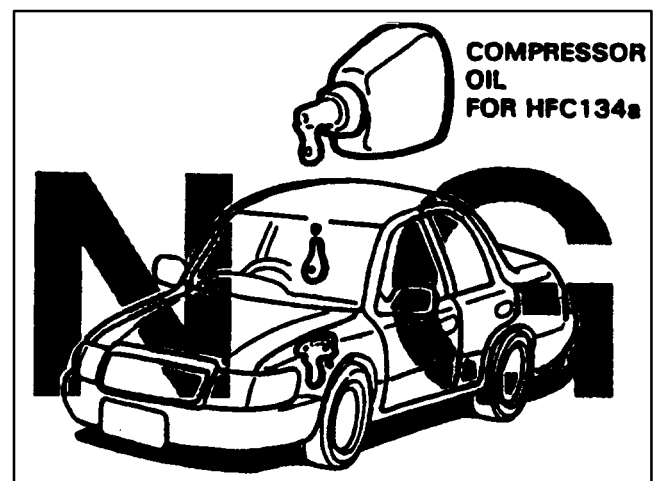
- ND-OIL8 is used in systems utilizing swash plate type compressors (10P/10PA).
- ND-OIL9 is used in systems utilizing through-vane (TV) type compressors.

Do not allow either of these oils (ND-OIL8 or ND-OIL9) to come into contact with any of the vehicles surfaces. It will cause discoloration of painted surfaces and deteriorate components made from acrylic or ABS (Acrylonitrile Butadiene Styrene).
