Collision Repair Information Bulletin

TITLE: Collision Damage Repair Precautions Bulletin #161

APPLICABLE VEHICLES: All Toyota, Lexus, Scion

DATE: Revised April 2022

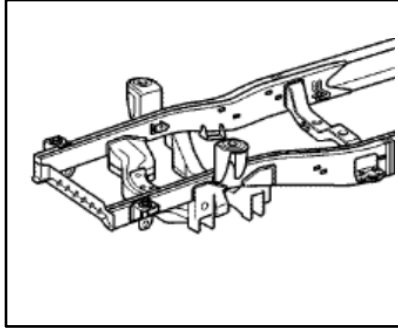
When to Replace Damaged Body and Frame Components

Body and frame deformations that cannot be returned to original shape by pushing, pulling, or hammering (known as cold straightening) are classified as kinks. Kinks require component replacement. Deformations that can be returned to original shape by cold straightening methods are classified as bends.
