Collision Repair Information Bulletin

TITLE:	Front/Rear Door Outer Panel Installation Substitution	Bulletin #199
SECTION:	Vehicle Exterior	
APPLICABLE VEHICLES:	All Toyota, Lexus and Scion Vehicles	
DATE:	December 2021	Page 1 of 2

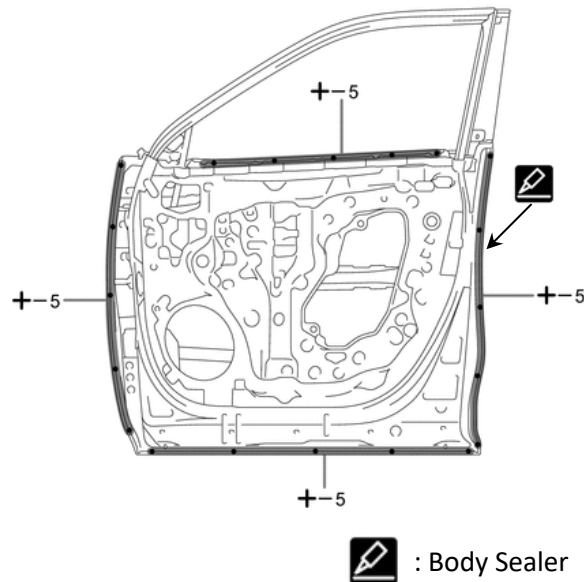
[Method 1] Body Sealer + Spot MIG Weld (Fig. 1)

Fig. 1 Body Sealer + Spot MIG Weld

Models and model years with installation method #1 and #2 can be substituted to installation method #3.

Hemming thickness must be within 0.2mm of the original door hemming thickness.

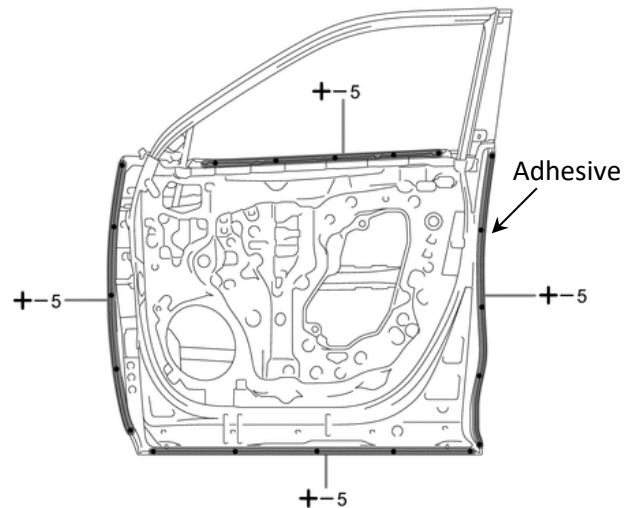
[Method 2] Adhesive (3M™ Automix™ Panel Bonding Adhesive #8115) + Spot MIG Weld (Fig. 2)

Fig. 2 Adhesive + Spot MIG Weld

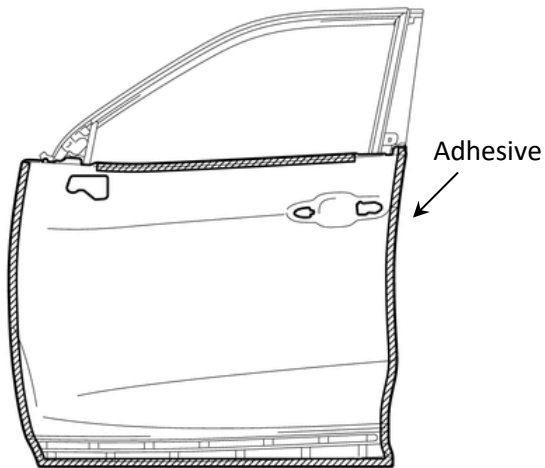
[Method 3] Adhesive (3M™ Automix™ Panel Bonding Adhesive #8115) (Fig. 3)

Fig. 3 Adhesive
