TECHNICAL INSTRUCTIONS FOR CELICA

I. OPERATION FLOW CHART FOR SSC P01 - A/C EXPANSION VALVE

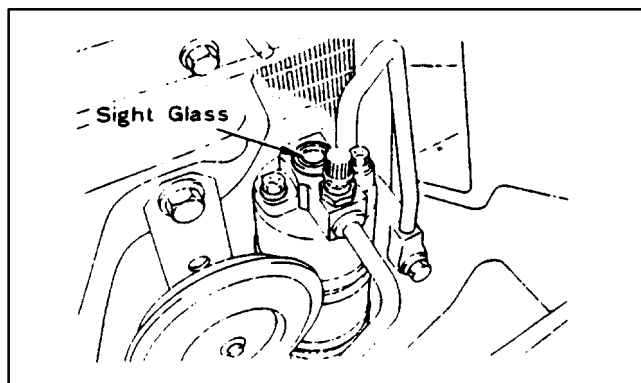
Figure 1

Check the sight glass (**Figure 1**) after maintaining the following conditions for 2 minutes. Perform the check with the cooling fan at a steady speed, not during switching either ON, OFF or between speeds.

CAUTION: Every vehicle shows air bubbles both immediately after starting and when switching from one condition to the other, so it is necessary to wait for stable cooling fan speed to perform the check.

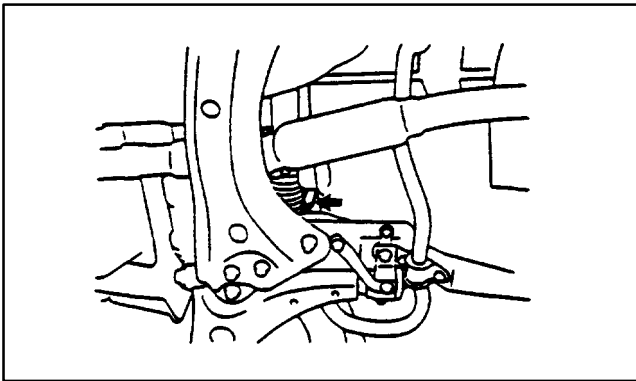
Figure 16

Use a leak detector to determine whether gas is leaking out of the A/C drain hose from the expansion valve. (**Figure 16**)

CASE B: Gas is not detected leaking out of the drain hose end. Follow procedures under **CASE B**. (Page Celica-7)

CASE C: Gas is detected leaking out of the drain hose end. Follow procedures under **CASE C**. (Page Celica-8)

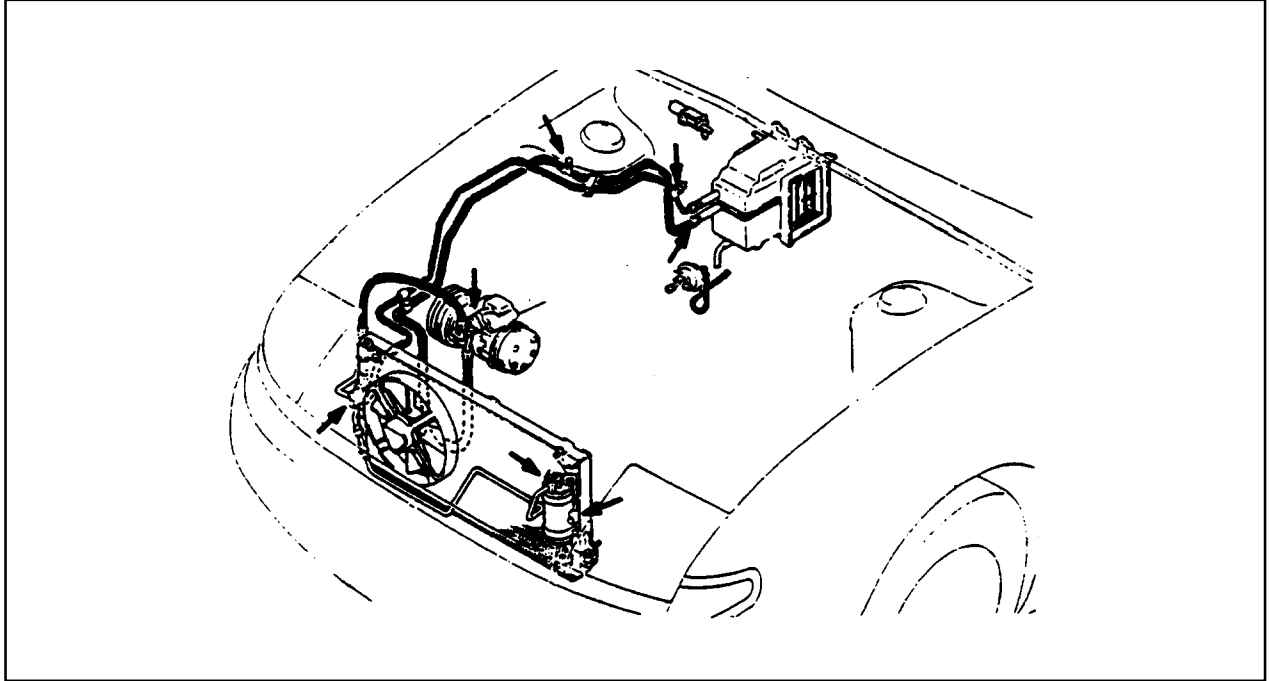
Figure 17

Check whether A/C is leaking from anywhere other than the drain hose end. Use a leak detector to determine whether gas is leaking from the locations shown by the arrows below.

- OK (No leaks found): Confirm full refrigerant charge. Cost of recharging will be covered by Toyota Warranty or at customer's expense (with consent) as applicable.
Add Toyota ND6 AC Refrigerant Oil Charge.
See **WORK PROCEDURE FOR CASE A** on Page Celica-2.
- NG (Leaks found): These leaks are either:
- (i) Covered by Toyota Basic Warranty Policy, or
 - (ii) Charge at customer's expense. (Ensure that customer gives prior consent before proceeding with the repair.)
 - (iii) Following completion of repair, add the Toyota ND6 AC Refrigerant Oil Charge as shown on Page Celica-2.

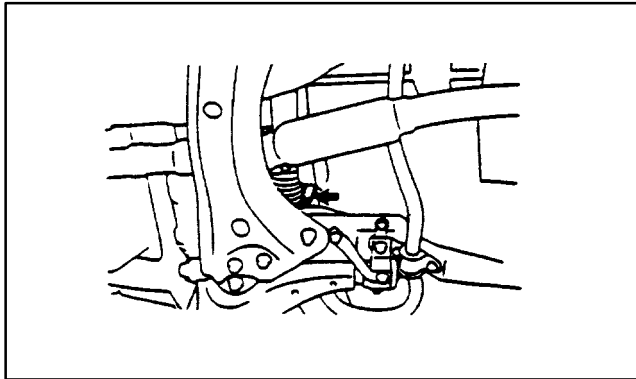
Figure 23

Refrigerant leakage from the evaporator or from the expansion valve location can be inspected at the drain hose. **(Figure 23)**

| (1) | OK (No leaks found): | Charge the refrigerant. |
| (2) | NG (Leaks found): | These leaks are either: <ul style="list-style-type: none"> * Covered by Toyota Basic Warranty Policy, or * Charge at customer's expense (ensure that customer gives prior consent before repair.) |
