SOCIETY FOR ECOSYSTEM RESTORATION
IN NORTHERN BRITISH COLUMBIA

Restoring Fish Passage in the Peace Region - 2023

Version 0.0.1 2024-05-31

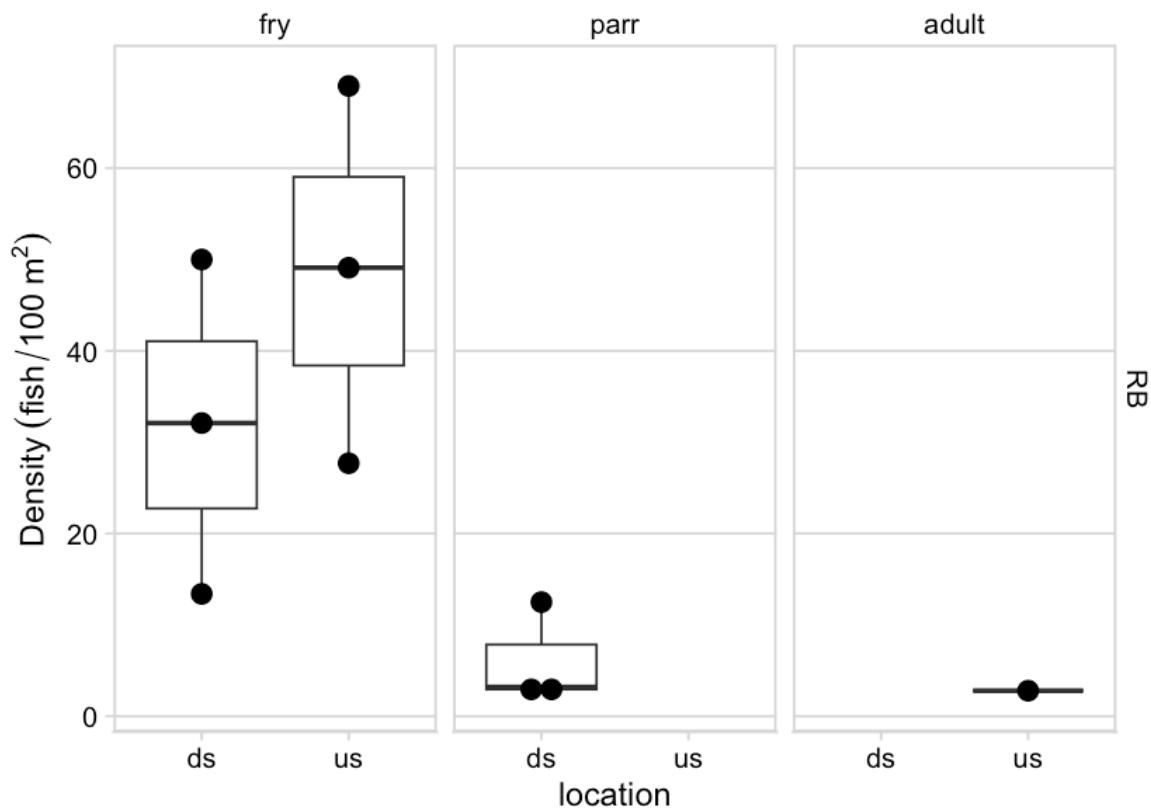
Figure 5.1: Densities of fish (fish/100m²) captured upstream and downstream of PSCIS crossing 125231.

Restoration of fish passage at crossing 125231 is lined up for the summer of 2024 with a design specifications to replace the two 1.2m round pipes (outlet drops of 0.65m) with a 12.2m steel girder/timber deck bridge on spread footing. Replacement of the crossing will provide access to habitat blocked to upstream migrating fish for likely 10 - 20 years (timeline depending on the rate of down cutting caused by the outlet drops) and the stream has no other anthropogenic obstructions to fish passage. The presence of burbot in the system is of particular interest as this fish provides good food values and in general, compared to numerous other species (ex. steelhead and coho), burbot are documented as less capable swimmers considering time-to-fatigue versus swim speed (Katopodis and Gervais 2016). The presence of burbot downstream of the crossing and absence in sample sites above could indicate that the crossing is preventing some migration of this species however sample areas were small and the habitat presence/preference may have been more a determinant of presence than the passability of the crossing.

Resampling of fish at the site in future years of the project is recommended to build our understanding of fish use, movement and health in the stream providing valueable data for monitoring the effectiveness of crossing replacement. Additionally, aquisition of aerial imagery following structure replacement is recommended so that aerial imagery and 3D models generated from the data can be compared to products generated from data gathered in 2023. These comparisons will be useful for communications related to the project as well as for providing insight into changes in stream morphology, effectiveness of environmental management plans and site rehabilitation efforts following construction.

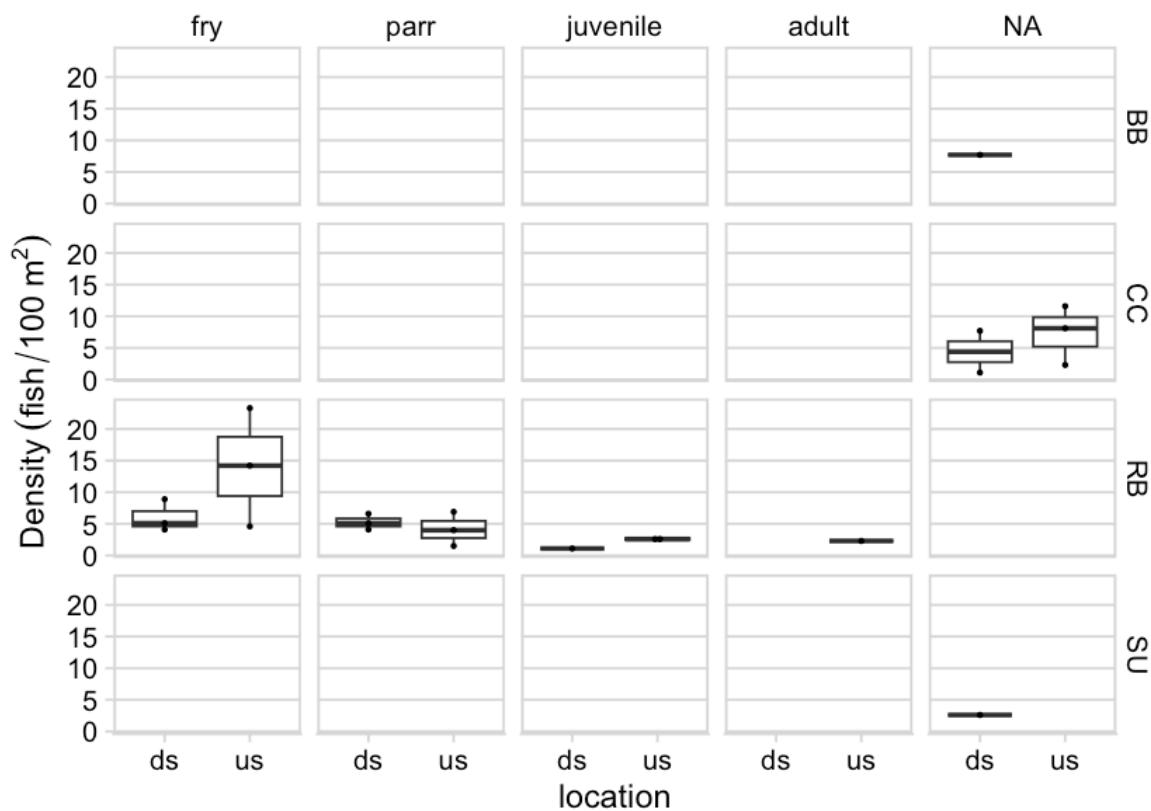
Figure 5.4: Densities of fish (fish/100m²) captured upstream and downstream of PSCIS crossing 125261.

Replacement of PSCIS crossing 125261 on Fern Creek is a priority for this overall project as this is a large system likely containing no other anthropogenic obstructions to fish passage. The presence of burbot in the system is of particular interest as this fish provides good food values and in general, compared to numerous other species (ex. steelhead and coho), burbot are documented as less

Recapture of fish PIT tagged during 2023 fieldwork will build our understanding of fish movement and health at the site with information collected useful for monitoring the effectiveness of crossing replacement. Additionally, aerial imagery and 3D models can be used to monitor changes in stream morphology and effectiveness of environmental management plans as well as site rehabilitation efforts following construction. The work is tentatively scheduled for 2025 with engineering design led by Canfor.

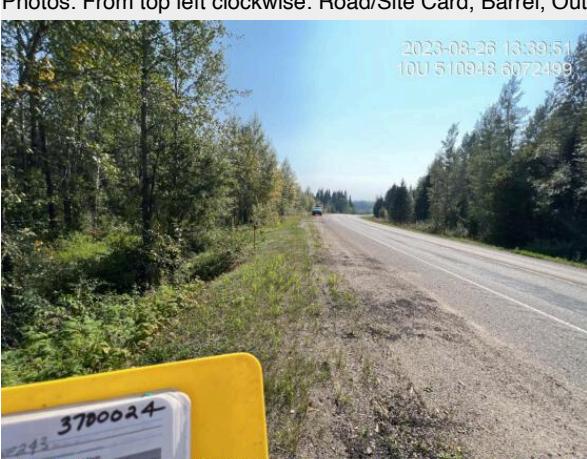
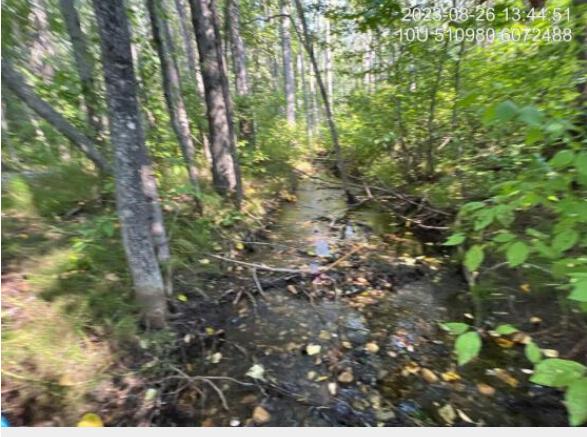
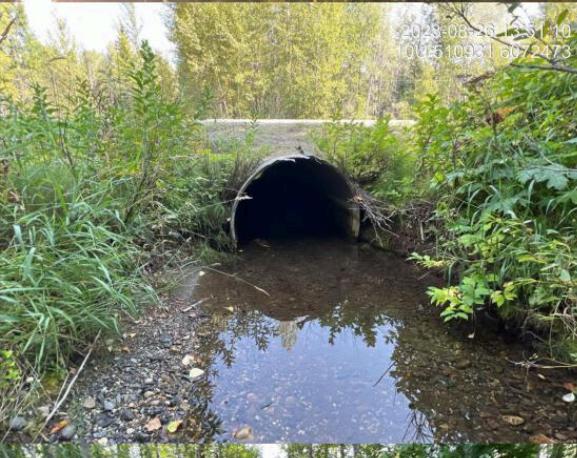
Stream Characteristics at Crossing

At the time of the survey, PSCIS crossing 198687 was backwatered and embedded - ranking as a passable - according to the provincial protocol (MoE 2011) (Table [5.16](#)). Water temperature was 7.4 °C, pH was 6.8 and conductivity was 411uS/cm.

Although the crossing appeared to be passable at the time of assessment it was noted that recent work had been completed to dredge out the stream channel upstream and downstream of the highway. This indicated that the structure currently in place was not appropriate for the site and that replacement of the crossing could be beneficial from a highway maintenance perspective as well as for reducing impacts on the potentially higher value habitat located immediately adjacent to the road (extensive gravels suitable for spawning). For this reason, a habitat confirmation assessment was completed to gather data on the value of the habitat upstream and downstream of the crossing.

Should restoration/maintenance activities proceed, replacement of PSCIS crossing 198687 with a bridge (NAm span) is recommended. The cost of the work is estimated at \$NA.

PSCIS crossing 198687 on 42 Mile Creek was ranked as a moderate priority for proceeding to design for replacement. The project team plans to follow up with the Ministry of Transportation and Infrastructure to discuss the potential for replacement of the structure and to provide the necessary data to support the replacement if it is deemed helpful.
