SOCIETY FOR ECOSYSTEM RESTORATION
IN NORTHERN BRITISH COLUMBIA

Restoring Fish Passage in the Peace Region - 2023

PEA-F24-F-3944-DCA

Prepared for
Fish and Wildlife Compensation Program
and
Fish Passage Technical Working Group

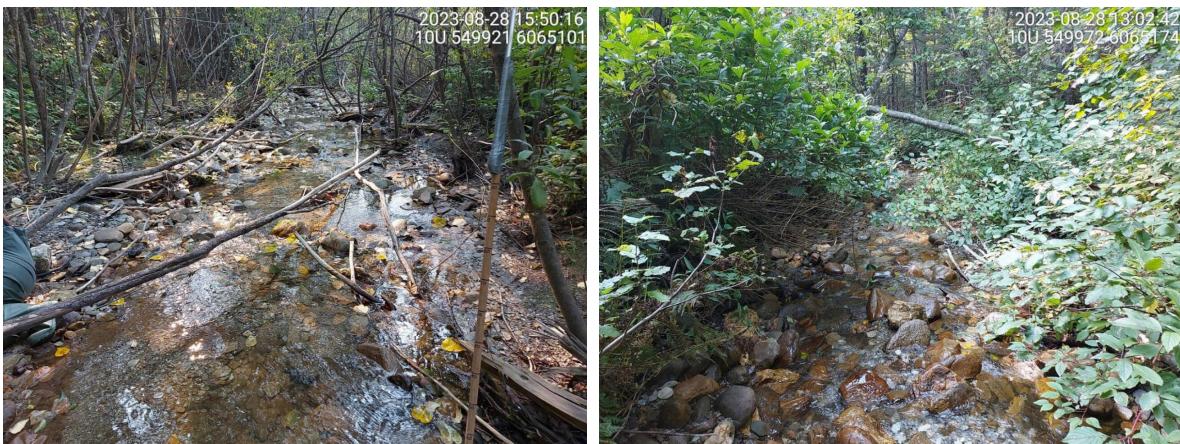
Figure 5.3: Left: Habitat electrofished downstream of PSCIS crossing 125231 in 2023. Right: Habitat electrofished upstream of PSCIS crossing 125231 in 2023.
