SOCIETY FOR ECOSYSTEM RESTORATION  
IN NORTHERN BRITISH COLUMBIA

## Restoring Fish Passage in the Peace Region - 2023

PEA-F24-F-3944-DCA

Version 0.1.0 2025-05-14

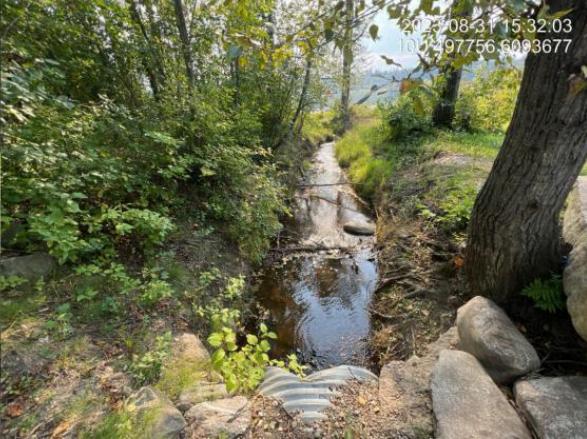
Table 5.16: Summary of fish passage assessment for PSCIS crossing 198714.

Location and Stream Data		Crossing Characteristics	
Date	2023-08-31	Crossing Sub Type	Round Culvert
PSCIS ID	198714	Diameter (m)	1.2
External ID	–	Length (m)	8
Crew	AI MD	Embedded	No
UTM Zone	10	Depth Embedded (m)	–
Easting	497758.4	Resemble Channel	No
Northing	6093674	Backwatered	No
Stream	Tributary to McLeod Lake	Percent Backwatered	–
Road	Campground Rd	Fill Depth (m)	0.5
Road Tenure	MOE	Outlet Drop (m)	0
Channel Width (m)	2.3	Outlet Pool Depth (m)	0.3
Stream Slope (%)	2	Inlet Drop	Yes
Beaver Activity	Yes	Slope (%)	5
Habitat Value	Medium	Valley Fill	Deep Fill
Final score	26	Barrier Result	Barrier
Fix type	Replace with New Open Bottom Structure	Fix Span / Diameter	10

It is recommended that if 198714 is not essential for vehicle traffic that the small structure be replaced with a walking bridge or removed completely. If either of those options are not suitable, replacement of the crossing with a bridge (10m span) is estimated to cost \$NA. The culvert under the highway would require extensive works to complete costing an estimated \$1,500,000
