小磨坊斗六廠辦更新工程

廠房更新前

小磨坊斗六廠外牆一期工程-辦公棟外牆檢測敲除修補

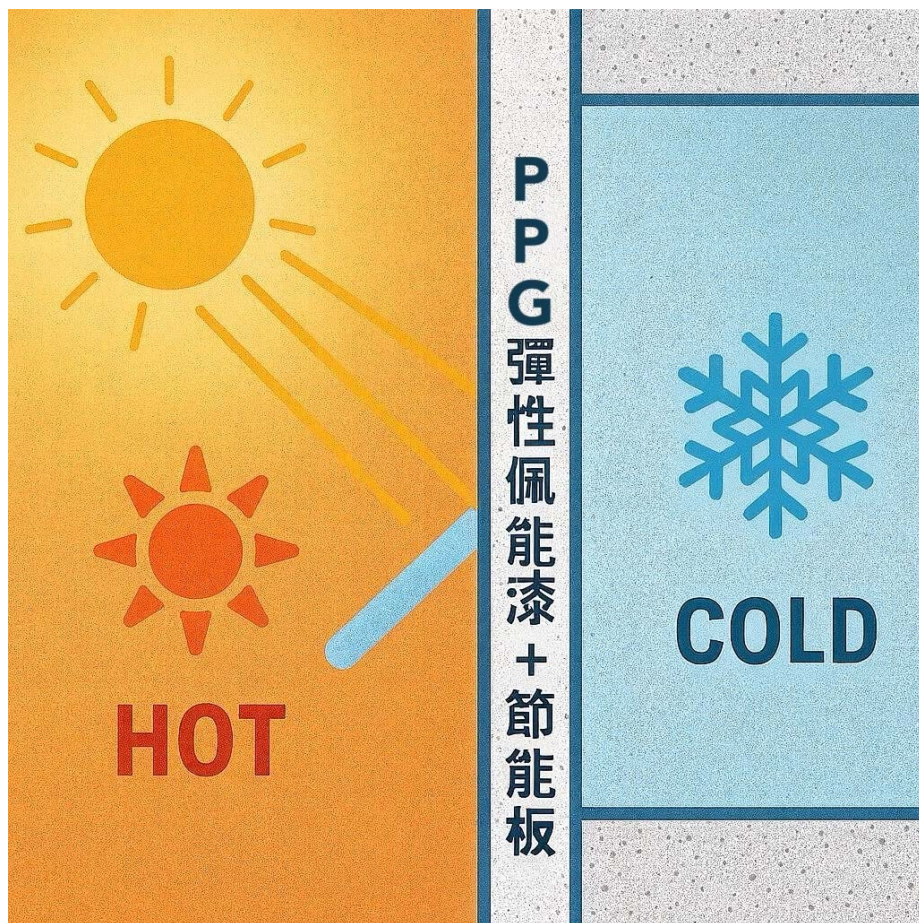
ALC版

- 接縫處滲漏水
- 鋼筋鏽蝕裸露
- 防水漆處理無效

PPG彈性佩能漆+節能板工法

隔熱漆+節能板 雙倍隔熱效果更佳

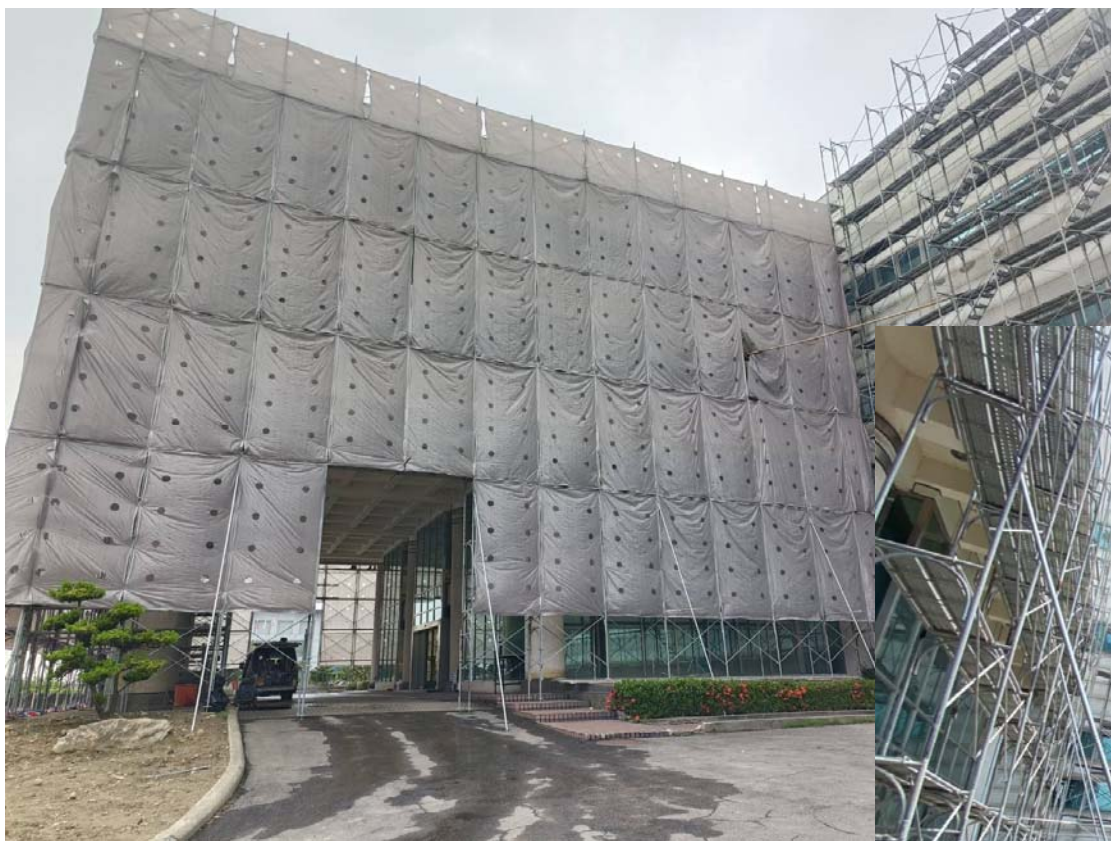
現場拍攝

完工照片

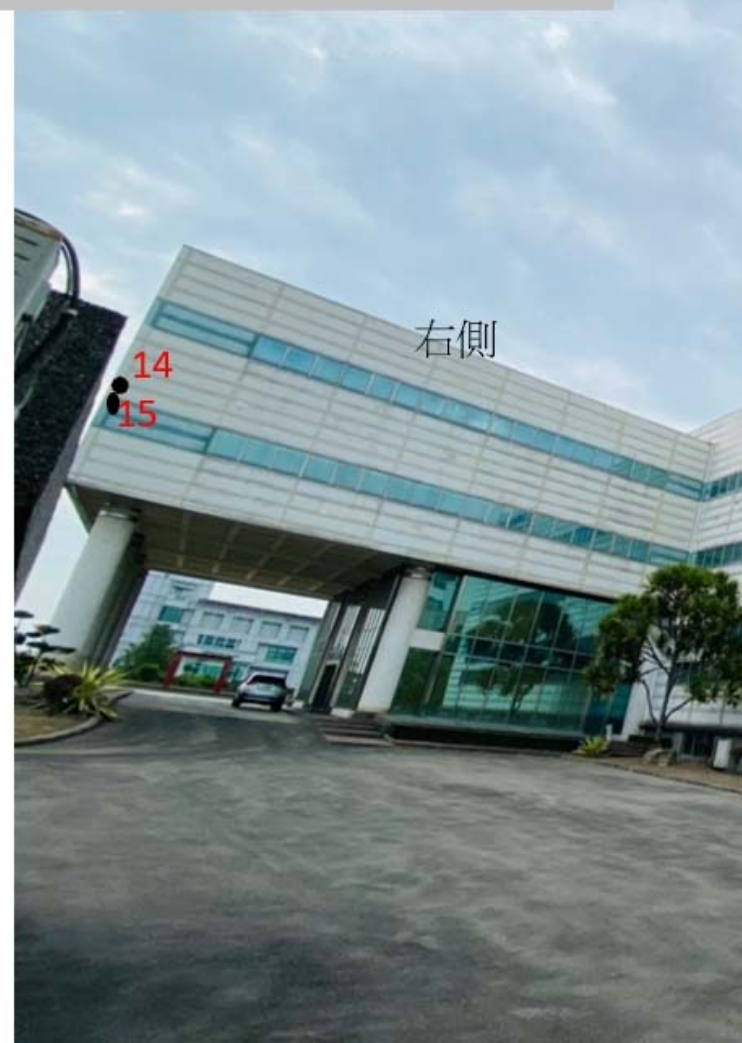
外牆檢測敲除標示

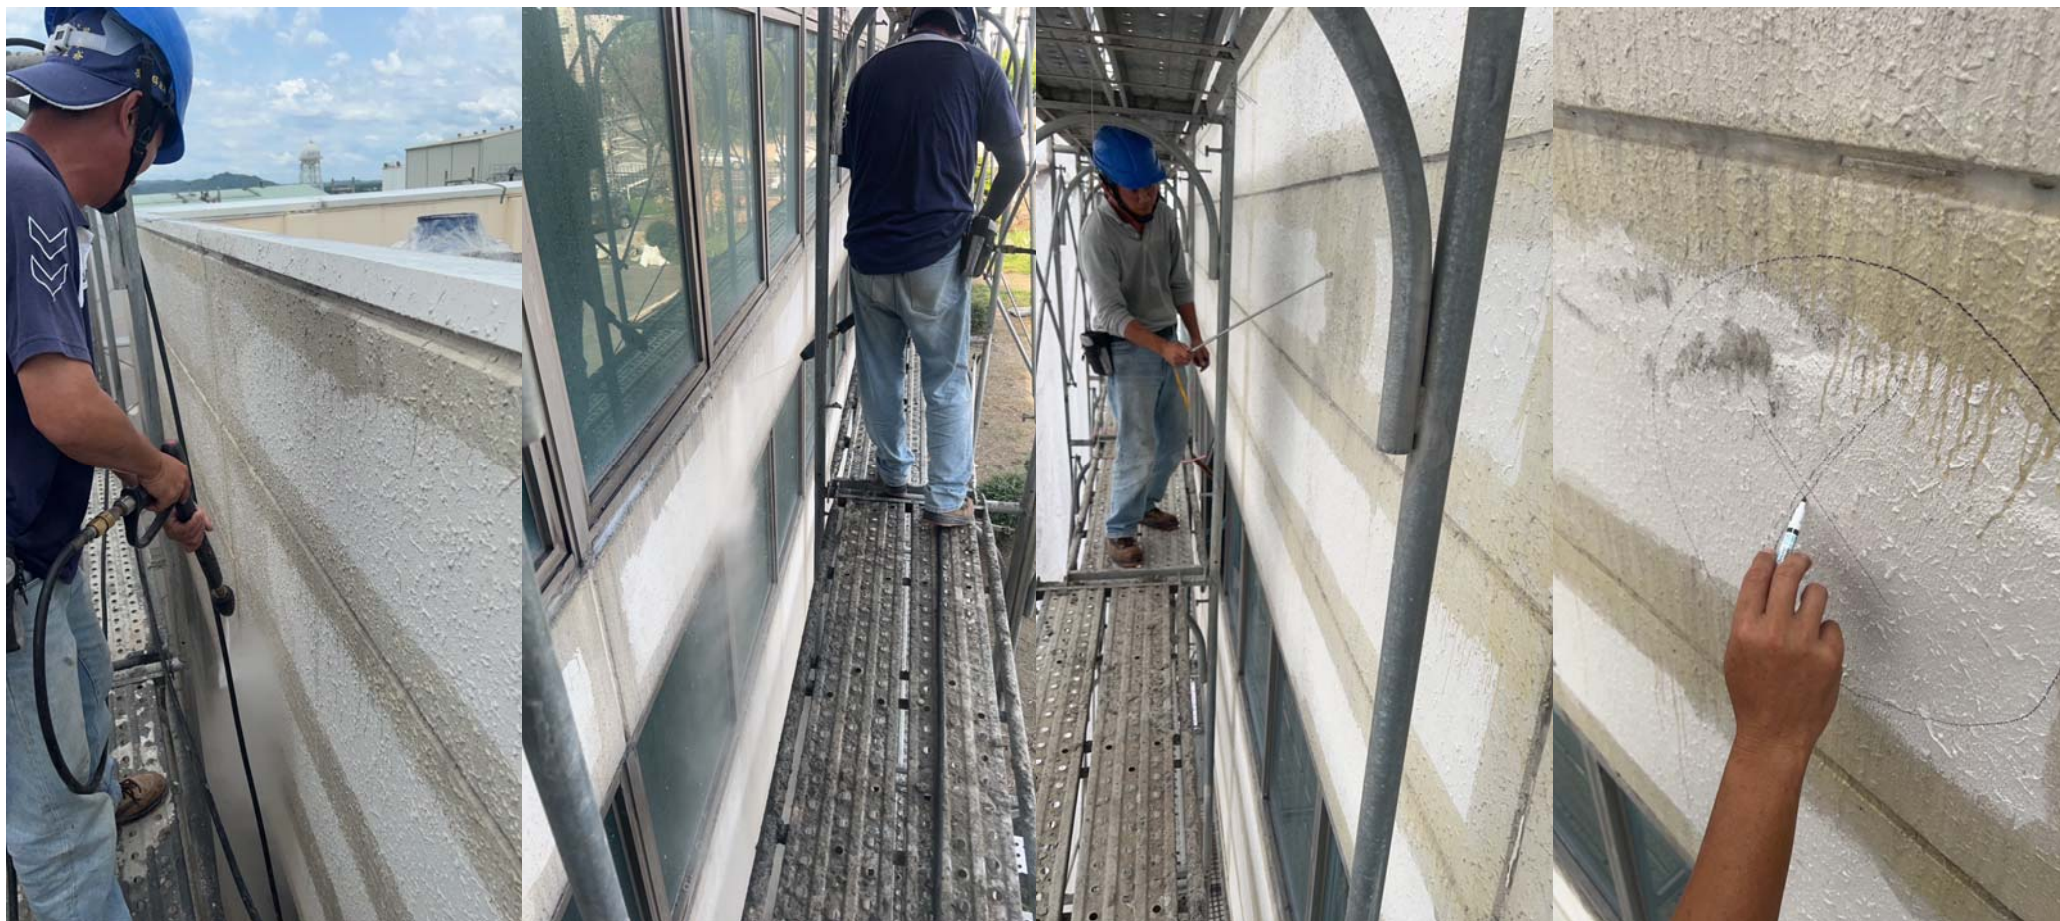
外牆檢測.清洗

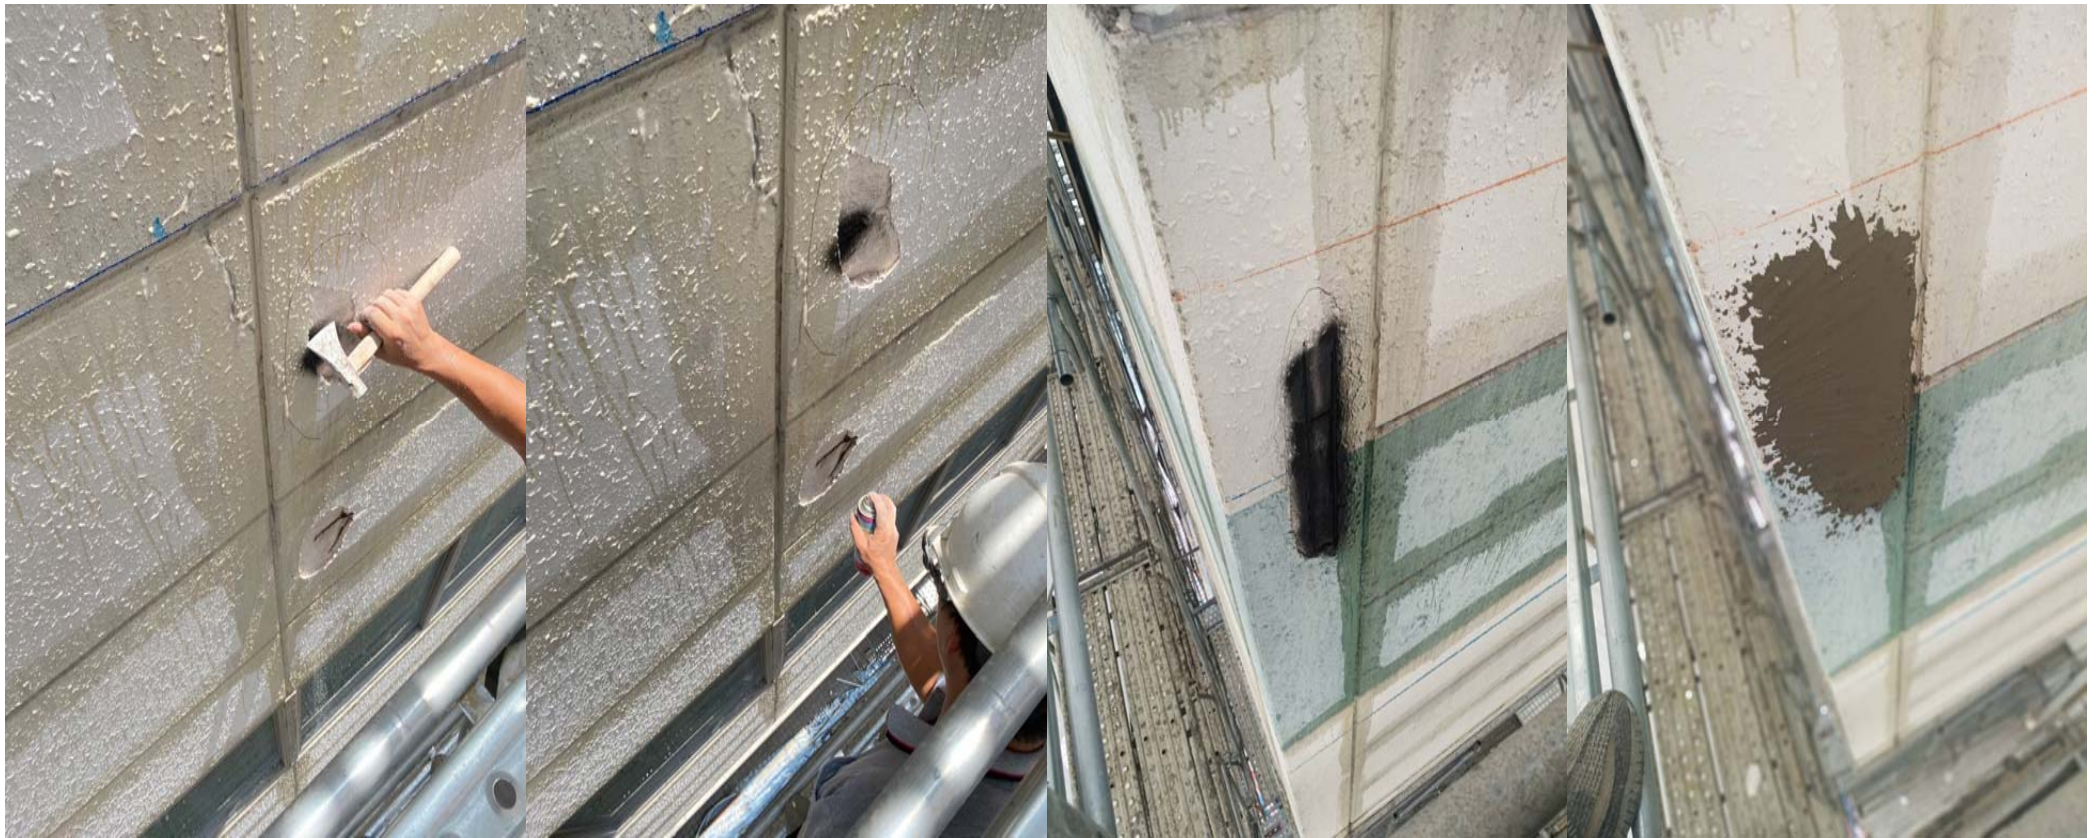
外牆敲除.防鏽.修補

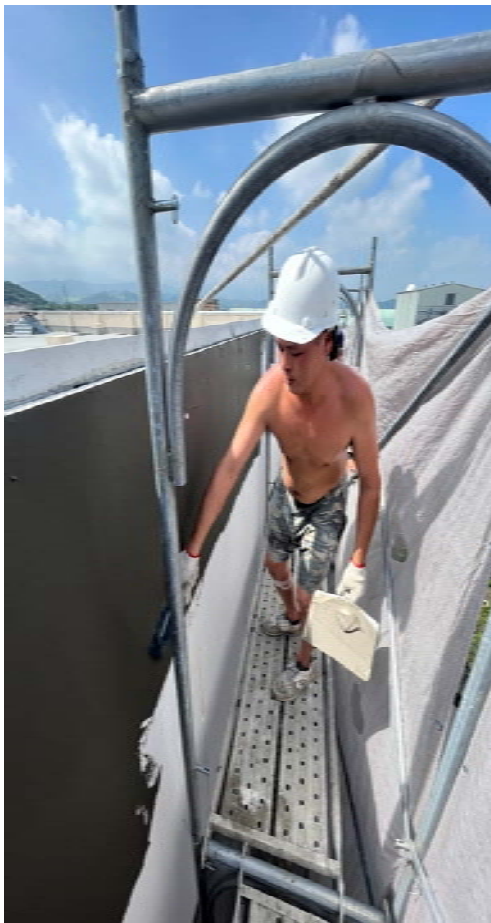
外牆節能版施工

節能版安裝

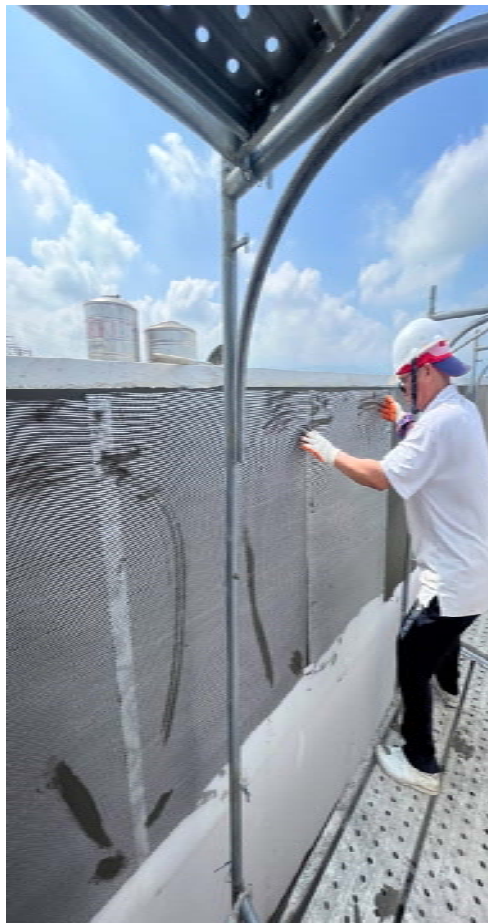
外牆節能版施工

節能版上泥
