C175 - Identification Tags for Engines that Require Thicker Integral Seals

C175 ID Tags for Engines that Require Thicker Integral Seals	DATE 6/16/2016	CHG NO 00	NUMBER 1606-4.01-1439
--	-------------------	-----------------	--------------------------

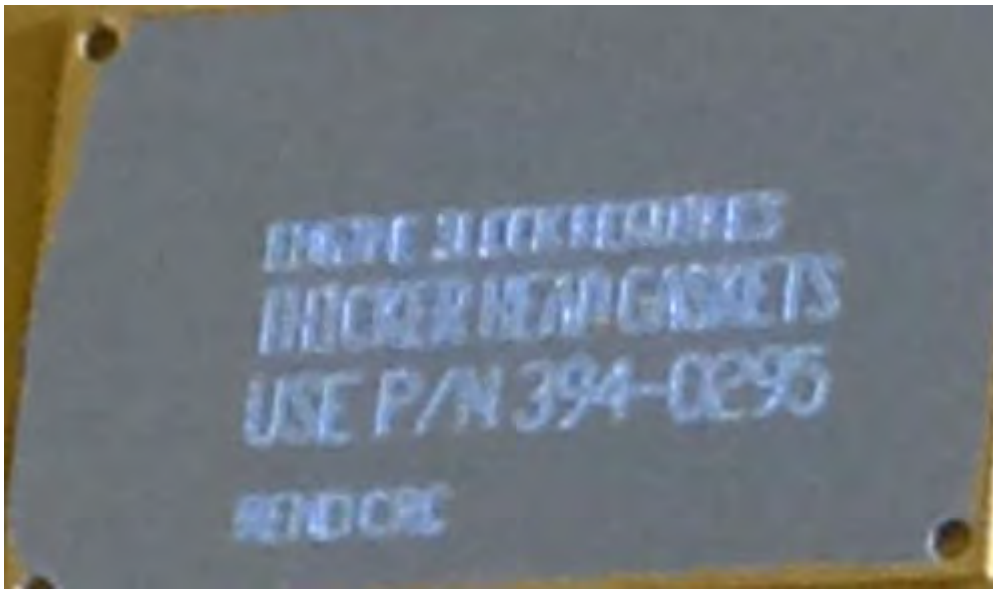
In this example, the plate reads:

ENGINE BLOCK REQUIRES
THICKER HEAD GASKETS
USE P/N 394-0295

RENO CRC

This Dealer has implemented a practice of affixing a stamped aluminum plate to each valve cover using epoxy on an engine that was milled under the specification. An additional plate is put next to the Component ID tag on the engine.
