Aftercooler Adapter Remover – 793C, 793D

Maintenance and
Repair

NUMBER
4.03-171229-01

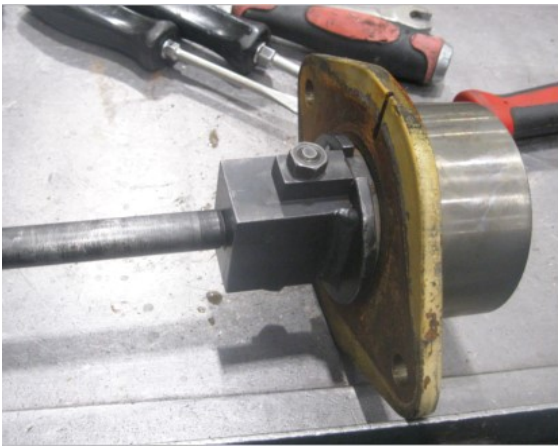
A tool was developed to eliminate the damage to the aftercooler housing (P/N 210-2603 & 210-2581) when removing adapters (P/N 371-5945 & 371-5944.) Due to the small size of the adapters, it is often difficult to remove them without the risk of causing damage to other components.

BEFORE

AFTER

Install the developed tool inside the space between the aftercooler core and the adapter. Make sure to adjust the nails and pull the adapter.

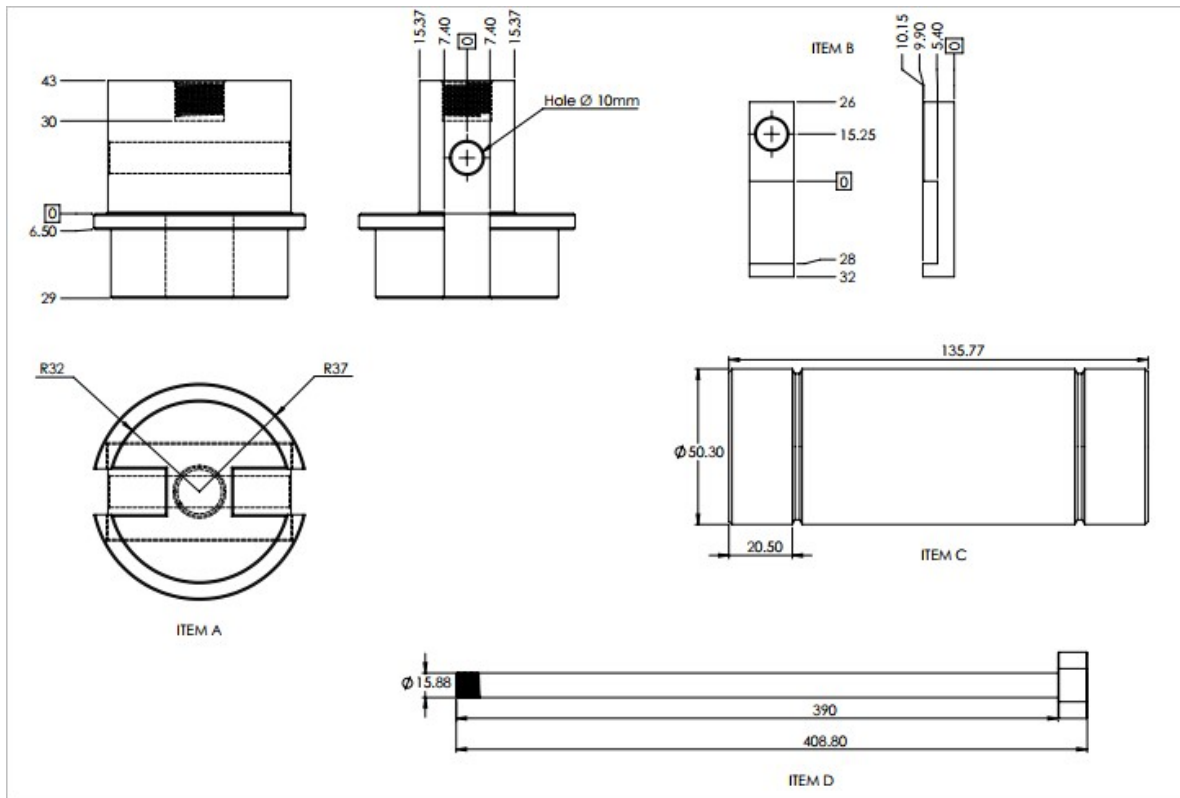
Design for the tool is shown below. Further dimensions are shown in the attachments section

Below are the required manufacturing drawings and the stress analysis conducted on the lifting tool.
