Change Assembly Superbolts Hoist Pedestal - CAT 7495

February 2023
1.04-230203-1

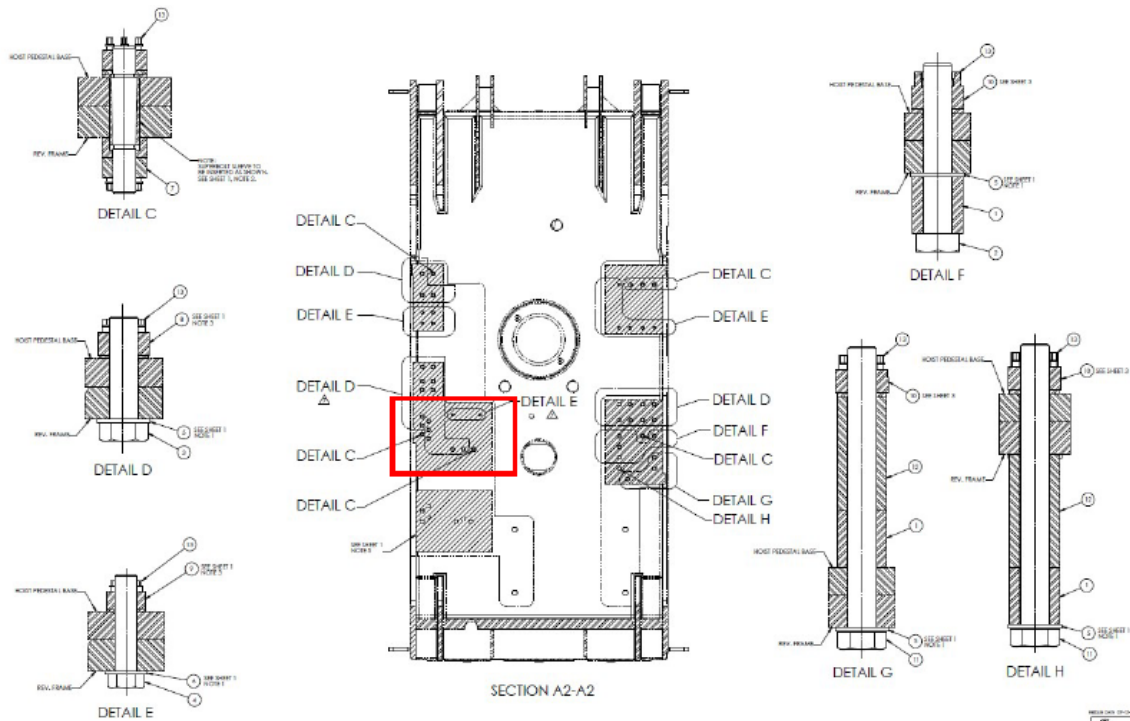
Figure 2: Location of super bolts of hoist pedestal

Below is the identification (inside the red rectangles) of the screws that had the assembly in reverse arrangement.

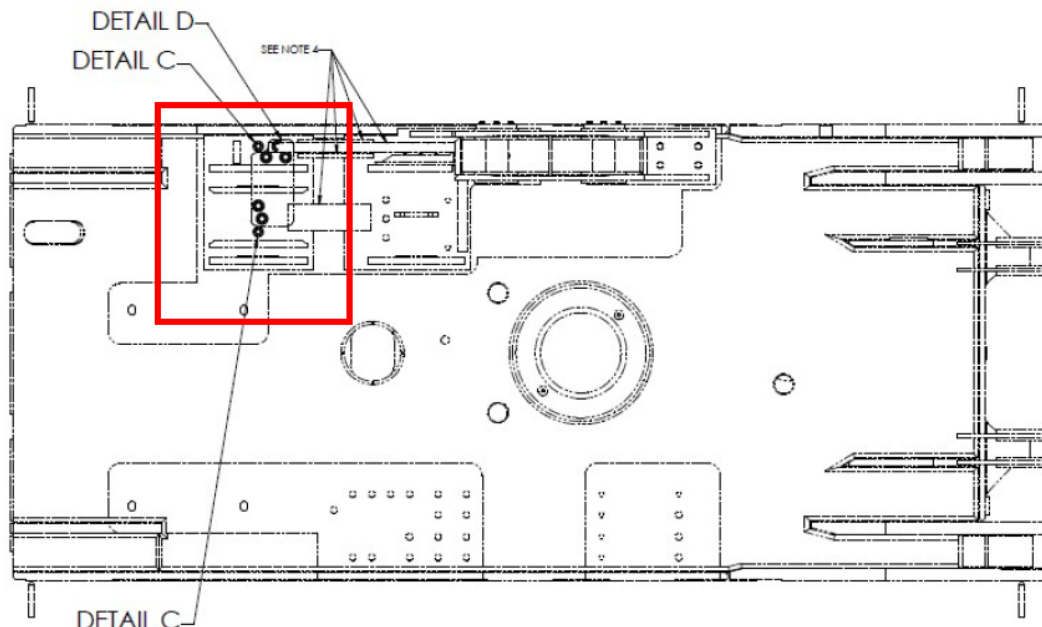
Figure 3: Screws arrangement "C" hoist pedestal

The screws arrangement "C" was kept according to the drawing orientation, even being covered by the reducer, as these have super bolts on both sides and would not bring the advantage of the models mentioned above.

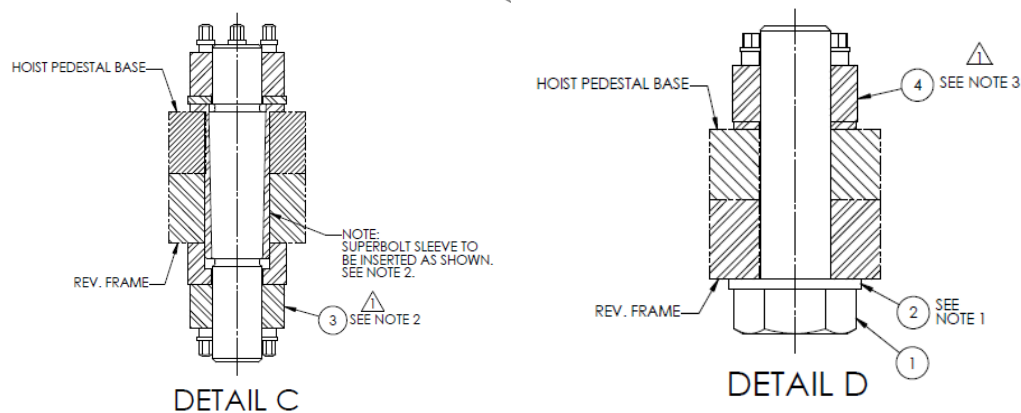
Figure 7: Super bolts detail

The inversion of the mounting arrangement in the drawings cited was carried out with a total of 12 screws model “D” and 2 screws model “E”.

1. Assemble the super bolts **PN 443-2362 model “D”** and **PN 467-0893 model “E”** in the position shown in this BP during the equipment assembly process or intervention to replace the super bolts.
2. At the time of installation, use suitable torque equipment and technicians with proper confined space training.
