Top Technical Failures: Power & Redundancy

The Field Reporting Integrity Gap

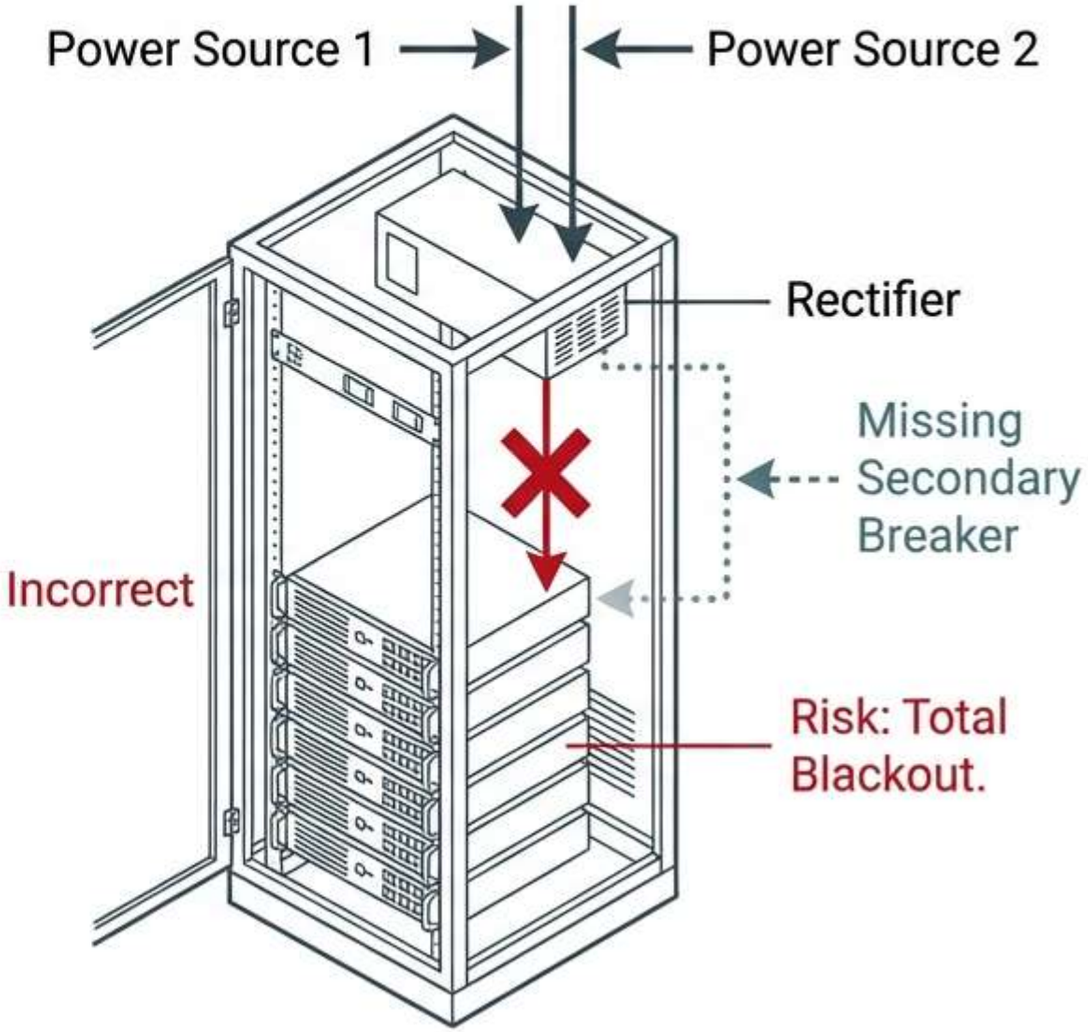
Issue: MW Equipment Power Redundancy mismatch (448 instances)

Requirement: Two different power sources to MW & BTS racks (Separate Circuit Breakers).

QC Findings:

- Wrong Photo: **407**
- No multiple sources for MW & BTS: **32**
- Missing photo: **9**

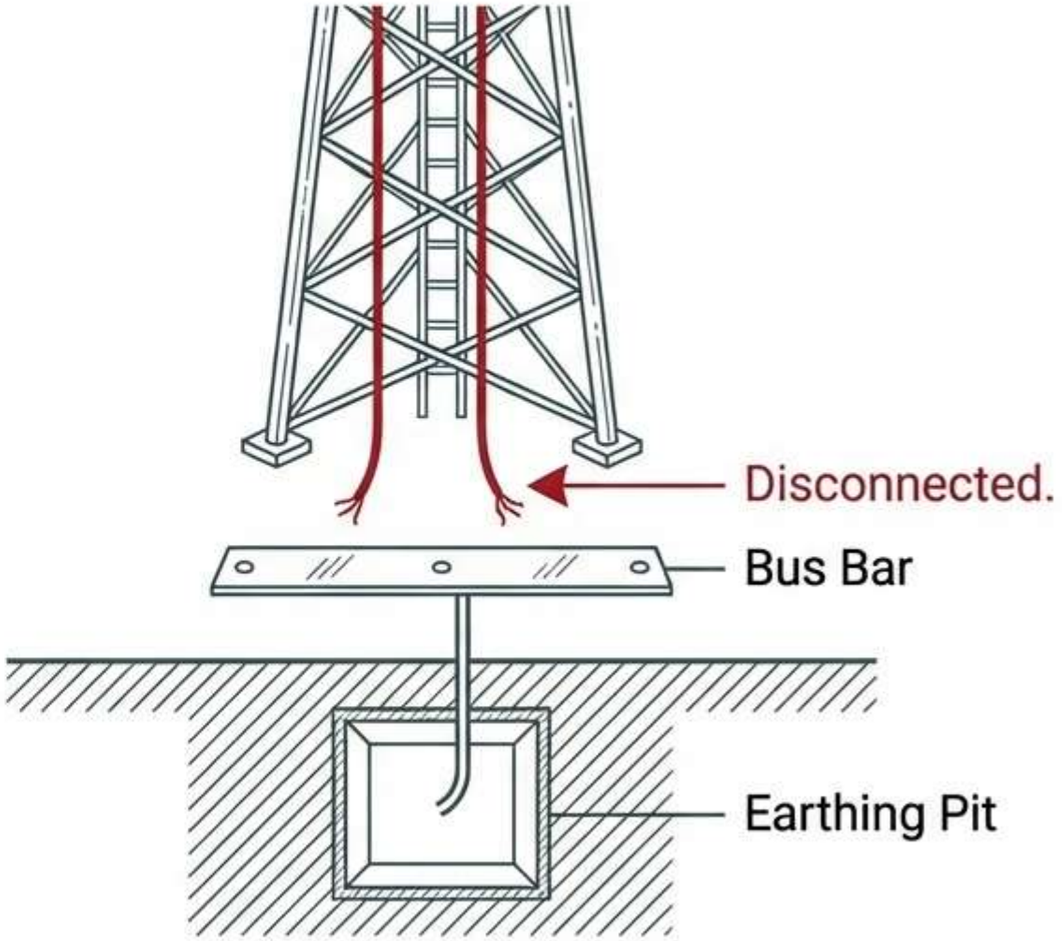
Issue: Main Grounding & Earthing Pit connections (434 mismatches)

Requirement: Connection to Earthing Pit, Rod, and Bus Bars.

QC Findings:
- No earth connected Bar: **362**
(Critical Safety Risk)
- Wrong Photo: **59**

Secondary Issues:
- RF Antennas Grounding: 327 mismatches
- MW ODUs Grounding: 270 mismatches

Risk: Equipment Damage & Safety Hazard.

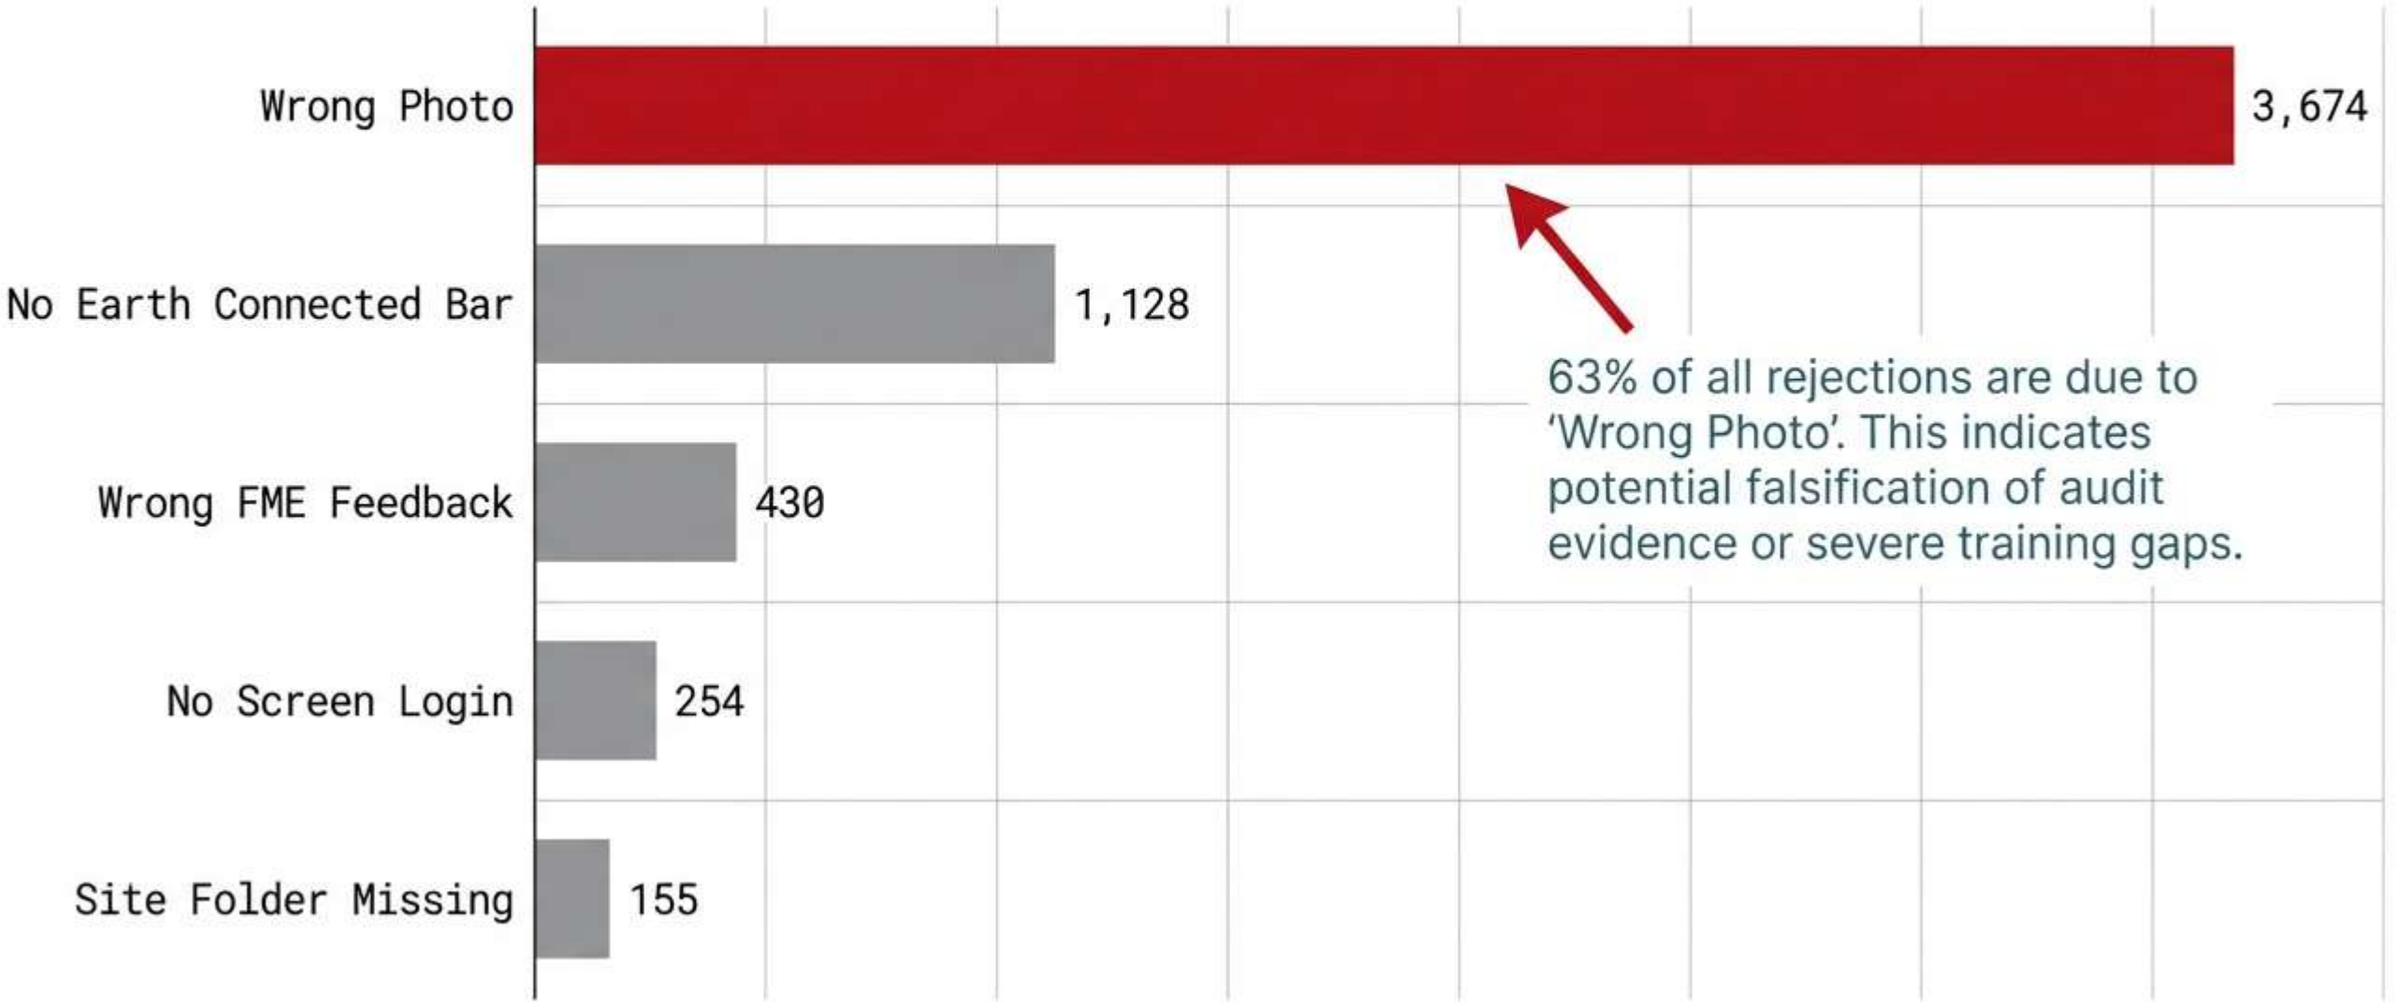
Analysis of QC Rejections

Why were the field reports rejected?
