MiDisplay General Letter

Subject	**MiDisplay General Letter**		
Applicable model(s)	MR Triton (Select Models)	Bulletin Ref	MMAL-25206
Service Group	54 Chassis Electrical	Latest Revision Issued	Rev B 20/08/2026

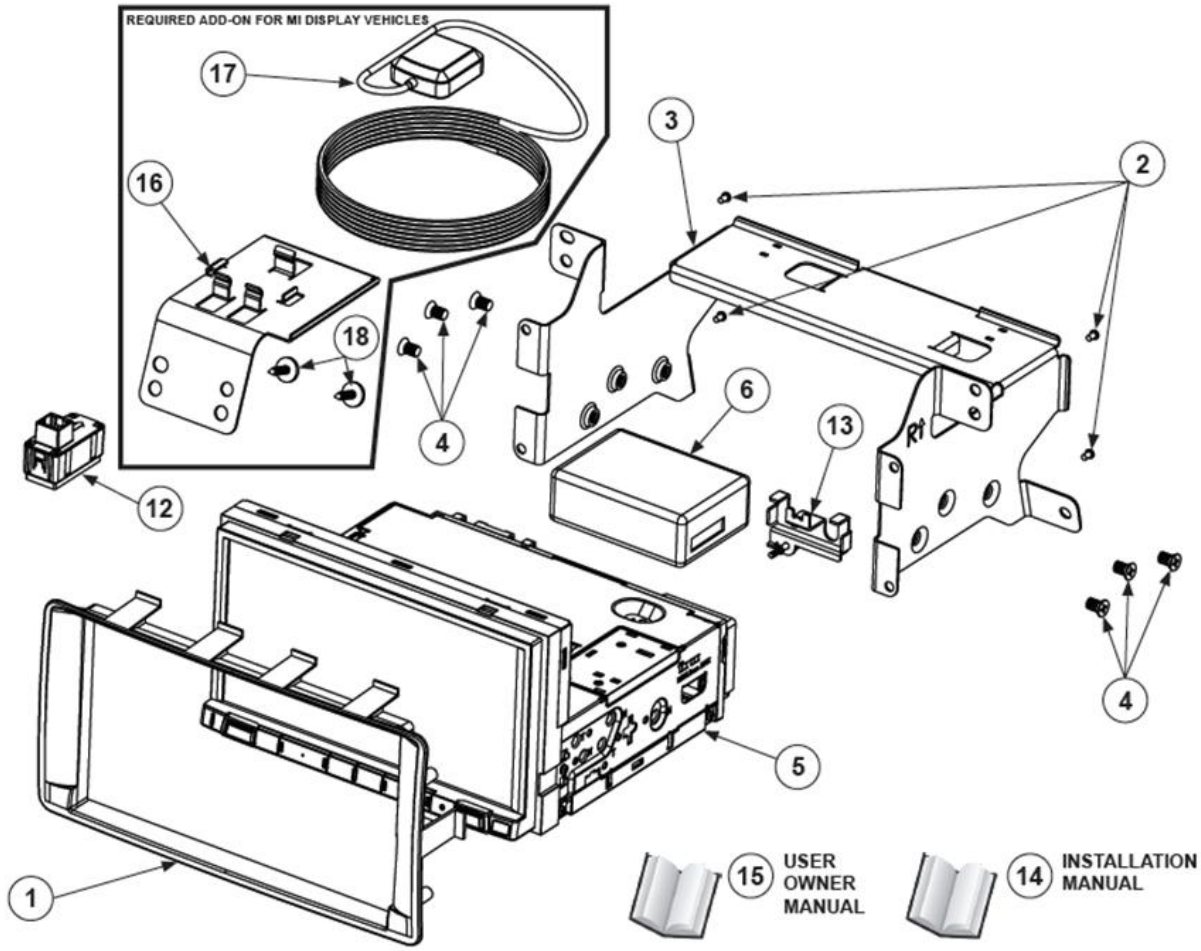
MR Triton MY19-23 ALPINE iLX-507Ai Infotainment Head Unit

The Alpine iLX-507Ai has been designed to meet or surpass the performance of the current MiDisplay audio unit. This new system offers a convenient plug-and-play installation.

For non GLX models - Alpine unit, new microphone and external GPS antenna will be supplied.

B For GLX models only - Alpine unit, new microphone, external GPS antenna and GLX harness will be supplied (until harness stock is depleted).
