ADVISORY HOTLINE FIX

(1) **Subject:** Timing belt tensioner arm bolt snaps on 4D56 engine.

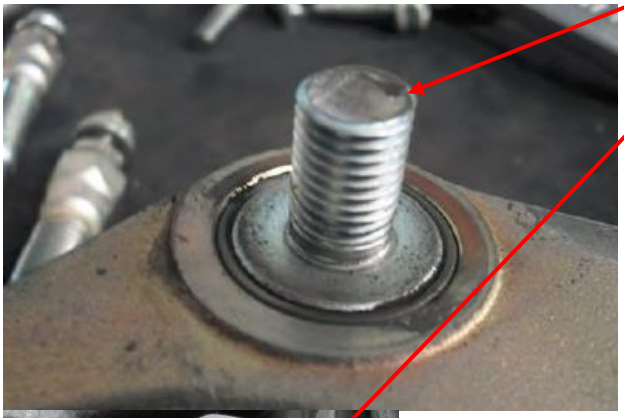
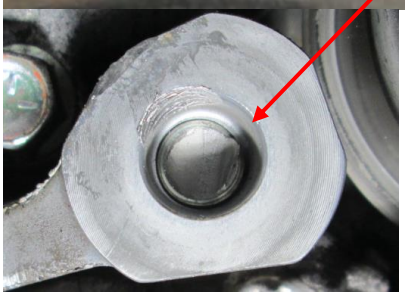
(2) **Possible Cause:** After investigation of failures, it has been concluded that the timing belt tensioner arm bolt has been incorrectly tensioned, leading to loosening of the bolt. Once the bolt is loosened, an incorrect load point is created on the threaded portion of the bolt, instead of the bolt shoulder, leading to fatigue breakage of the threaded section where the thread begins in the oil pump casing (see below).

Please Note: MMAL are only aware of failures that have occurred after this bolt has been removed and refitted during service. Dealers are reminded that this bolt is a torque critical component, as bolt breakage can lead to catastrophic engine failure.

This bolt is torque critical. Please tension as per WSM specification (48 +/- 6 Nm).
