Hotline Fix – MQ13-002, QE13-001

Vehicle logging various DPF related DTC's due to temperature sensor failure.

MQ Triton, QE Pajero Sport

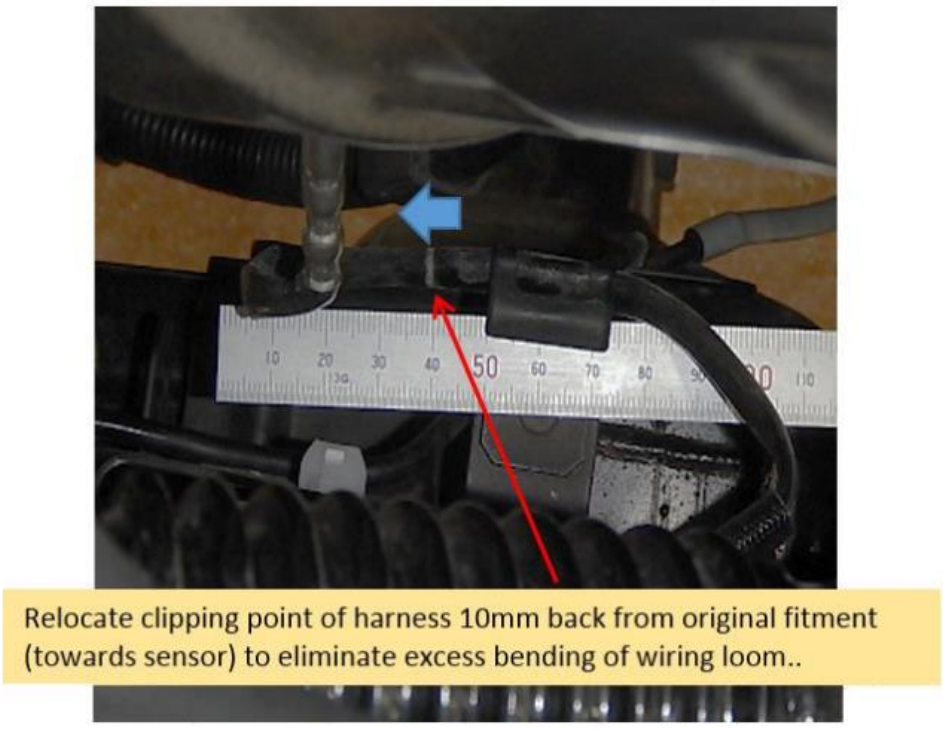
DPF Temperature sensor #3 (Data List Item 119) may have an intermittent internal fault, causing an incorrect reading to be supplied to engine ECU.

A yellow mark was introduced during manufacturing that is aligned with the bracket to ensure no excess stress on the sensor wiring for vehicles manufactured after 1/7/2016.

Wiring rework instructions:

Relocate clipping point of harness 10mm back from original fitment (towards sensor) to eliminate excess bending of wiring loom..
