MMAL DEALER BULLETIN

Bulletin Subject	**Coolant seepage/leakage from core plug at rear of cylinder head on 4N15 Engine.**		
Applicable model(s)	MQ/MR Triton, QE/QF Pajero Sport		
Notice Category	**Hotline fix**	Technical Bulletin	**MQ/MR/QE/QF14-001**
Service Group	14 - Engine Cooling	Latest Revision Issued	22/12/2025
Revision number	C	MMAL Reference	TSL2407029-A

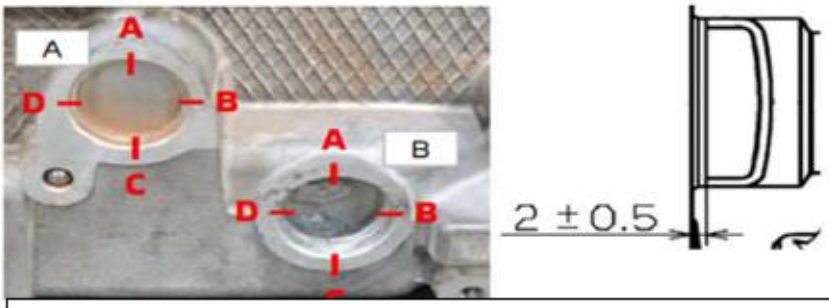
The core plug may have been installed to the incorrect depth or straightness. If this occurs, repeated hot/cold cycling of the engine may allow the core plug to move in the bore. This movement breaks the bond of the core plug adhesive, allowing the core plug to progress to a position that allows coolant to bypass the plug.

New Assembly Specification - Depth of A, B, C & D are now all within 0.5mm of each other.

2) Reduce the specification for the maximum tilt level of the core plug (Within ±0.5mm at depth points A, B, C & D of the plug).
