ADVISORY HOTLINE FIX

Group: 52 – Interior	**Original Date:** 01/05/2018	**No.** MQ52-003
Model: MQ Triton	**Subject:** Recovering air vent after locking knob or fins.	
Revised on: …….. **Revised on:** …….. **Revised on:** ……..	R. Versteeg National Service Manager Service Operations	
MMAL Ref TSL1704026	**Document consists of 3 pages**

1) **Subject**: Recovering air vent after locking knob or fins.

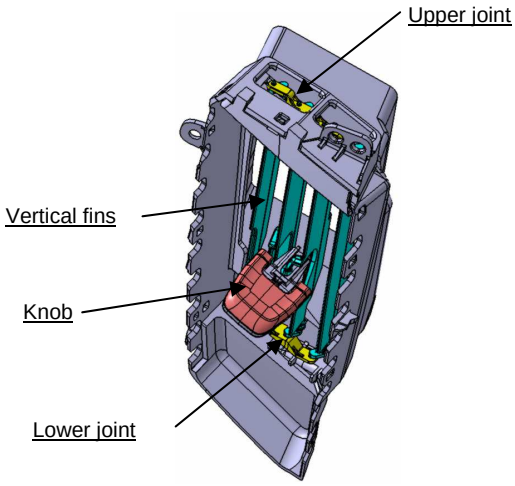
1) Mechanism of fin movement

Nine horizontal fins are connected to a joint.
The joint moves all horizontal fins at the same time once the knob is moved.

Behind the horizontal fins, there are four vertical fins.
They are connected to an upper and a lower joints.
The joints move all vertical fins at the same time once the knob is moved.

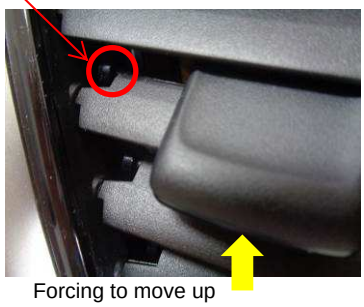
(1) Stuck the fin then broken the fin.

1. The lowest fin is pushed down. (e.g. wiping the surface)

2. The lowest fin rotates.

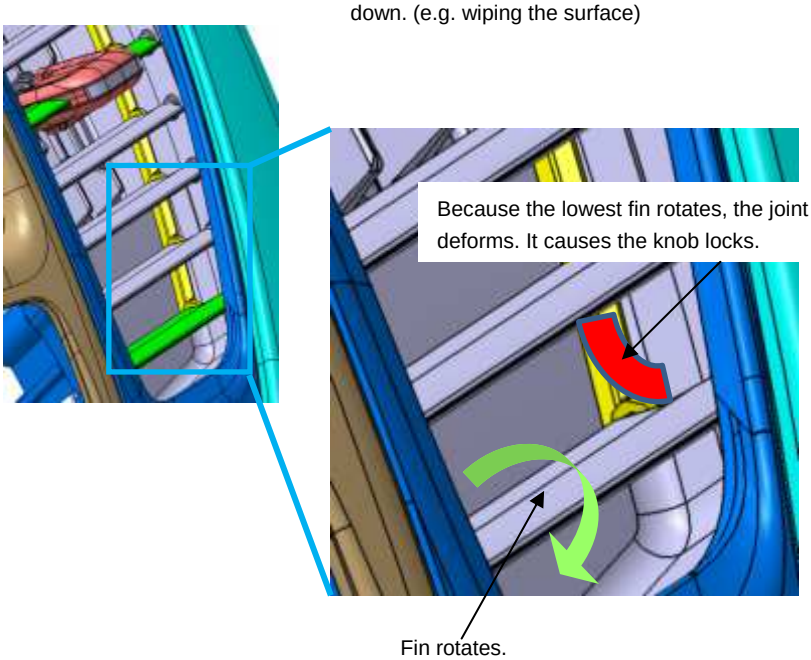
Center fin broken at axis

Forcing to move up

3. The knob locks. If it is forced to move up, the center fin is broken at the axis.

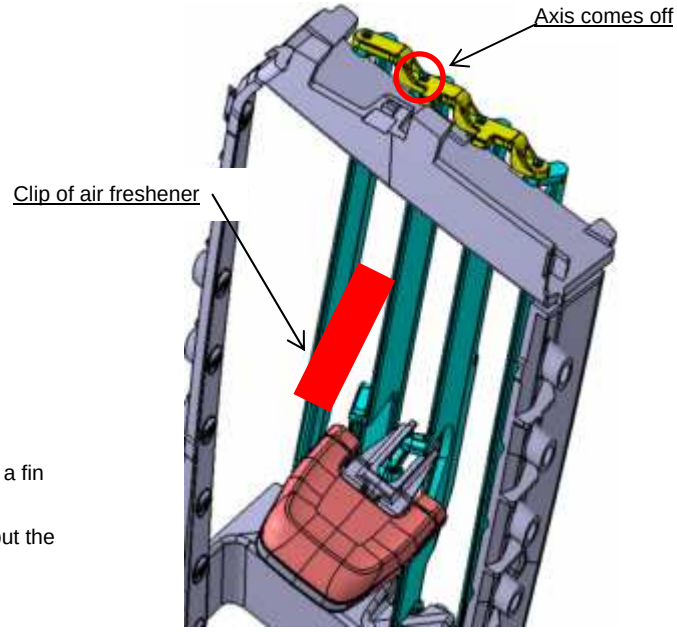
(2) Stuck by air freshener

An air freshener lies on the air outlet.
It obstructs movement of fins.

A clip of an air freshener goes inside and stays between a fin and one another.
When a knob is moved left/right, the fin does not move but the joint tries to move.
The axis of the fin comes off from the joint.

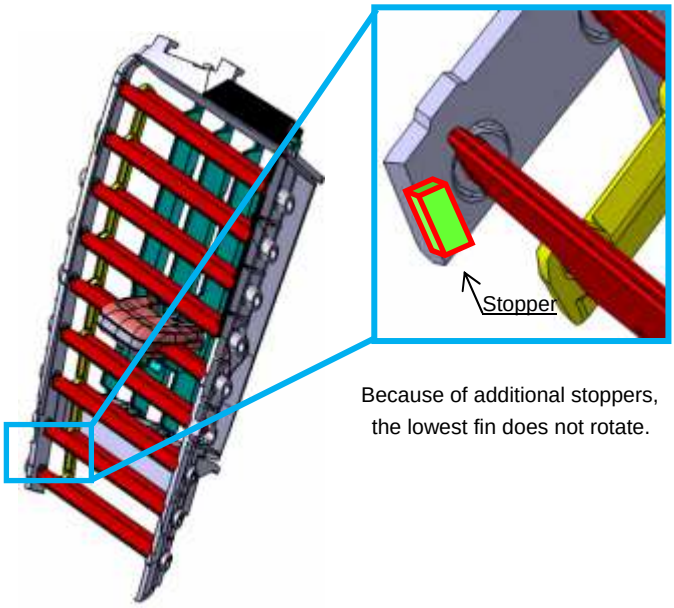
When the knob is up/down, fins do not move but the joint (yellow) tries to move.
The axis of the fin comes off from the joint.
