ADVISORY HOTLINE FIX

(1) **Subject**: Change to front stabiliser bar linkage torque setting.

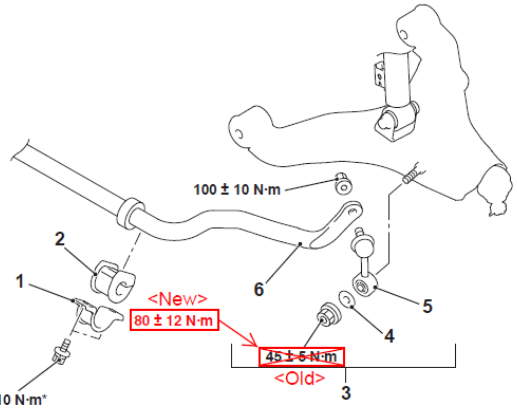
(2) **Possible Concern:** Due to rotational torque applied to the front stabiliser linkage during front suspension actuation, the stabilizer linkage retaining nut may loosen during service.

(4) **Field Fix**: As per the vehicle's maintenance schedule, please ensure to "Check suspension system for damage and looseness" during periodic maintenance. If the stabiliser bar linkage retaining nuts are found to be loose, please re-tension as per the revised specification (Refer to Service Bulletin 33-2019-003 for further details). If the retaining nut/s are found to be missing, please replace the nut/s and torque to the revised specification.
