HOTLINE FIX

Group: 54 – Chassis Electrical	**Original Date:** 13/08/2019	**No.** QE54-002
Model: QE Pajero Sport	**Subject:** SDA in call receiver echo/grammatical error in start message/bluetooth volume level.	
Revised on 12/09/2019 **Revised on** ..... (date) **Revised on** ..... (date)	Neil Dunn Head of Service Service Operations	Neil M Dunn
MMAL Ref P4487(C)	Document consists of 11 pages.

1. **Subject**: SDA in call receiver echo/grammatical error in start message/Bluetooth volume level.

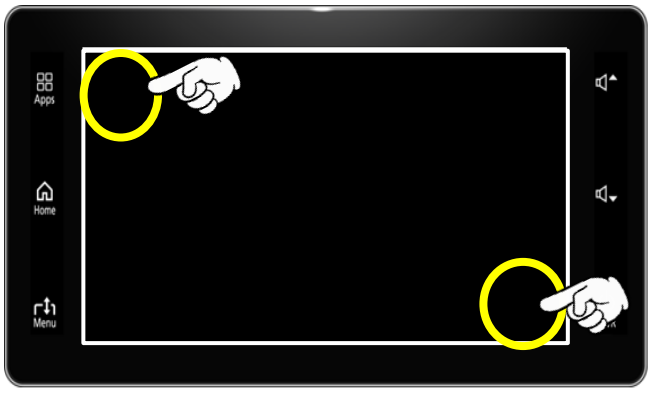
Check the contents of the "Version Information".

- If the latest software version is shown there is no need to update the software
- If the software version is not showing as the latest version, complete the software update.

New Software Version
2.3.0006.0200
