Hotline Fix – ZL54-003, QE54-004, YA54-005, ZK54-006, XC54-002, NX54-003, MQ54-004, MR54-001

SDA freezing due to residue on touch panel.

04/11/2021 – Revision A

All with SDA1.

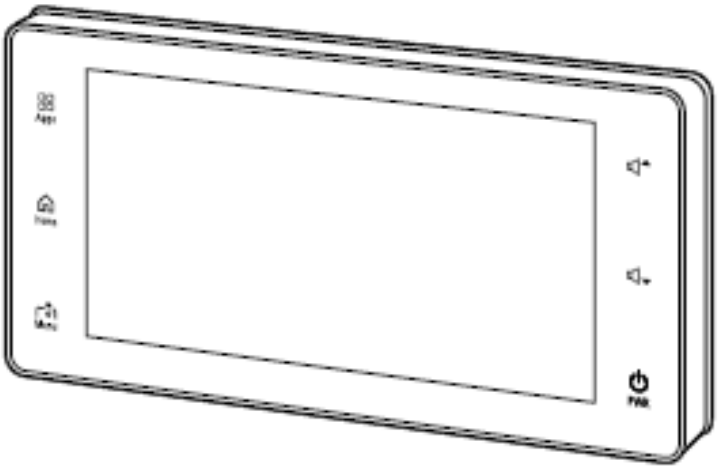
Residue on touch panel.

MMAL has been advised by the exchange unit supplier that many exchange units are being returned with residual build up of grease/grime on the touch panel of the SDA, and has advised that this may cause the SDA unit to register false touch inputs, which may contribute to a screen freeze concern.

If a customer presents a vehicle with this concern, please clean any residual build up from the touch panel with a soft, dry cloth (such as a commercially available microfiber cloth), as per the SDA handbook.
