Hotline Fix – ZM37-001

Clunk/click noise occurs from steering rack on Outlander / Outlander PHEV.

ZM Outlander and ZM Outlander PHEV.

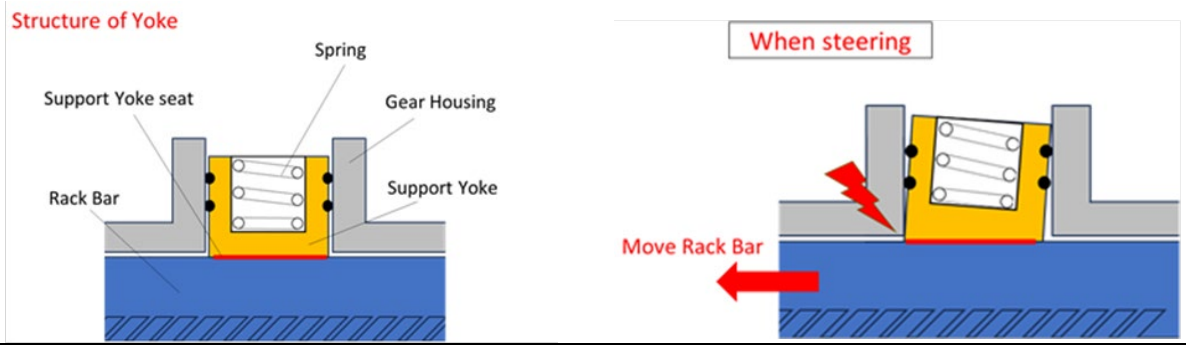
Complaint 1: Clunk noise from near the driver's feet when starting to turn the steering wheel.

Complaint 2: Click noise near full steering lock on sealed roads.

Complaint 1
If the grease between the rack and the support yoke seat becomes too thin, friction increases. When the steering wheel is turned, the support yoke may move and contact the rack housing. This may cause a clunk noise and vibration. Due to the design, the noise may not be completely eliminated.

Complaint 2
The crimping load of the assist side yoke plug may be insufficient.. As the steering components move during steering, the plug can also move slightly and create a clicking noise.

On a customer complaint basis, replace the steering rack with the new one according to the workshop manual procedure.

The steering rack includes the EPS-ECU. Therefore, it is necessary to perform the programming then auto configuration of the EPS-ECU and the calibration of the steering torque sensor, according to the workshop manual.

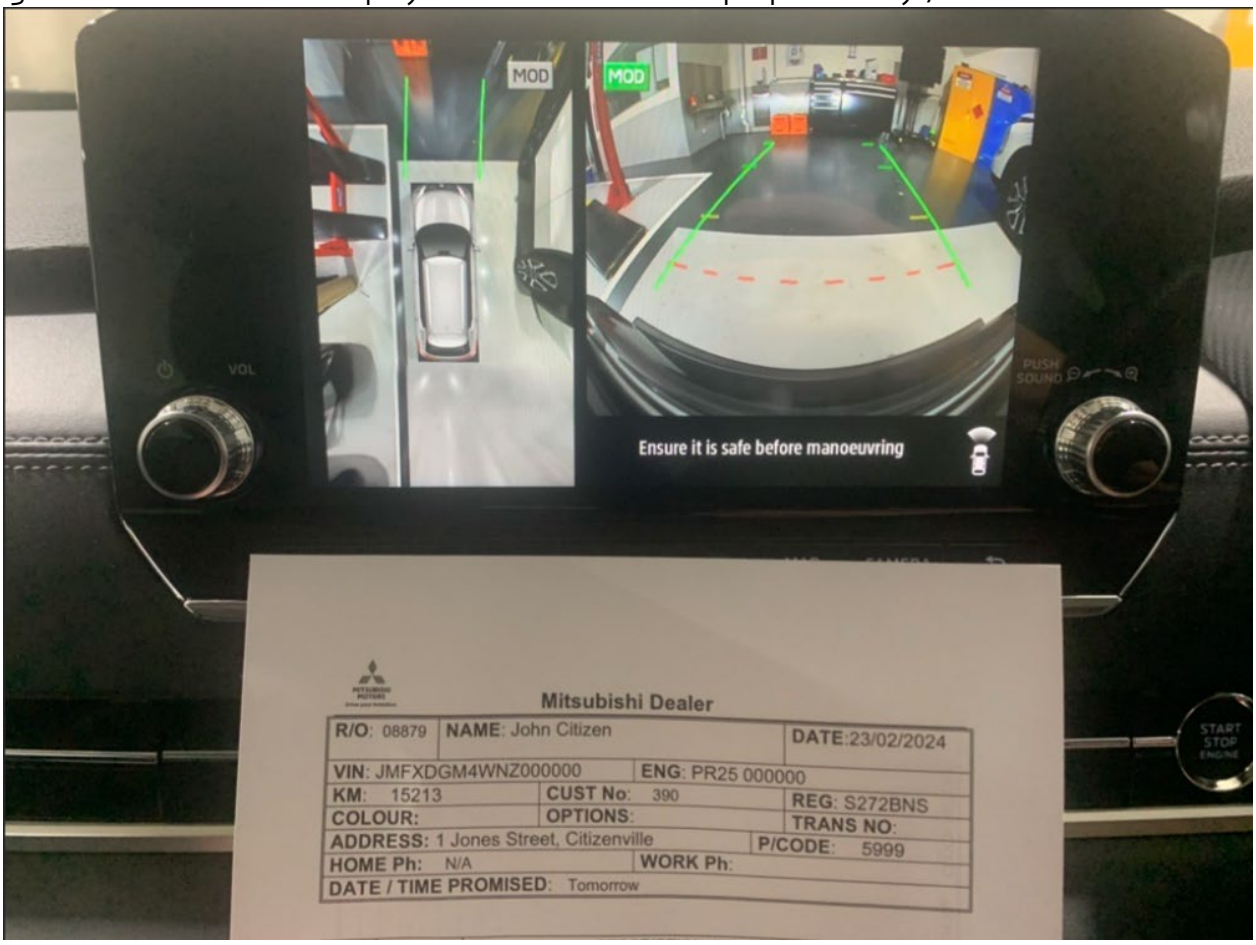
Example: Multi Around Monitor display requires calibration

For vehicles with multi-around, it is necessary to confirm the conformity of the image and re-calibrate the camera if required.
