RV Inspection Report

Prepared for: JW Malcolm

Inspection Date / RV Model:
2026-6-23 / 2025 Forest River Rockwood MiniLite 2515s

VIN: 4X4TRLB23SD461721

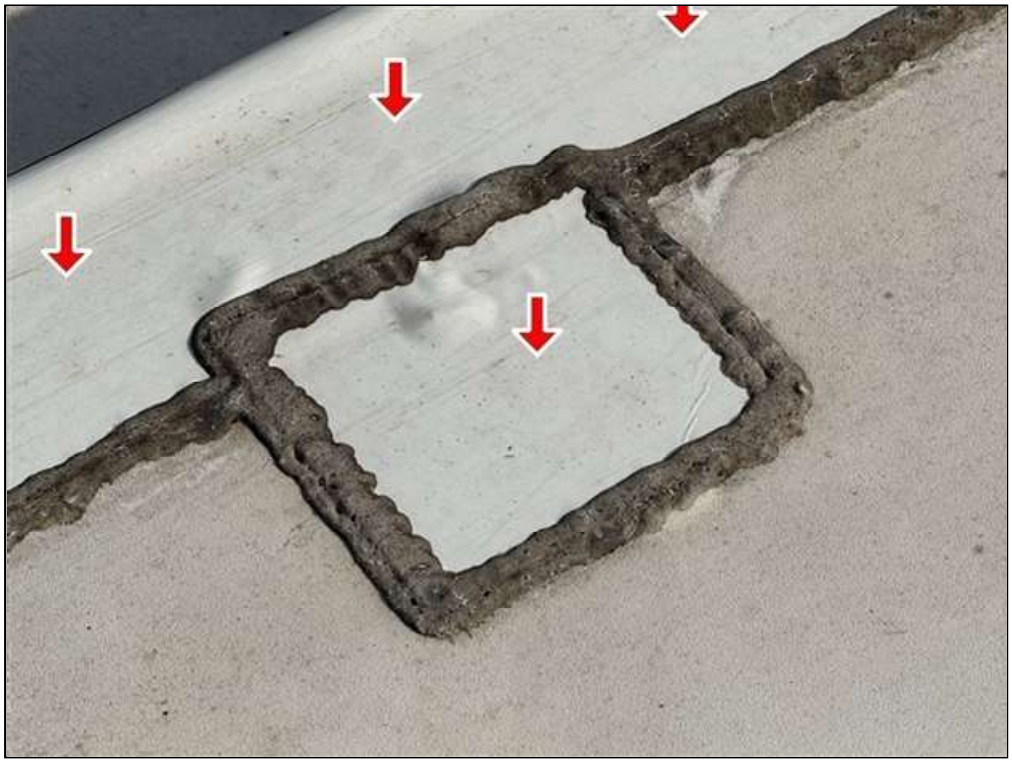
Roof Overview Rear to Front

Roof Overview Front to Rear

(2) Repair work has been performed on the streetside from the middle to the front.

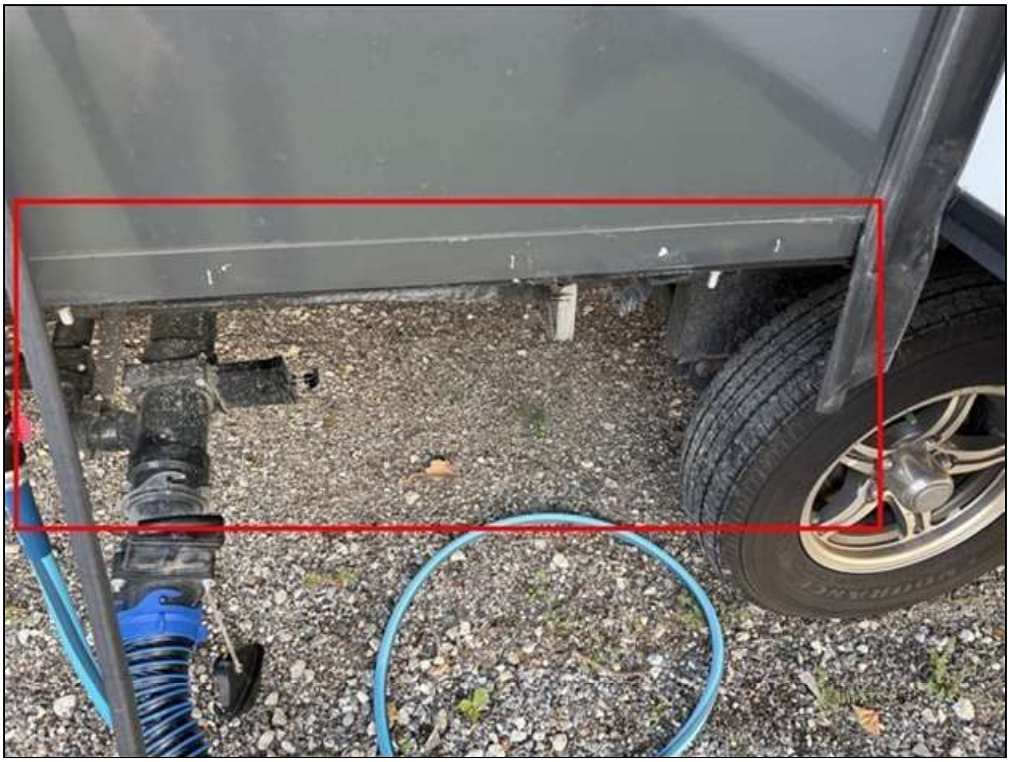
Area With Missing Streetside J Skirt

There is extensive damage to the streetside side wall J skirt from halfway back to the slideout. The J skirt has been removed in that section and damage exists on the portion that is still present. It is recommended that this be further evaluated by a qualified RV technician.

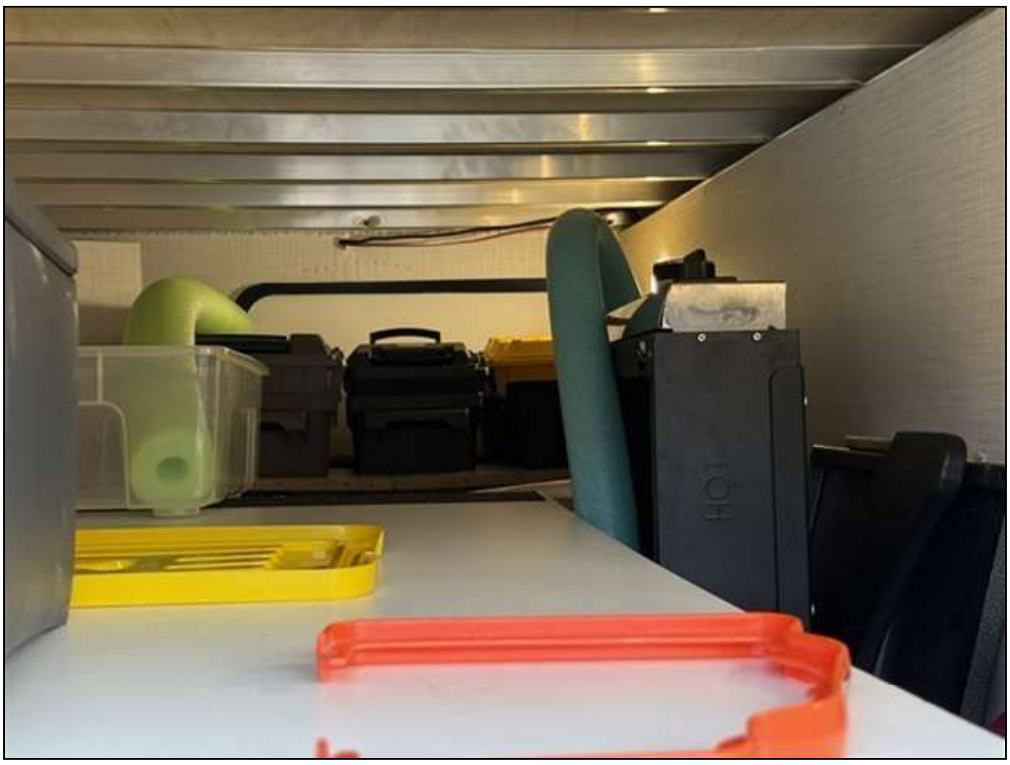
Streetside Cargo Door

The streetside side wall cargo access door has scratches. It is recommended that this be further evaluated by a qualified RV technician.

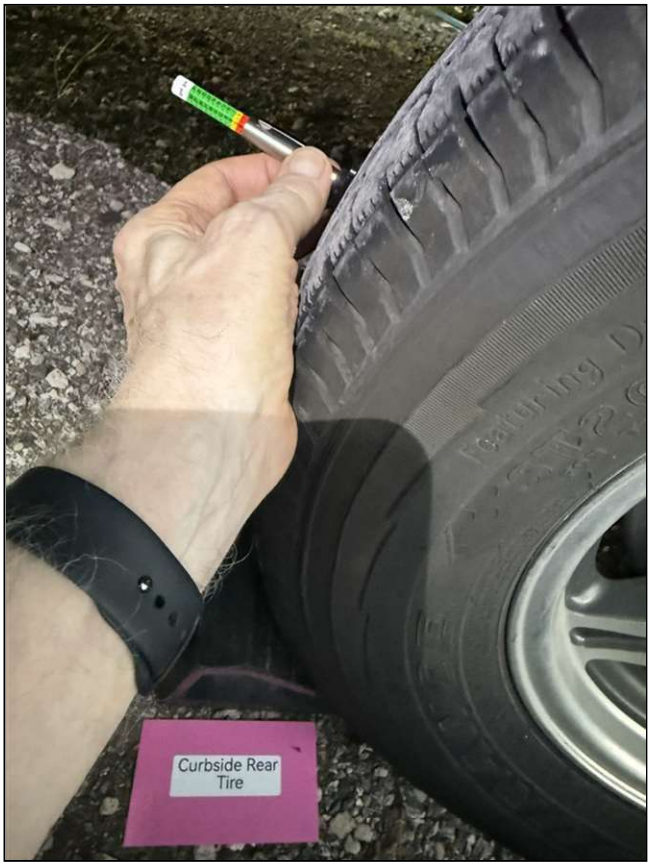
The curbside rear tire tread depth is less than the recommended value. This is a LIFE SAFETY ISSUE. It is recommended that this be further evaluated by a qualified RV technician prior to towing.

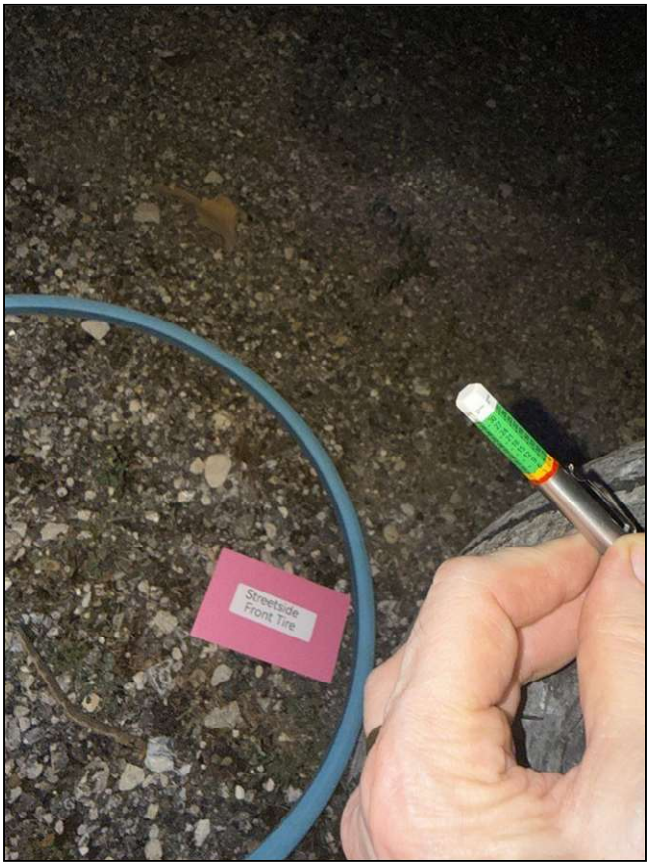
The streetside front tire tread depth is less than the recommended value. This is a LIFE SAFETY ISSUE. It is recommended that this be further evaluated by a qualified RV technician prior to towing.

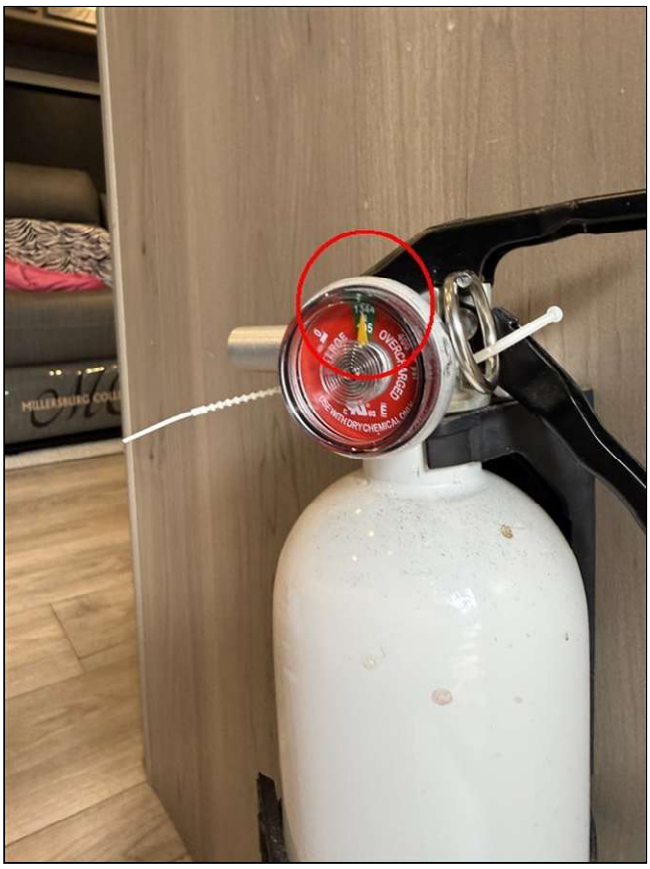
Fire Extinguisher

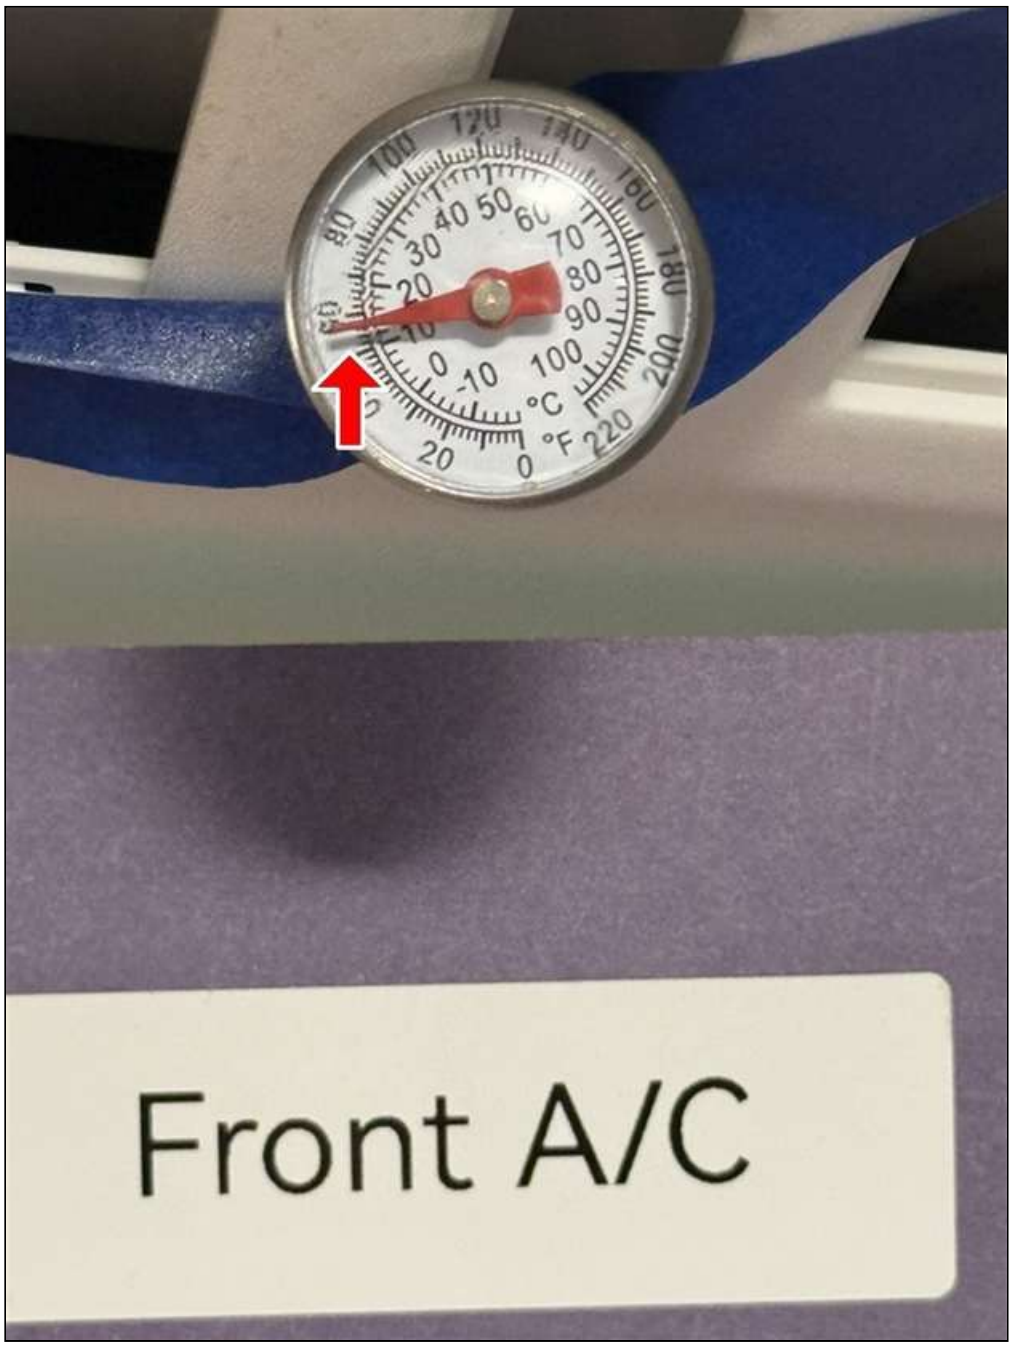
Air Conditioner Air Intake Temperature

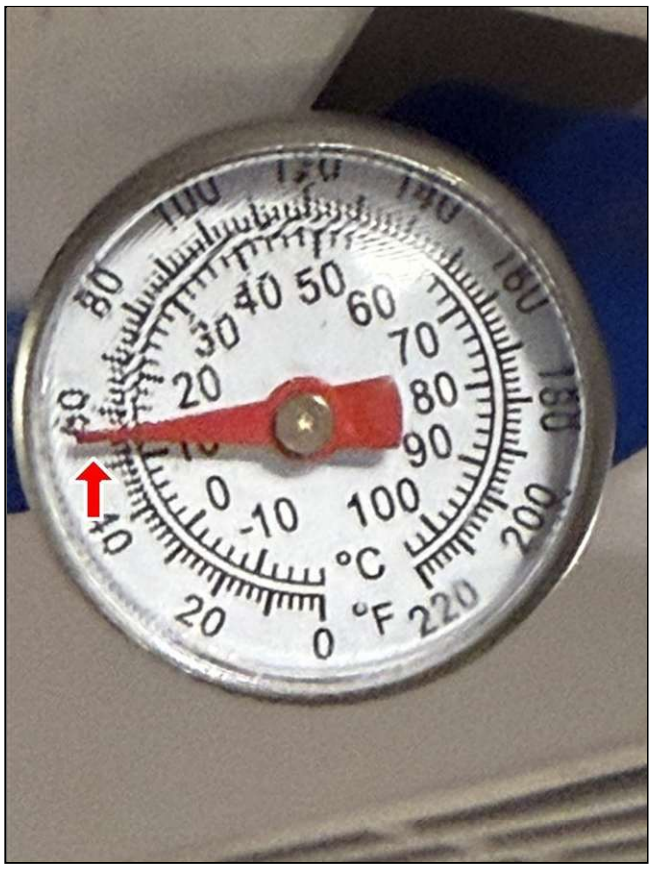
Air Conditioner Cool Air Output Temperature
