# RV Inspection Report

## Prepared for: Dana Hext

## Inspection Date / RV Model:
## 2026-6-23 / 2025 Forest River Rockwood MiniLite 2515s

VIN: 4X4TRLB23SD461721

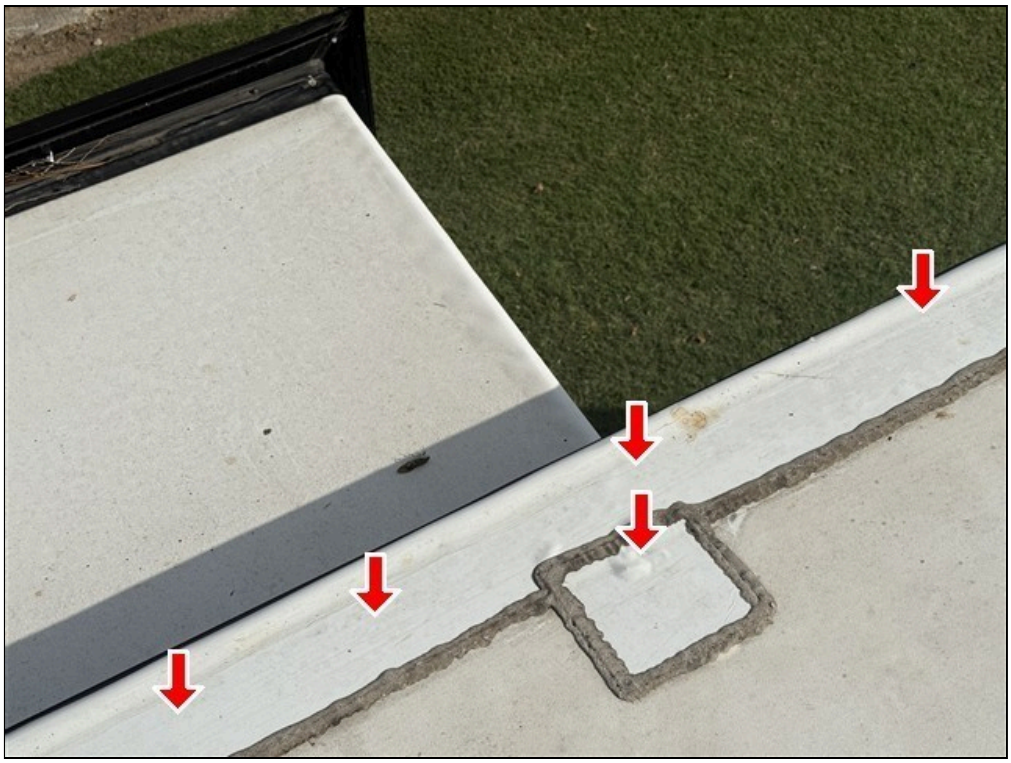
Roof Streetside Middle

(2) Repair work has been performed on the streetside from the middle to the front.

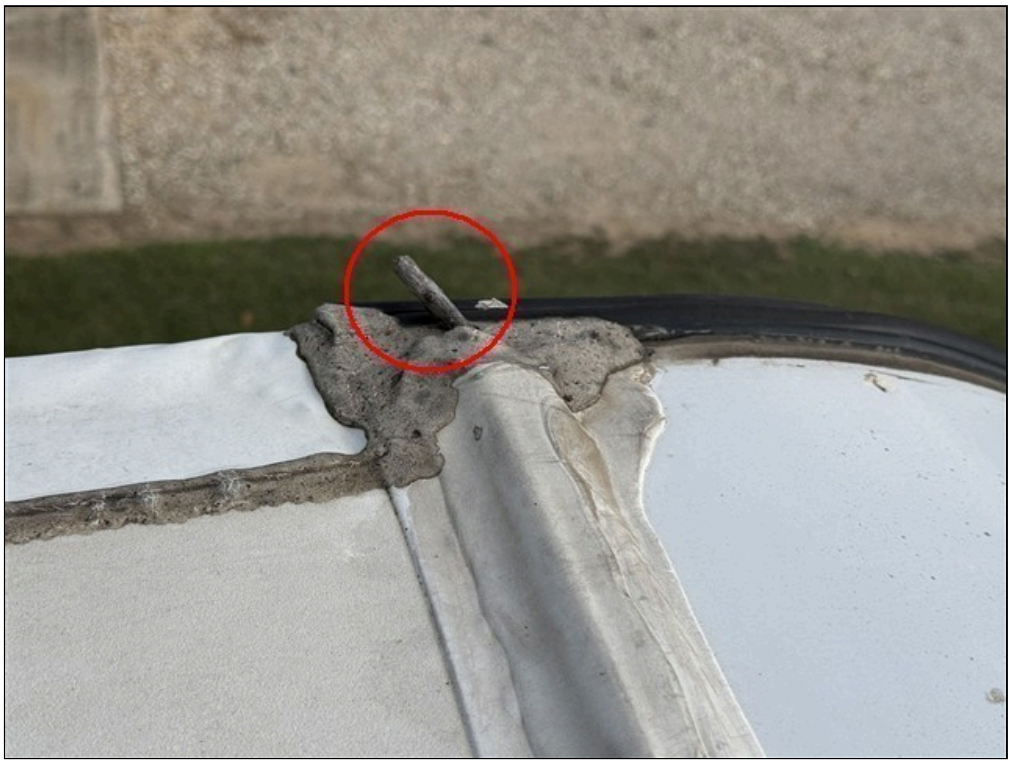
**3.1 Front Cap, Joints and Seals - Condition**

Poor

The streetside front cap seal has a protrusion. This could allow water intrusion. It is recommended that this be further evaluated by a qualified RV technician.

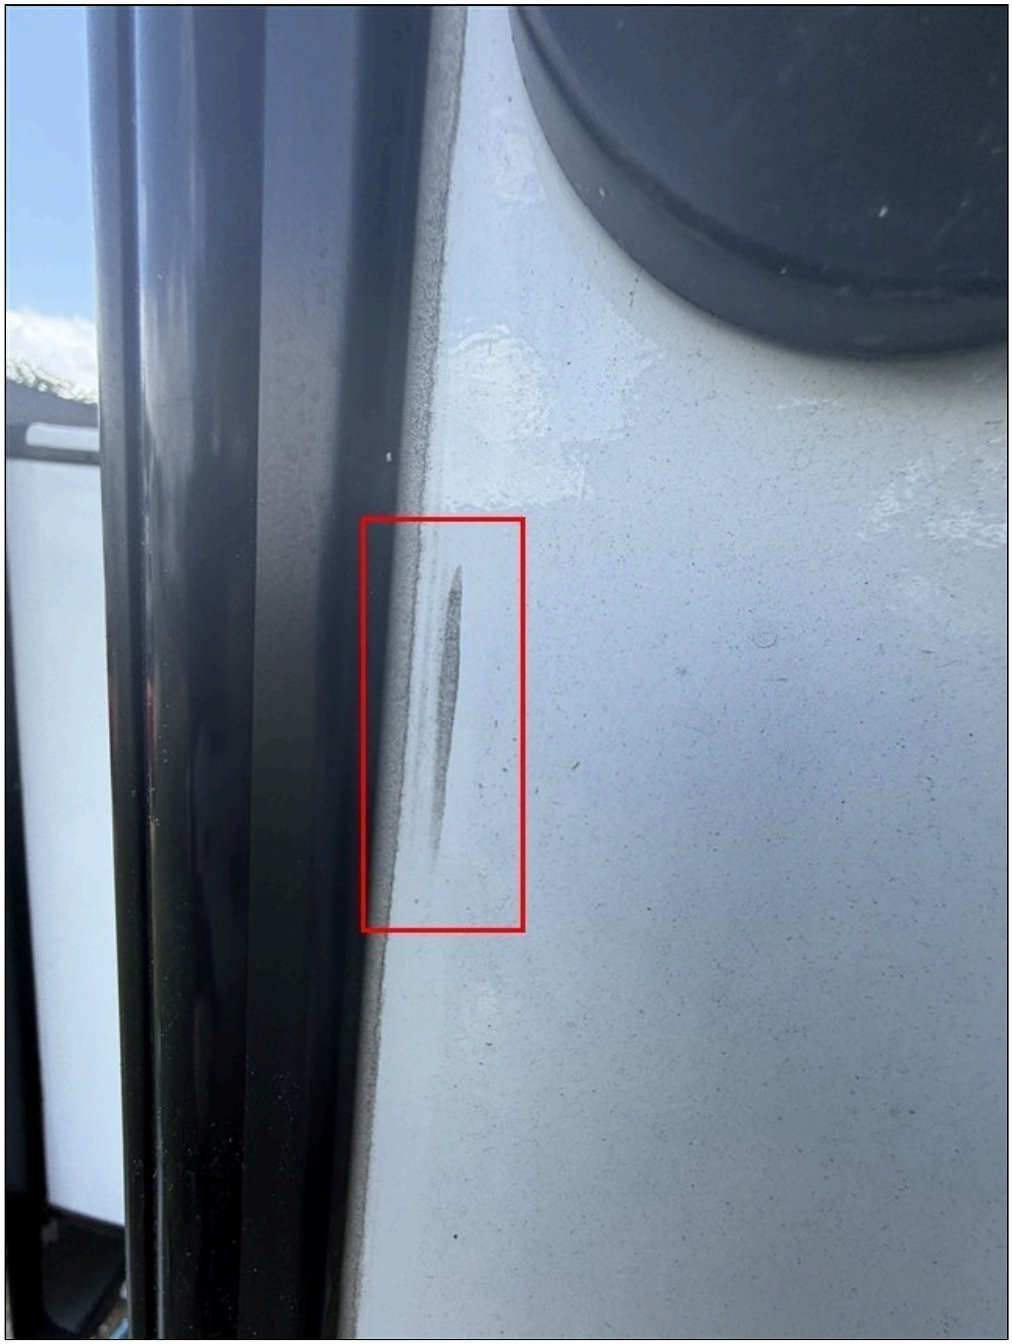
Rear Cap

(2) There are some black marks behind the ladder on the left side just to the left of the window on the rear cap. It is recommended that this be further evaluated by a qualified RV technician.

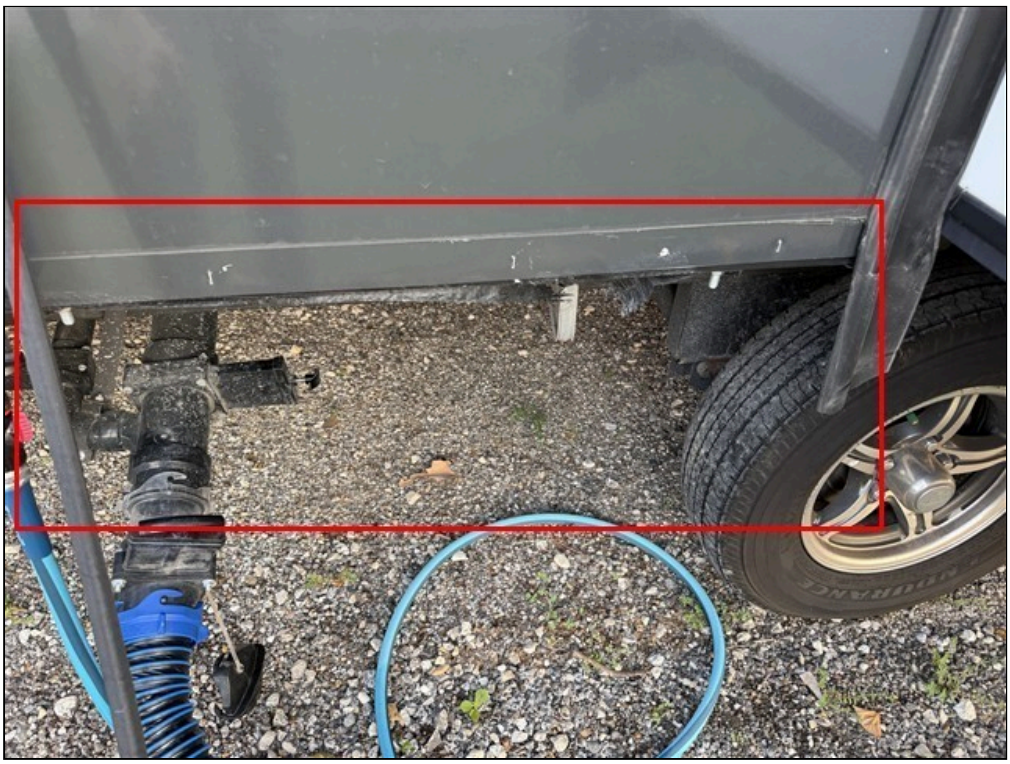
Area With Missing Streetside J Skirt

There is extensive damage to the streetside side wall J skirt from halfway back to the slideout. The J skirt has been removed in that section and damage exists on the portion that is still present. It is recommended that this be further evaluated by a qualified RV technician.

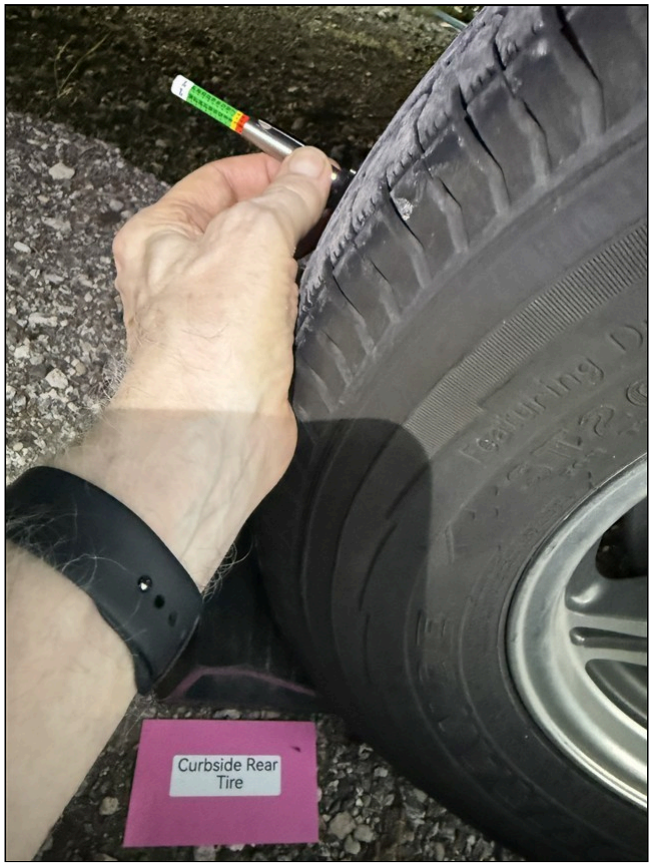
**8.2.B Tire Tread - Condition**

Poor

The curbside rear tire tread depth is less than the recommended value. This is a LIFE SAFETY ISSUE. It is recommended that this be further evaluated by a qualified RV technician prior to towing.

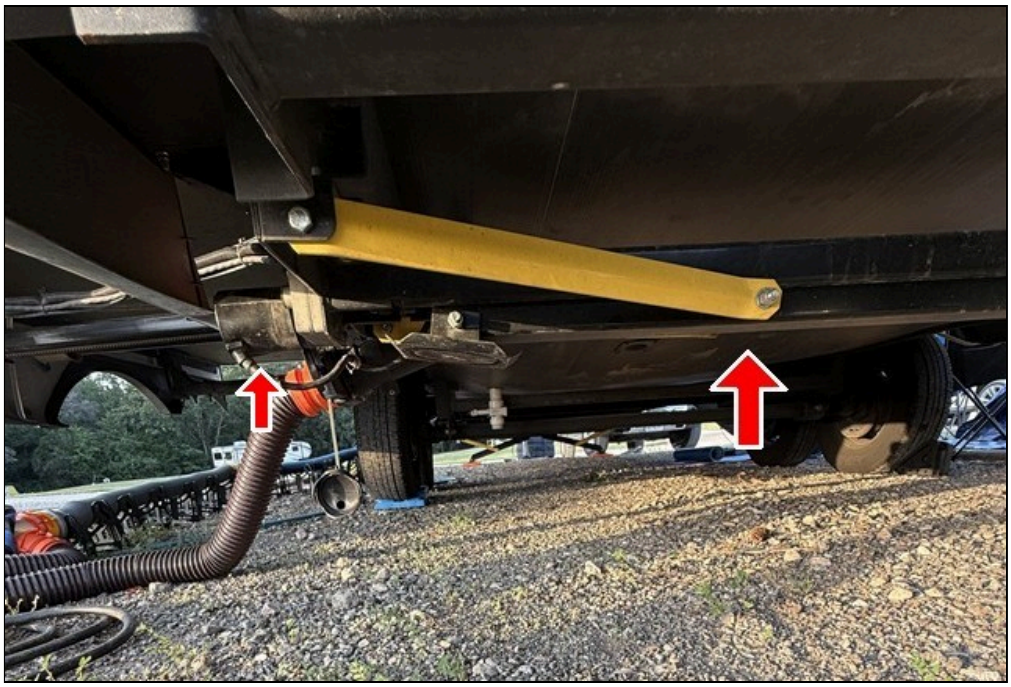
**9.3 Travel Trailer - Stabilizers - Condition**

Poor

The streetside rear stabilizer is not operational. It is currently in the retracted state. It is recommended that this be further evaluated by a qualified RV technician.

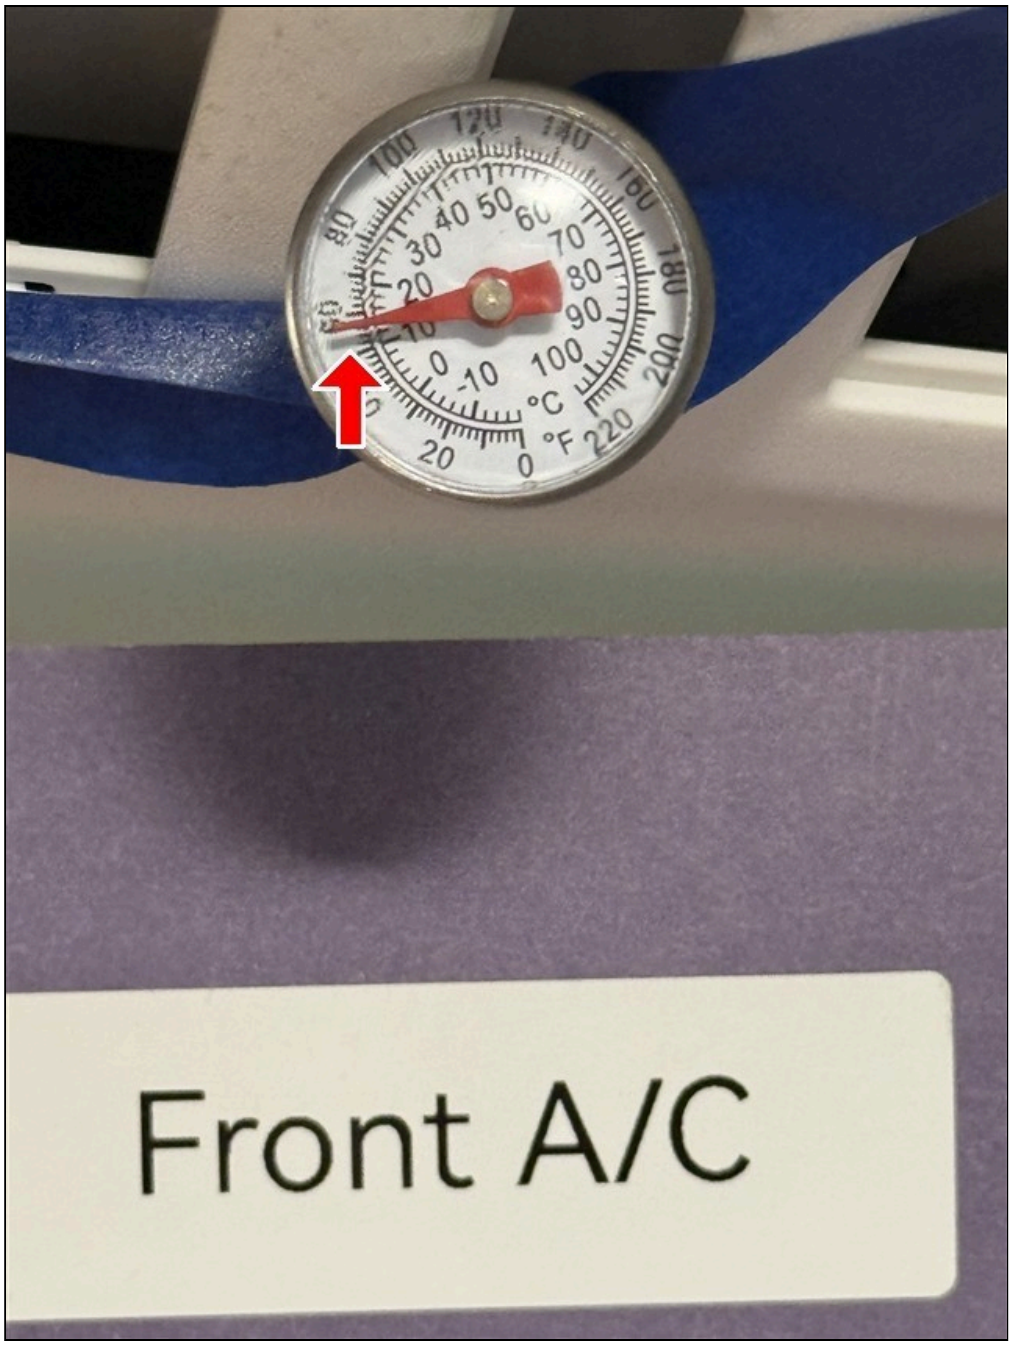
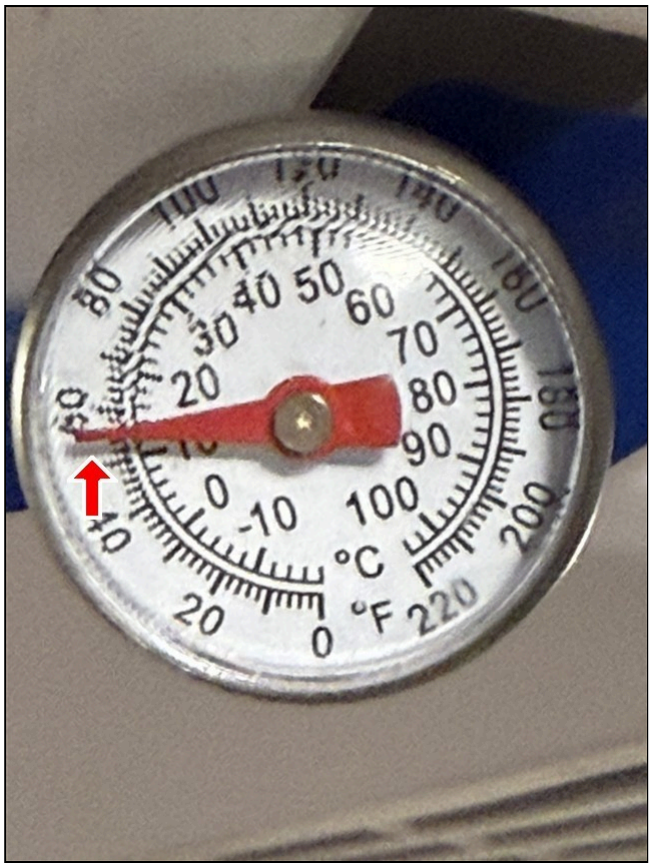
Air Conditioner Air Intake Temperature

Air Conditioner Cool Air Output Temperature

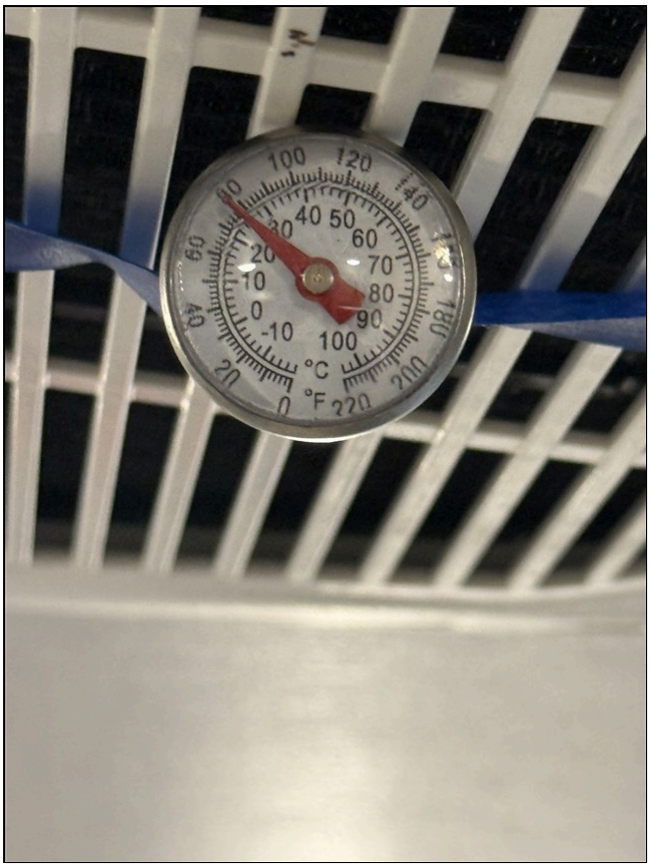
Air Conditioner Cool Air Output Temperature

Air Conditioner Air Intake Temperature
