Uniform Mitigation Verification Inspection Form

Inspection Date: 11/19/2015		
Owner Information		
Owner Name: Brian Spatola		Contact Person:
Address: 7728 Deer Creek Ct.		Home Phone:
City: Davie	Zip: 33328	Work Phone:
County: Broward		Cell Phone:
Insurance Company:		Policy #:
Year of Home: 2009	# of Stories: 2	Email: nmspatola@hotmail.com

Inspectors Initials DB **Property Address** 7728 Deer Creek Ct., Davie, FL 33328

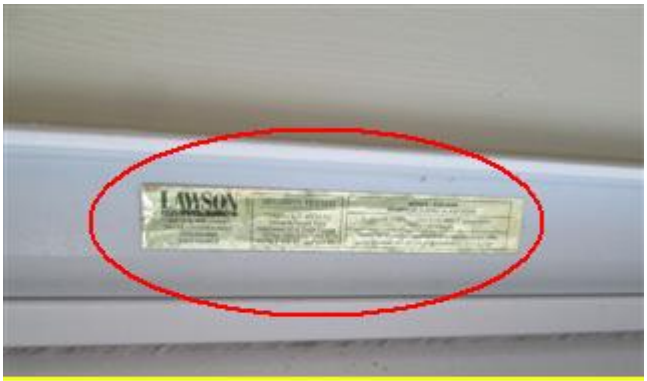
Opening Protection - Hurricane Impact
Rear Glass Doors
