Uniform Mitigation Verification Inspection Form

1012 West Yale St. Orlando, FL 32804

Wind Mitigation Photos

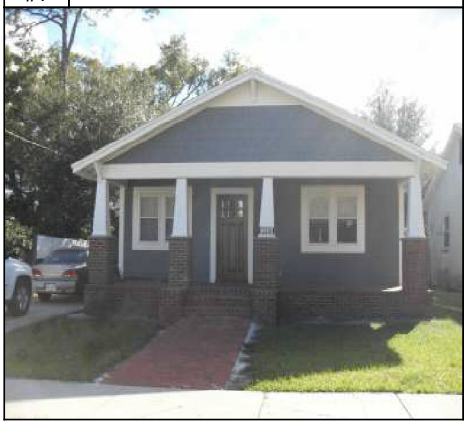
Photo #1	Front View Of House

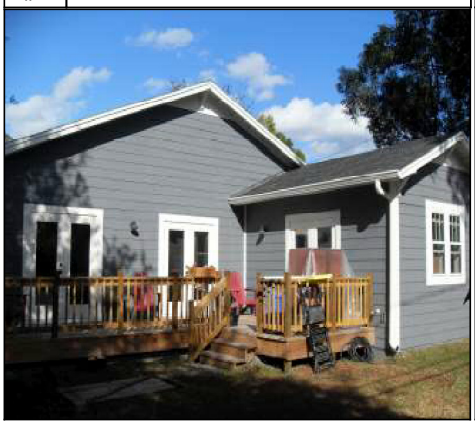
Photo #2	Rear View Of House

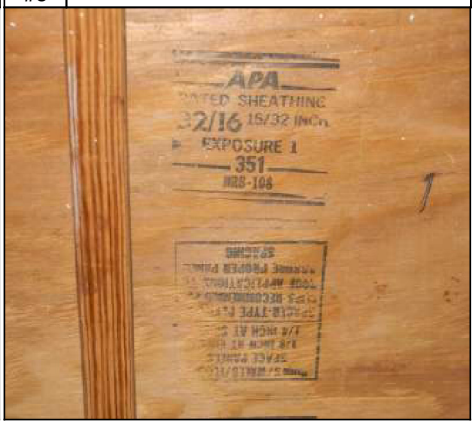
☒ C. Plywood/OSB roof sheathing with a minimum thickness of 7/16" inch attached to the roof truss/rafter (spaced a maximum of 24" inches o.c.) by 8d common nails spaced a maximum of 6" inches in the field. -OR- Dimensional lumber/Tongue & Groove decking with a minimum of 2 nails per board (or 1 nail per board if each board is equal to or less than 6 inches in width).

Photo #3	Roof Deck/Sheathing

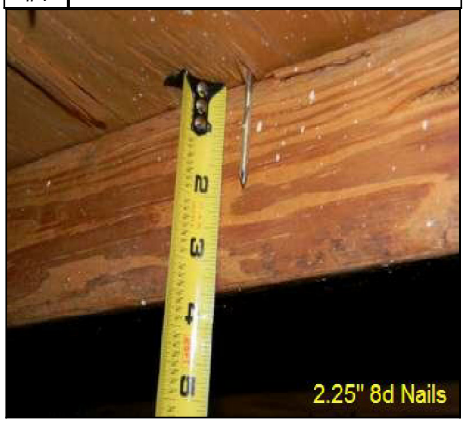
Photo #4	Roof Deck Attachment
