FRC Procedure 2015_005

Wire Bobbin Back Tension problem (during AWF operation and Positioning function)
"This back tension checking procedure applicable for α- CiA model machines"

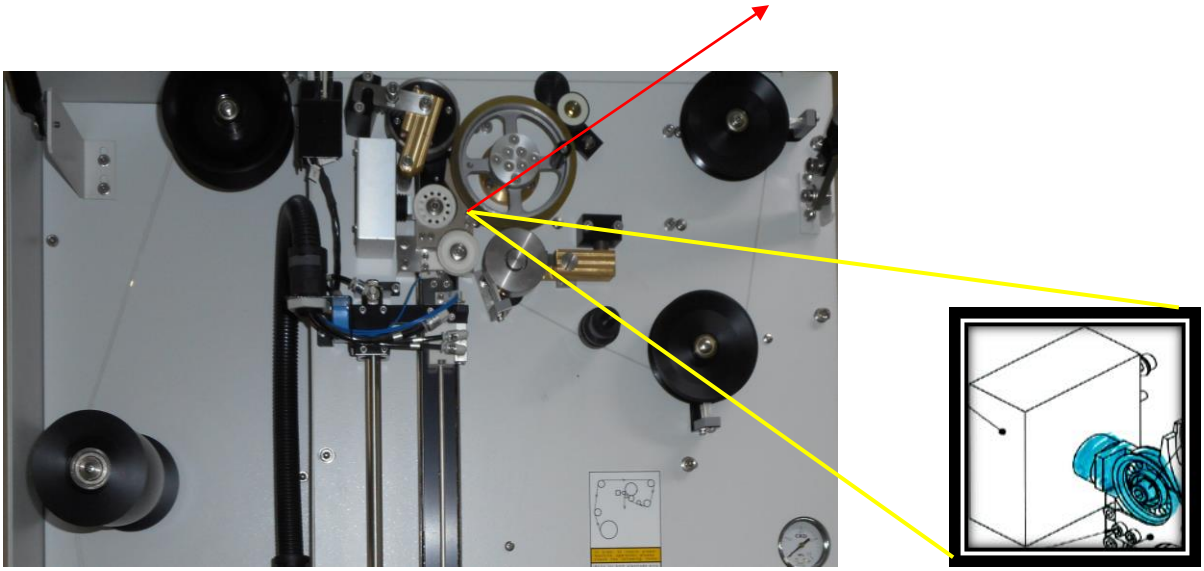
2. Please touch the tension control unit by the finger. (Wire tension sensor)

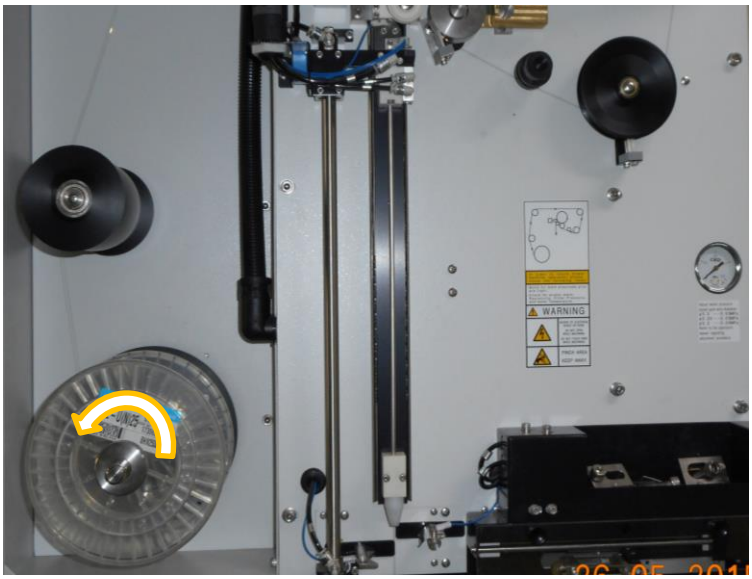
3. Check the back tension of the bobbin [by rotating the bobbin anti clock].

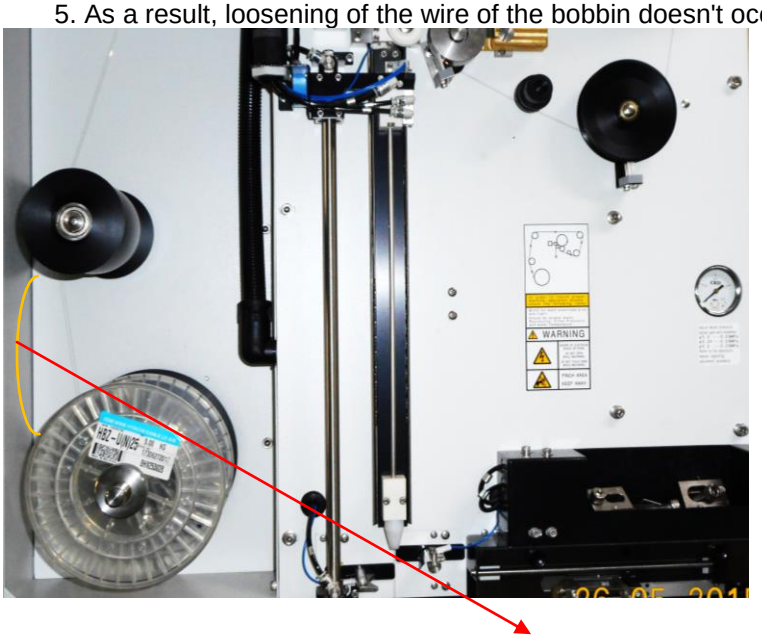
4. If the back tension is normal, the back tension of the bobbin is available.

5. As a result, loosening of the wire of the bobbin doesn't occur.

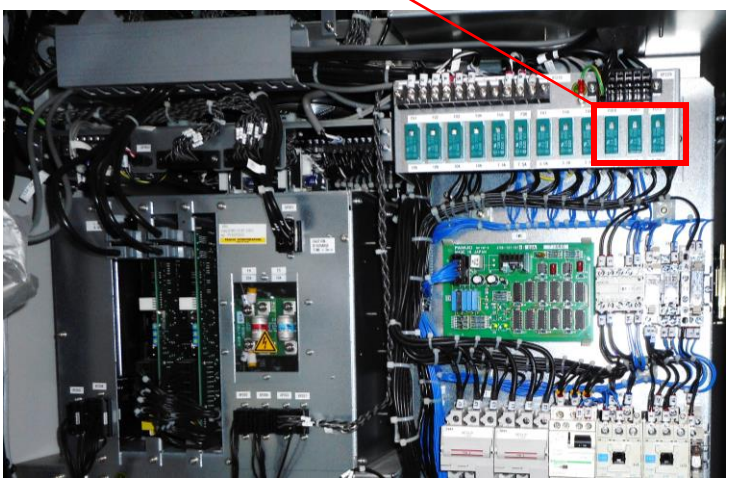
7. Check fuses blows. F10, F11, F12 [Electrical Panel]

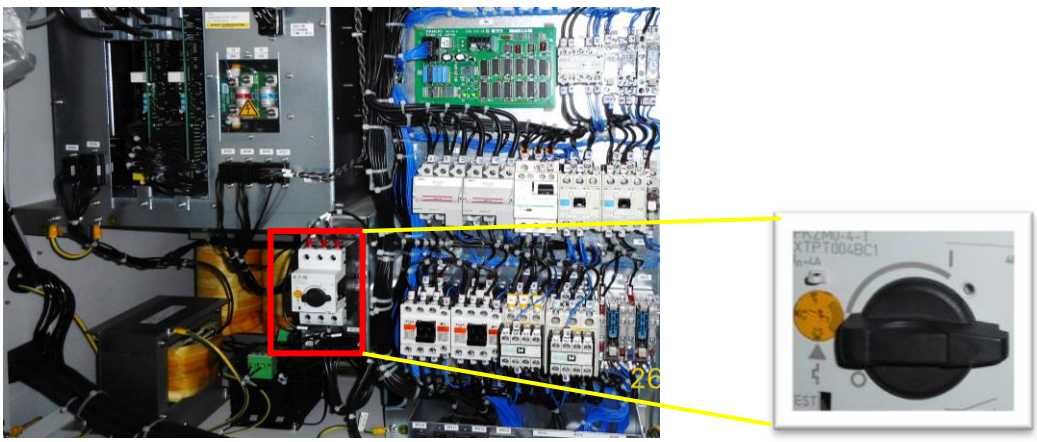
8. Check QF5 breaker is tripped.

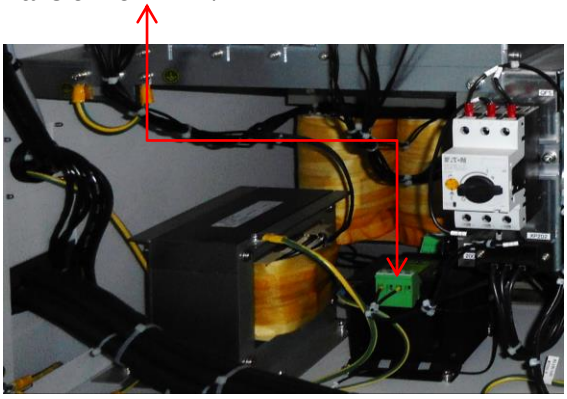
9. Check the input Voltage to breaker [AC 200V, 1Phase], if there is no voltage please check the Transformer -TM1.

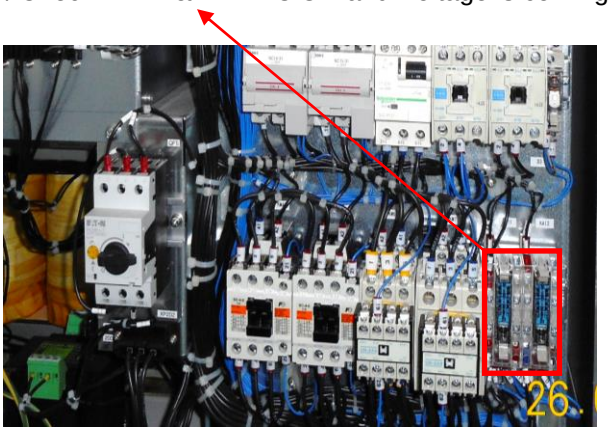
10. Check KA11 & KA12 is ON and Voltage is coming up to wire no 64.

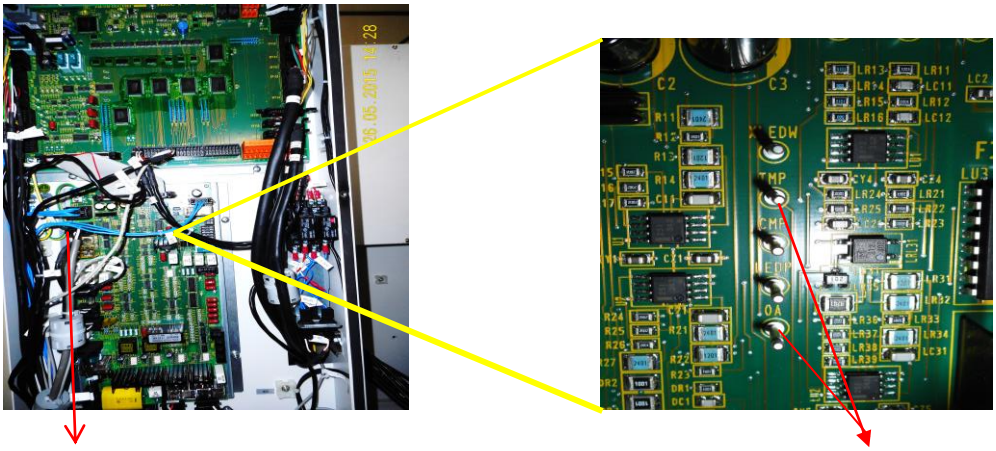
11. Check the AIO PCB 0~10VDC Voltage between “TMP” & “0A” test pins as shown below Pic.

12. Voltage value will be depending on back tension value setting. If Voltage is not appearing (zero) then **AIO PCB is faulty.**

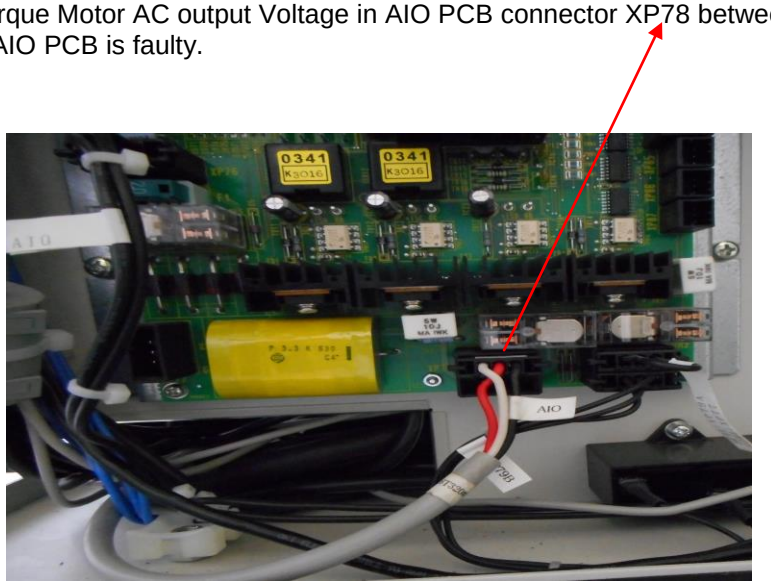
13. Check the Torque Motor AC output Voltage in AIO PCB connector XP78 between A1 & A2, if no output voltage than AIO PCB is faulty.

14. If voltage is appearing on XP78 still back tension not appearing than Torque Motor or Cable is faulty.
