RS Procedure 2015_006

RS - Rear Platen Vibration problem checking Procedure

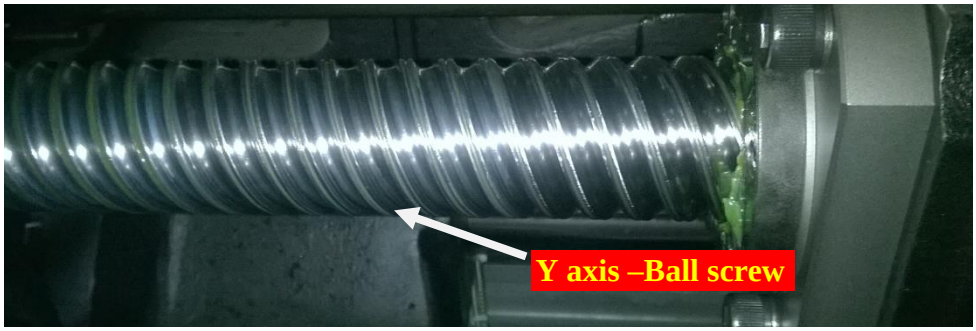
1. **Checking Y axis ball screw**…….
   Check/ Inspect the Y axis ball screw closely for worn out / damage condition.

Take close picture of Ball screw.

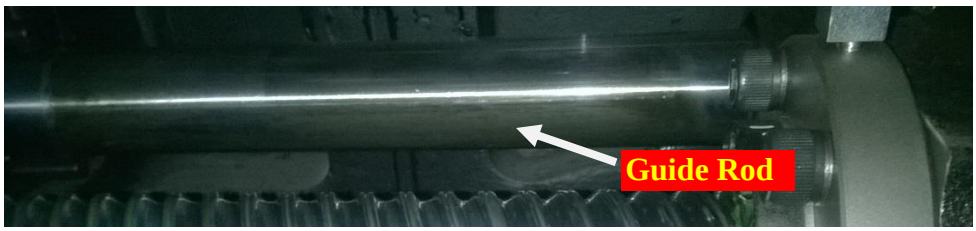
2. **Checking Y axis Guide Rod**…….
   Check/ Inspect the Y axis guide rod closely for worn out / damage condition

Take close picture of Ball screw.

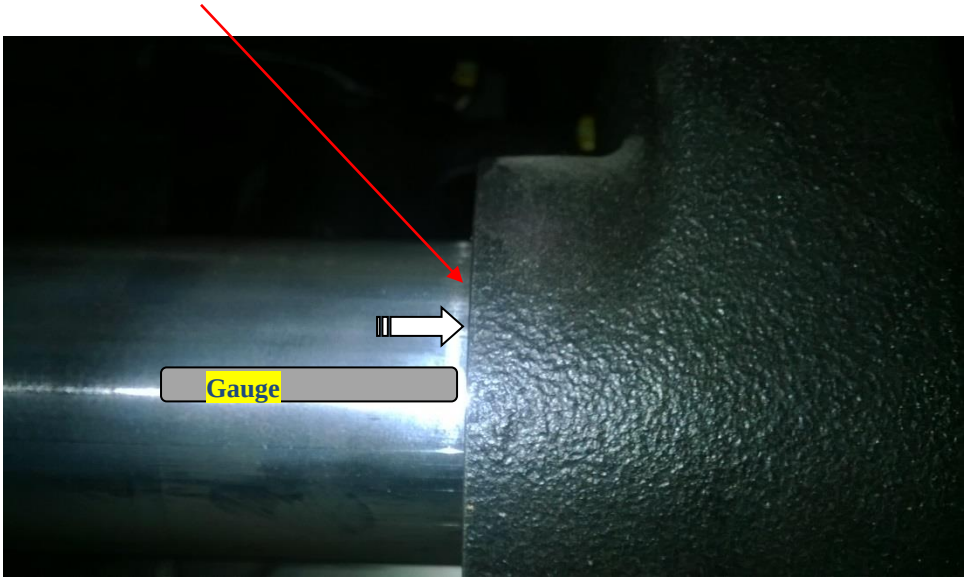
3. **Inspect the gap between Guide Rod and Guide Rod Bush**.
   Check Guide Rod gap

It must be measured by thickness gauge. If it is more than 0.1mm, it may be worn.

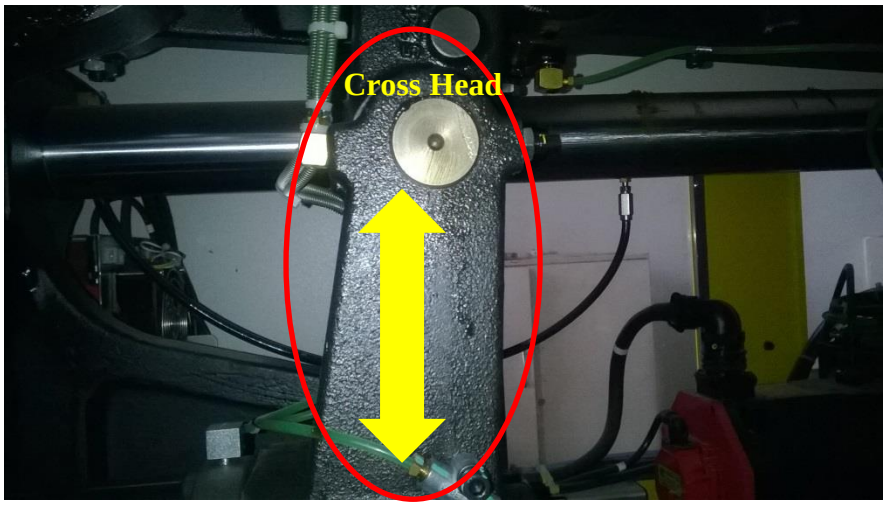
4. **Check the Cross head movement……..**
   In Manual mode check during lock up is cross head is moving moved up and down as below picture.
   .

If this movement occurs then platen will be vibrated. Please reconfirm the guide rod & Bush clearance.

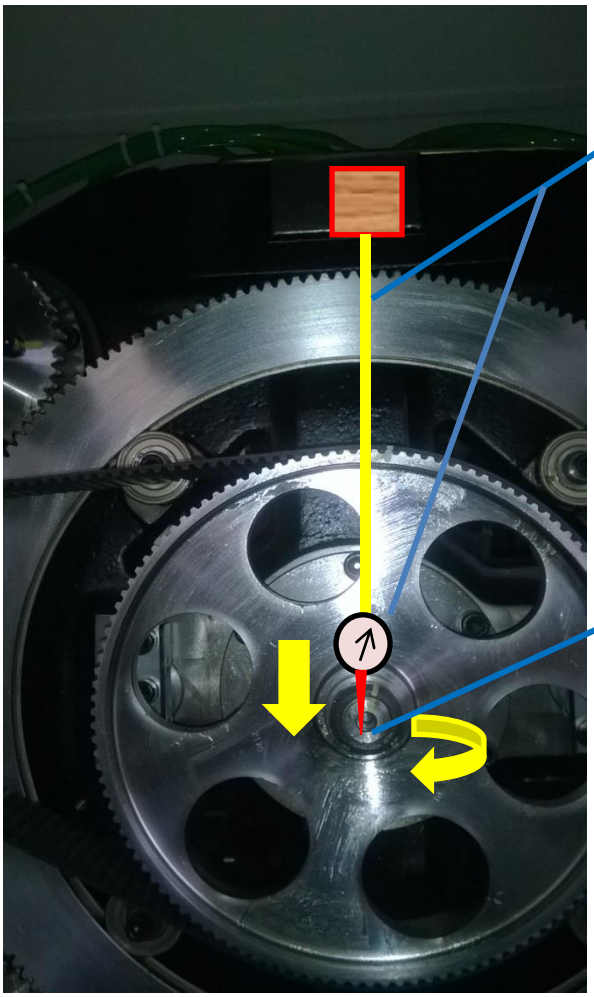
Dial Stand & Dial Gauge

5. **Checking of vibration at Y axis bearing :**
   Fix dial gauge on rear platen, please check Y axis ball screw end moving (Radial and Axial) as shown in below picture. If Y axis ball screw end is moving more than 0.1mm , bearing may be worn out, hence it cause vibration.

Check the movement of Y axis ball screw end (Bearing unit) - [**Radial and Axial**
