AGRICULTURAL MACHINERY TESTING AND EVALUATION CENTER

TEST REPORT NO. 2013 - 28

**AMPC Trailing Harrow
Model: 20 x 24**

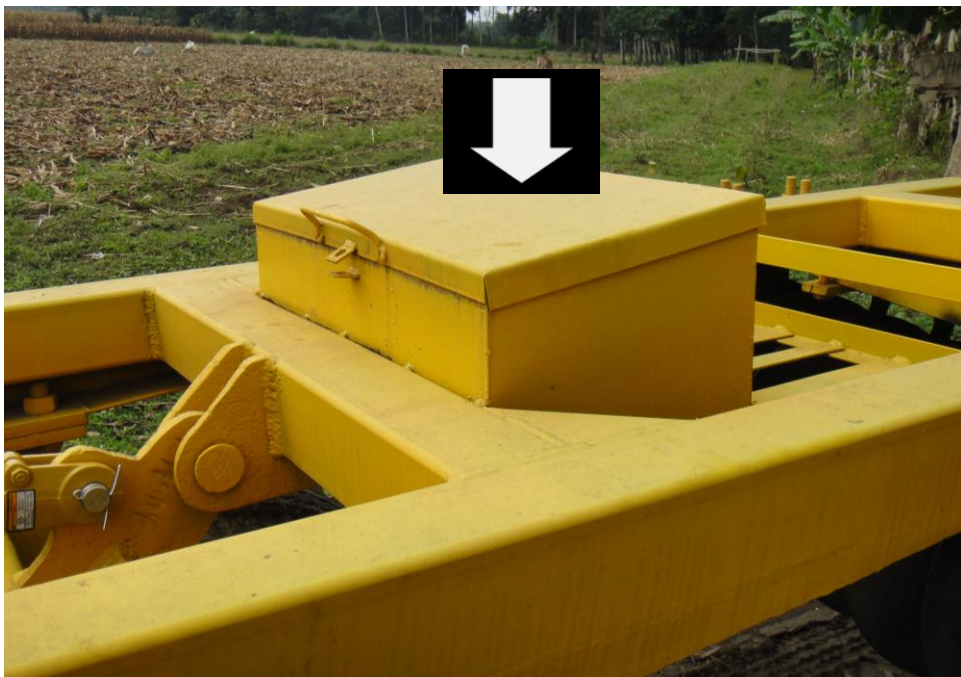
1. Complete cutting of the furrow slice was observed when the harrow was used as a primary tillage implement (**Figure 7**).
2. The tractor was stable, i.e. it maintained a straight path, during operation (**Figure 8**).
3. Grease fittings were provided at the bearing housings.
4. A tool box (**Figure 9**) was installed on the harrow.
