AMTEC

Test Report No. 2018 – 0379

Agricultural Machinery – Power-Operated Corn Sheller ACT MINI – GOLDEN BOW

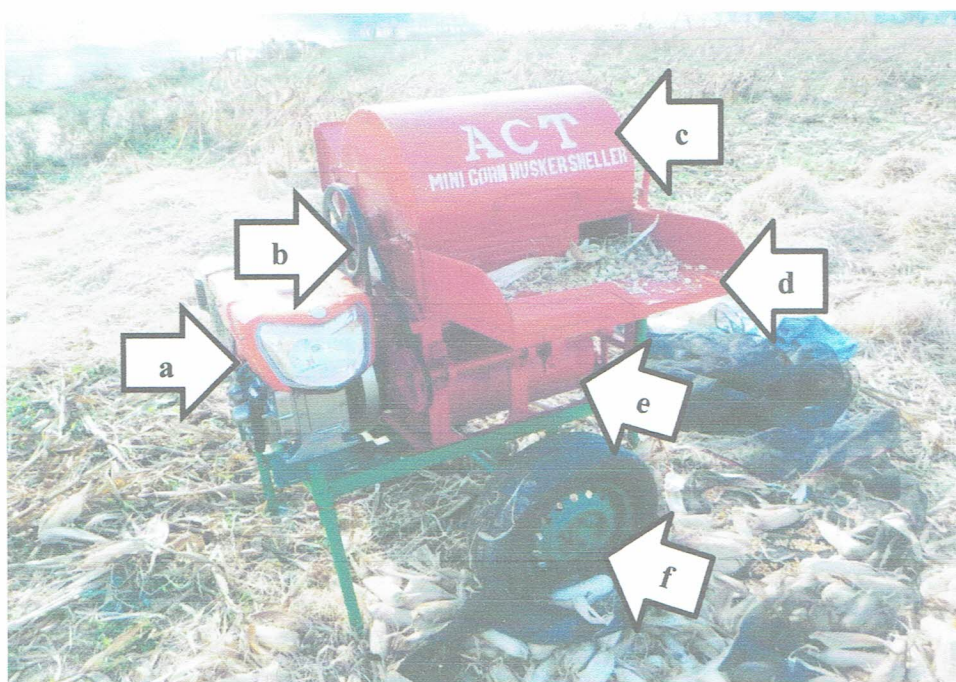
Figure 1. Parts of ACT MINI – GOLDEN BOW Corn Sheller powered by 6.0 kW GOLDEN BOW 80D1 Diesel Engine:

- (a) Prime mover, (b) Belt-pulley transmission, (c) Shelling chamber
(d) Feeding table/ tray, (e) Blower, and (f) Transport wheel.
