Three issues. A stronger coordinated model.

PROJECT RECORD / OCTOBER 2026

REVISED ELECTRICAL MODEL

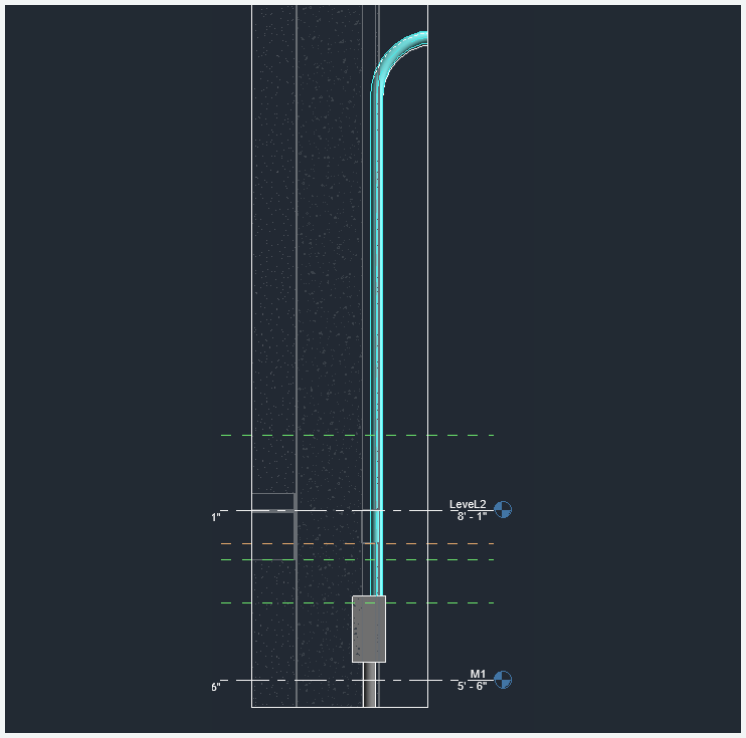
BEFORE / WALL-FACE ROUTE

Section shows the earlier relationship between the vertical run and wall face.

The risers and elbows intersected the architectural wall; the intended routing needed a clearer model representation.

Moved the risers fully into the wall and adjusted the elbow positions. Refreshed the model and reran the hard-clash tests.

Three original elbow pairs: Resolved. Remaining concealed-riser wall intersections: Approved as intentional for this educational review.

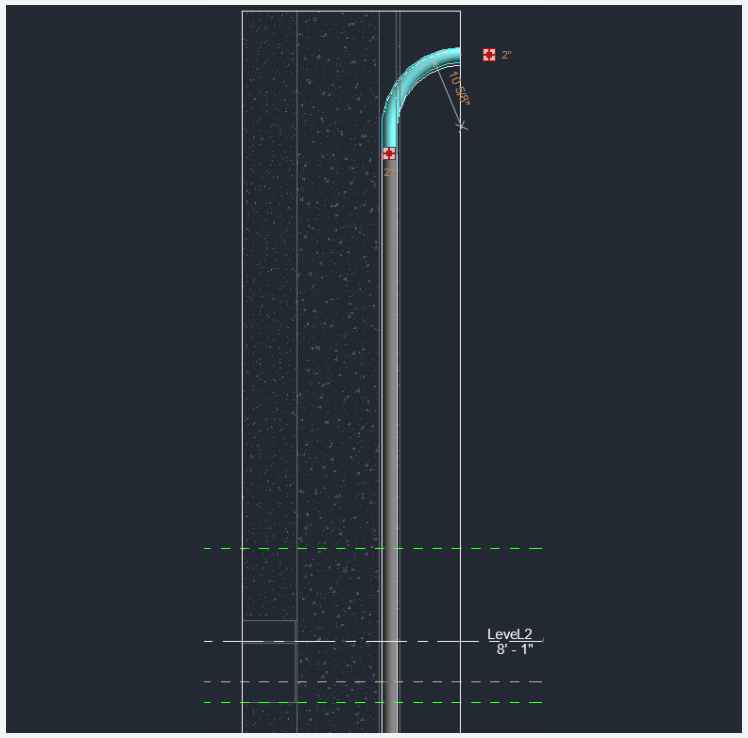
AFTER / REPOSITIONED RISERS

Revised section shows the concealed route and adjusted upper bend.

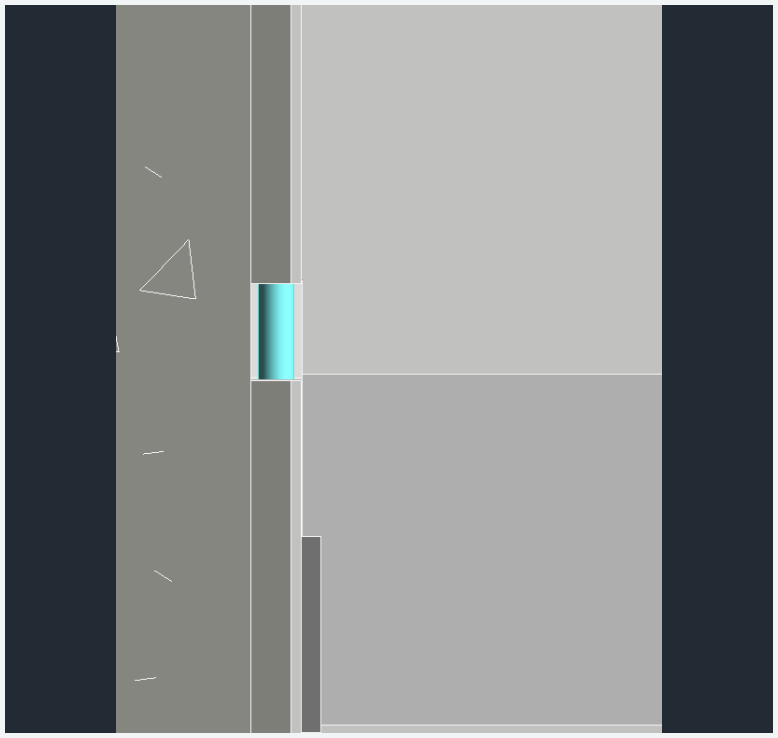
CHECK / WALL CUTAWAY

Cutaway retains the small exposed horizontal transition at the nook.

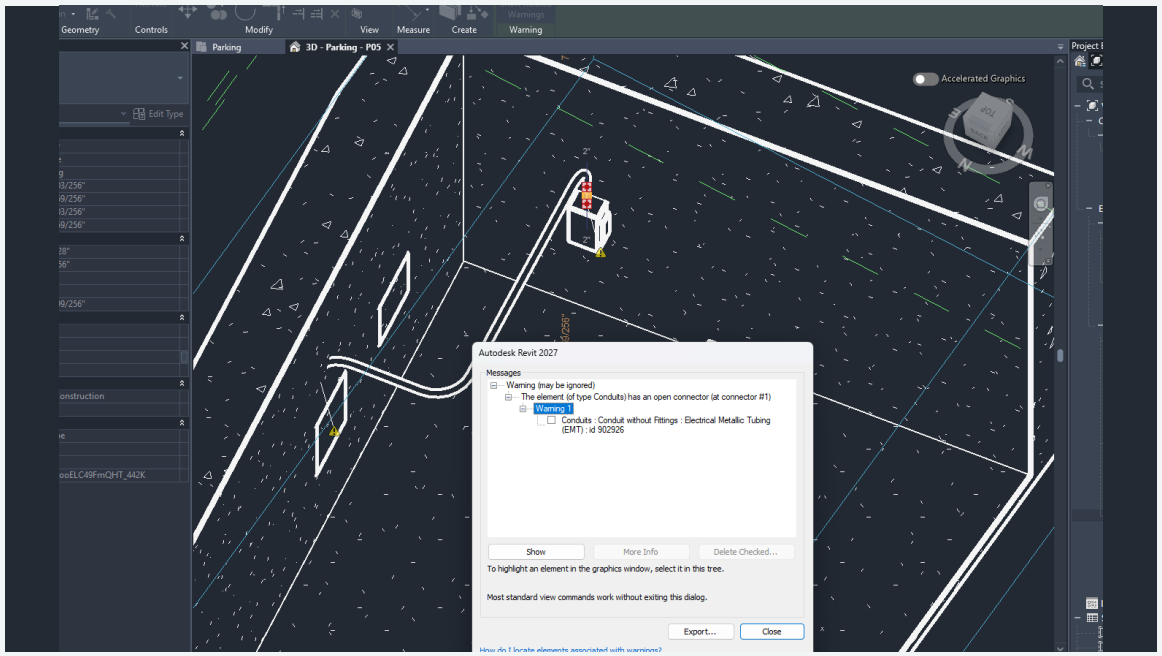
BEFORE / CONNECTION TRIAL

The earlier trial includes an open-connector warning and a difficult routing arrangement.

Reworked equipment spacing, mounting positions, and connector alignment. The revised model presents the panel, disconnect, and transformer connections as an organized system.

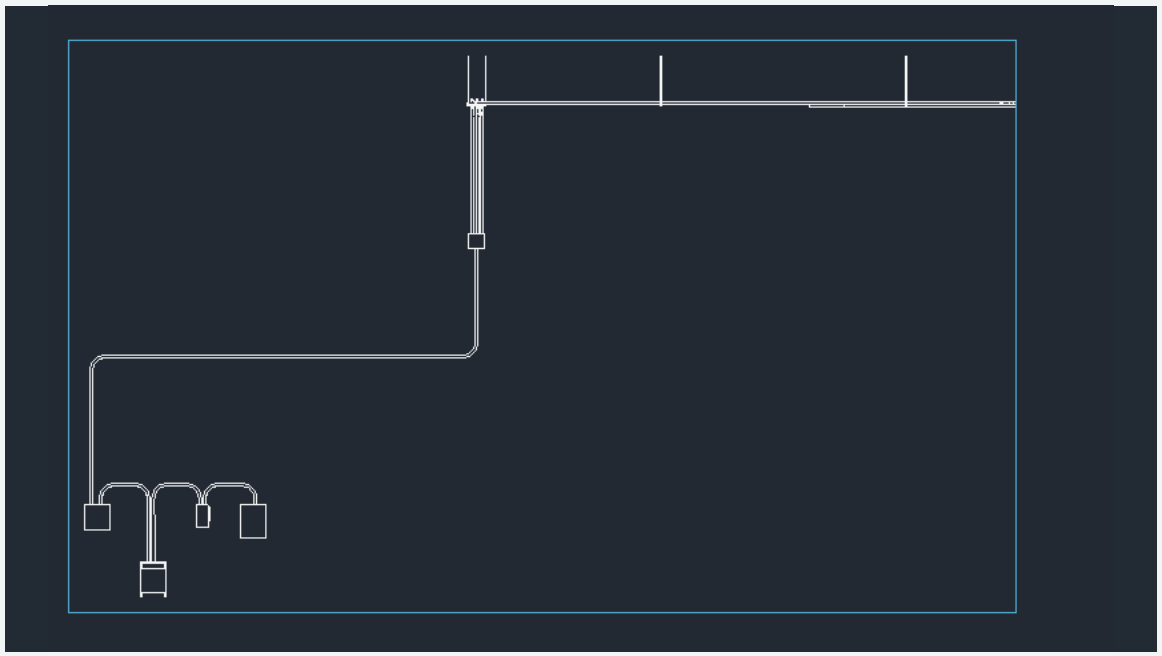
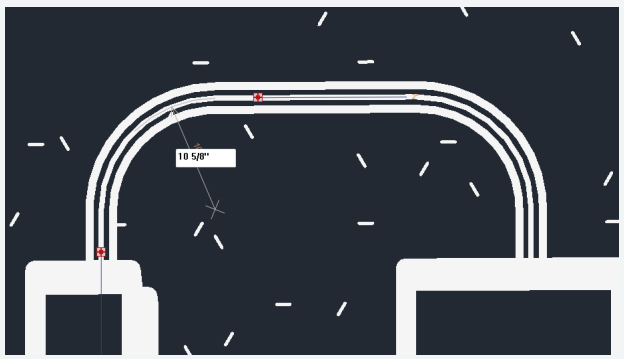
AFTER / COORDINATED ARRANGEMENT

Revised equipment row connects into the riser and overhead distribution.

Modeled feed sequence: P480-1 > DS1 > TX1 > P208-1.

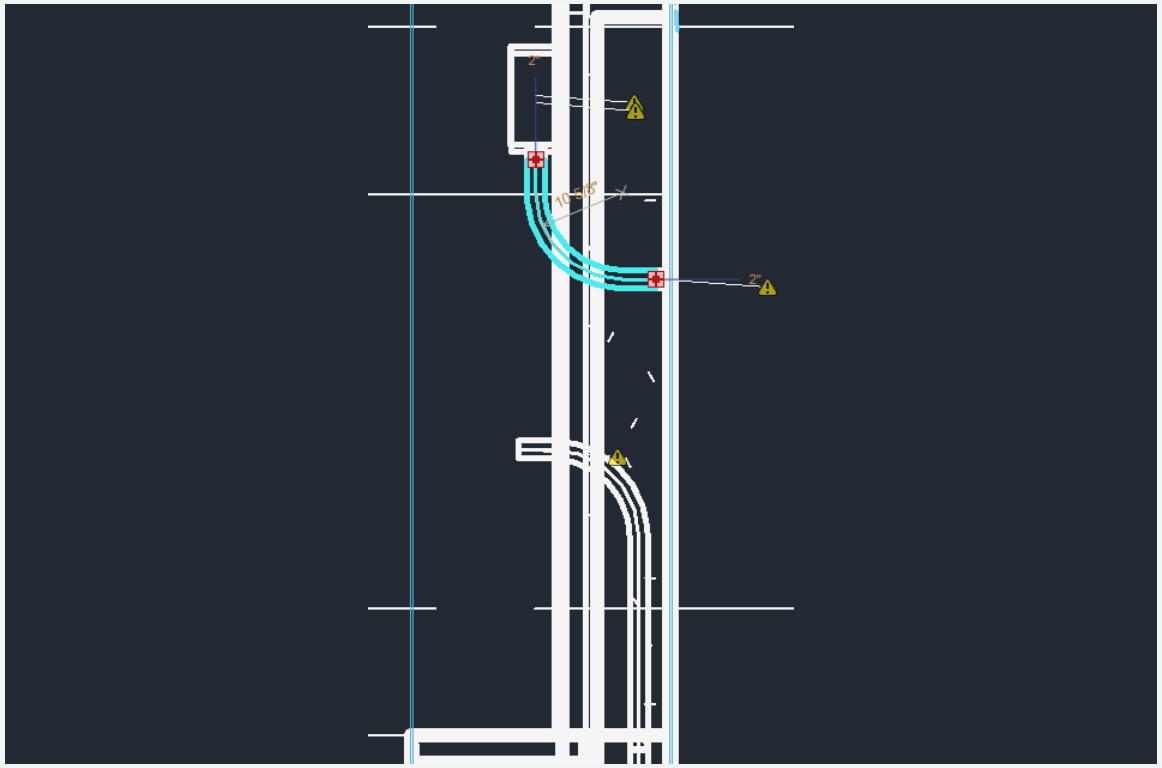
BEFORE / EARLIER BOX CONNECTION

Earlier box and elbow configuration during connection troubleshooting.

The junction-box interface and elbow arrangement needed to fit the intended riser route and concealed wall placement.

Refined the J1 placement and conduit approach. Organized the top connection as a straight vertical run to the upper bend.

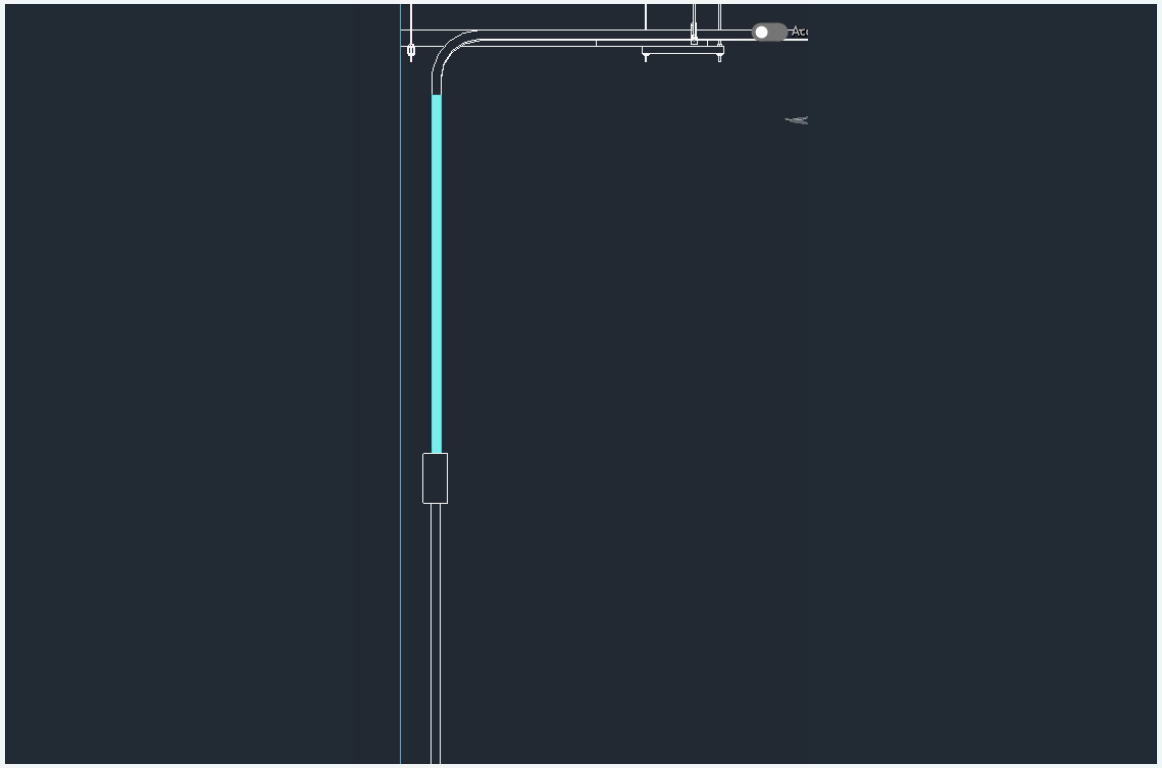
AFTER / STRAIGHT TOP CONNECTION

Revised straight connection above J1, with the bend at the overhead transition.

The final view records the revised connection geometry. The latest clash run has no New or Active results across all 13 tests.
