R005 - DRAFT SEQUENCE - NOT INSTALLATION APPROVAL

Depth and sealing / review correction

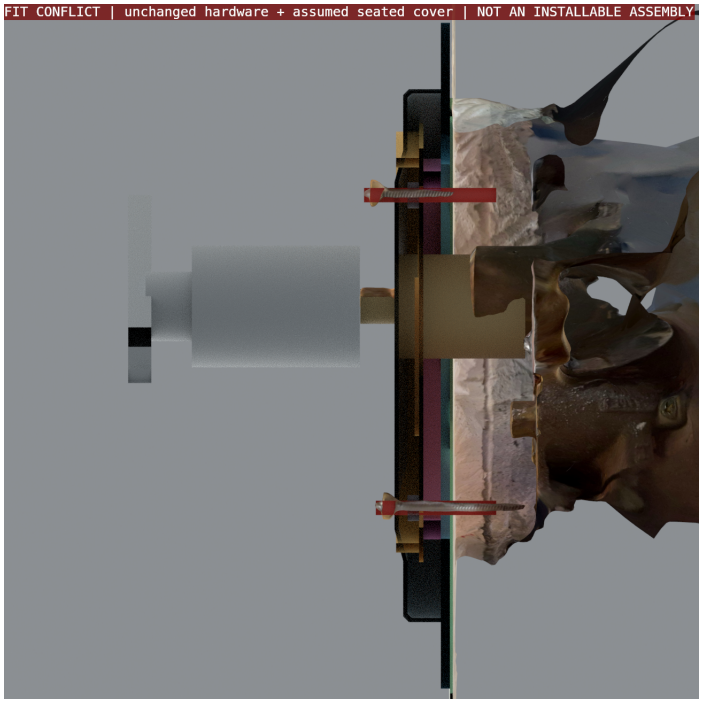
Readings reference the worksheet revision; any newly changed areas are identified.

Take the requested dimensional readings and label the matching locations. Report any future plumbing, stud or wall change before using the model for fit.

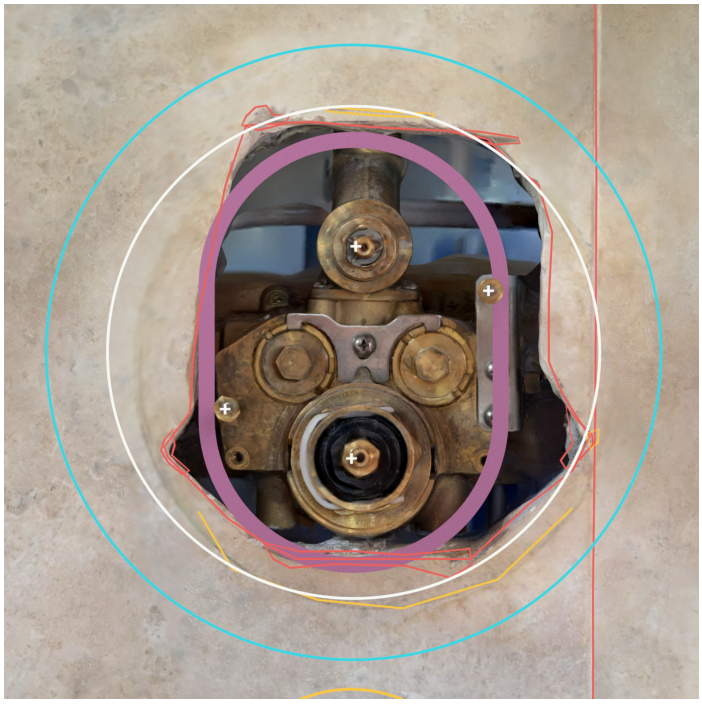
Stud rear travel and engagement, Check 10 tip identity/depths, plaster-guard or axis-datum check, and correct adapter/handle seating recorded.

Trace reported rear stud contact with wood; verify valve rough-in depth and identify the stem adapters separately. Check available adjustment, final seating and supply/valve leakage before selecting a repair.

Do not shorten studs, force trim, or loosen pressure-containing parts for a homeowner measurement. No valve relocation target is approved.

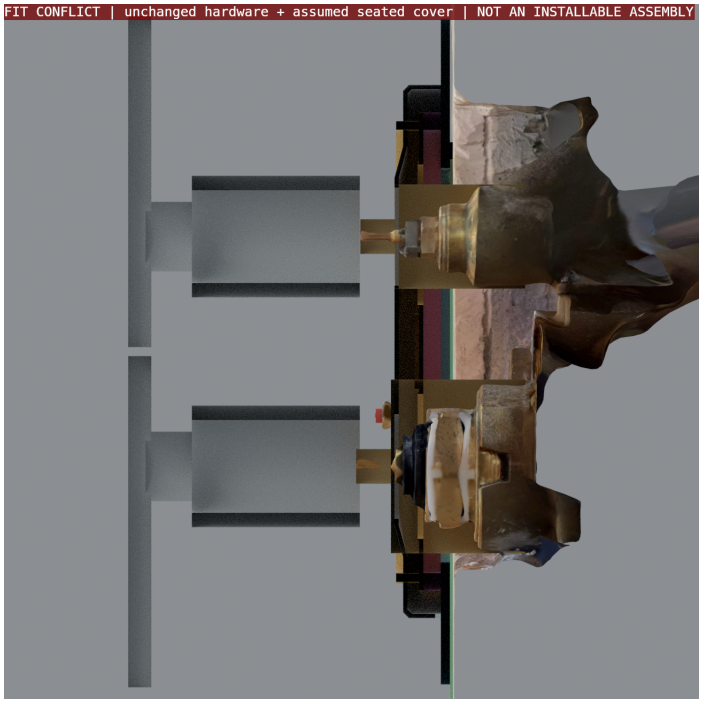
Worst cuts concealed with sound overlap; no rocking; continuous foam support; trim seats; threads engage; drain down; full travel and tool/removal access.

Paper proves no depth clearance. Prototype materials are not approved permanent wet-area materials. Record failures; do not force the fit.

Check the planar template first, then trial the actual layer thickness with the original inner plate, gasket, trim and handles.

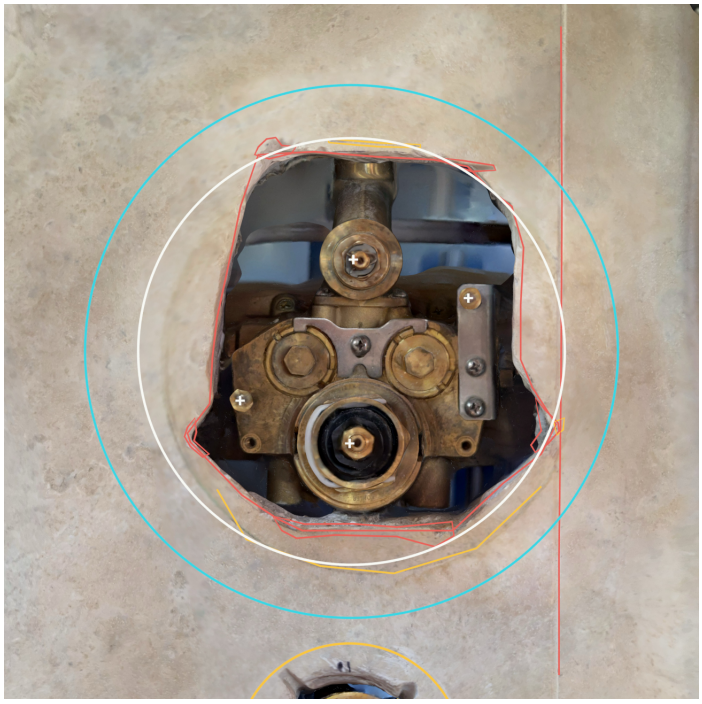
Incoming dimensions, flatness, thickness, edges and finish accepted; sealing path continuous; service parts remain removable; drain unobstructed.

The current seated-cover trial has solid intersections and is rejected. No selected mortar, backing, sealant, finish or cure schedule exists. Do not install from this draft.

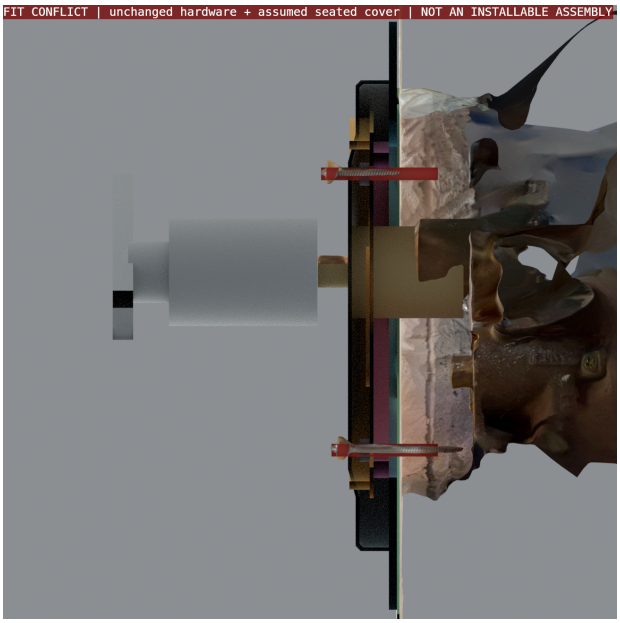
Record product cure conditions, test duration/conditions, observed locations and results. Retain a future removal procedure.

Stop if moisture appears. Investigate supply leakage separately from surface-water entry. A local pass does not certify the concealed shower system.

First check supply/valve behavior with surfaces kept dry; then test controlled water exposure around the assembled trim while observing available access.

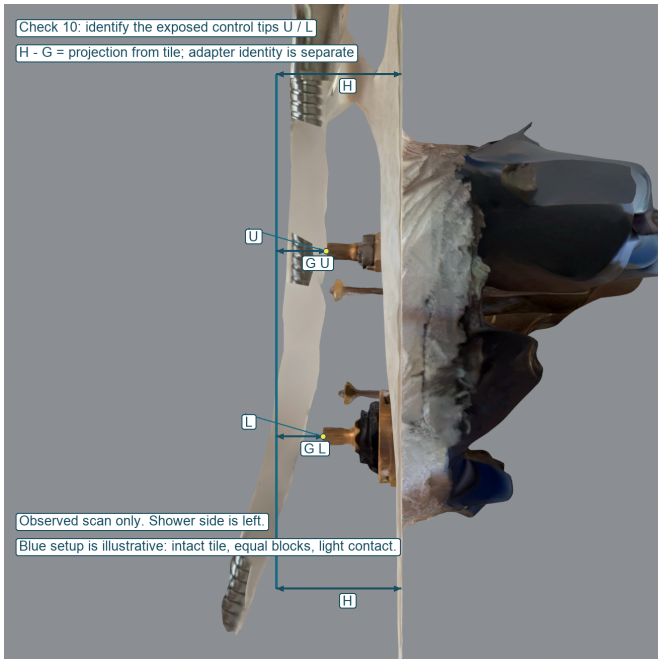
Control depth / diagnostic follow-up

The user confirms excessive stud projection and reports rear bolt contact with wood. Trim studs thread into the valve; they do not need wood anchorage. Identify the same rear fasteners, framing/blocking and usable travel before selecting a remedy.

K-2973-KS specification p3: the labeled upper bare-tip and finished-wall dimensions imply a nominal upper-tip interval -6.3 to 27.0 mm from tile. Current comparison: 32.0 mm (conditional scan tip; identity and physical scale unverified). This is outside nominal interval if same bare tip. It is not a valve-relocation target.

Check 10 identifies the as-found tips/adapters and records block height H and both underside-to-tip gaps. H - G gives signed projection. The installer separately checks the plaster guard or documented axis datum. The 7/16-inch trim-stud limit does not apply to control stems.

Correct adapter and screw lengths must permit handle engagement and full cover/bonnet seating. An added backing plate changes that relationship again. Internal valve seals contain supply water; improper trim seating concerns external shower-water entry. Test these separately after the complete assembly is resolved.
