R003 - DRAFT SEQUENCE - NOT INSTALLATION APPROVAL

02 / Check plumbing and factory adjustment

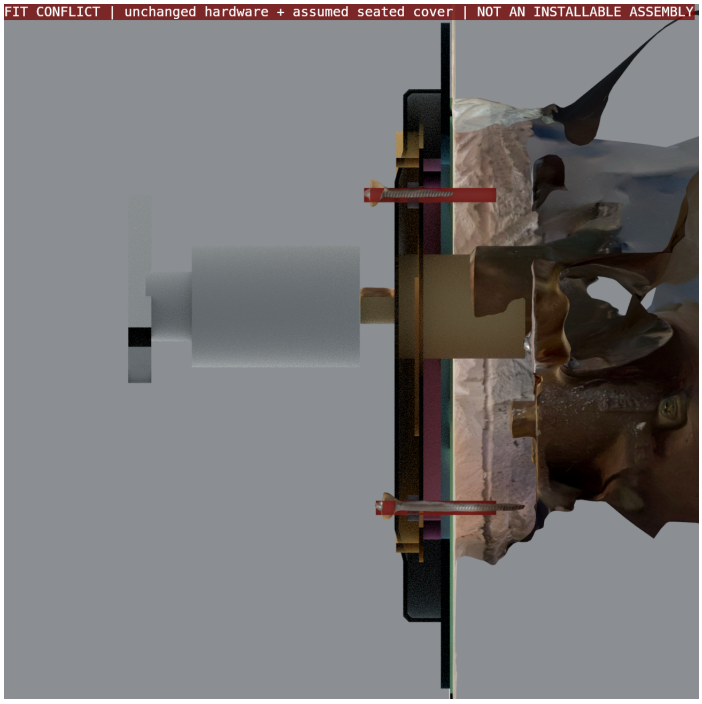
Readings reference the worksheet revision; any newly changed areas are identified.

If a valve moves or repairs hide a cut, the old scan cannot certify current fit.

Take the requested dimensional readings and label the matching locations. Report any future plumbing, stud or wall change before using the model for fit.

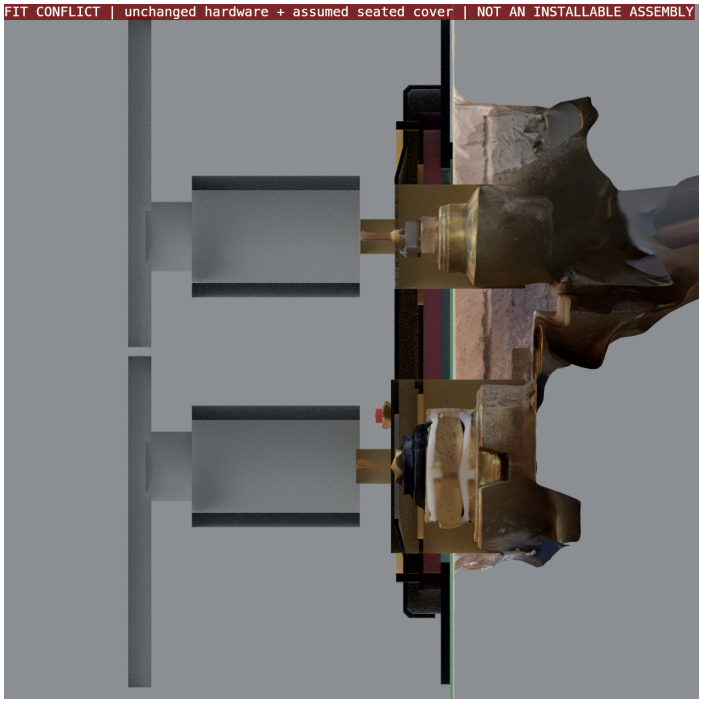
Worst cuts concealed with sound overlap; no rocking; continuous foam support; trim seats; threads engage; drain down; full travel and tool/removal access.

Paper proves no depth clearance. Prototype materials are not approved permanent wet-area materials. Record failures; do not force the fit.

Measured loose-part envelope: 15.44 mm from uncompressed foam back to frontmost metal, with approximately 6 mm free foam thickness and 6 mm representative band width. This free-state plate intersects the assumed cover; actual compression and local cavity geometry must be checked before judging installed fit.

Check the planar template first, then trial the actual layer thickness with the original inner plate, gasket, trim and handles.

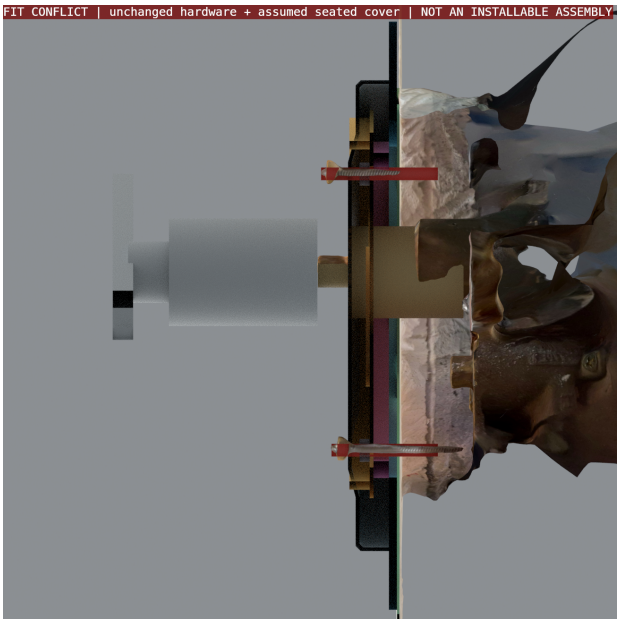
Record product cure conditions, test duration/conditions, observed locations and results. Retain a future removal procedure.

Stop if moisture appears. Investigate supply leakage separately from surface-water entry. A local pass does not certify the concealed shower system.

First check supply/valve behavior with surfaces kept dry; then test controlled water exposure around the assembled trim while observing available access.
