R002 - DRAFT SEQUENCE - NOT INSTALLATION APPROVAL

Depth and sealing / review correction

Control depth / diagnostic follow-up

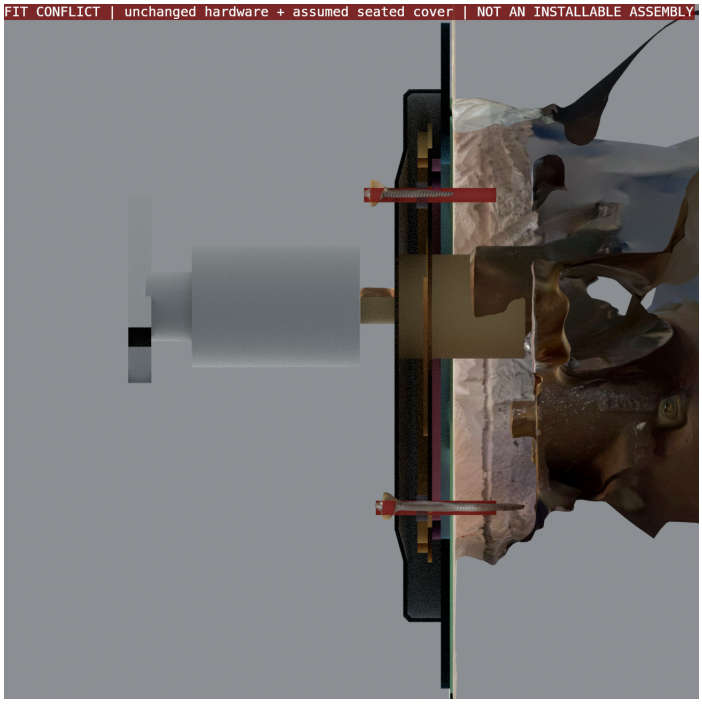
Readings reference the worksheet revision; any newly changed areas are identified.

Take the requested dimensional readings and label the matching locations. Report any future plumbing, stud or wall change before using the model for fit.

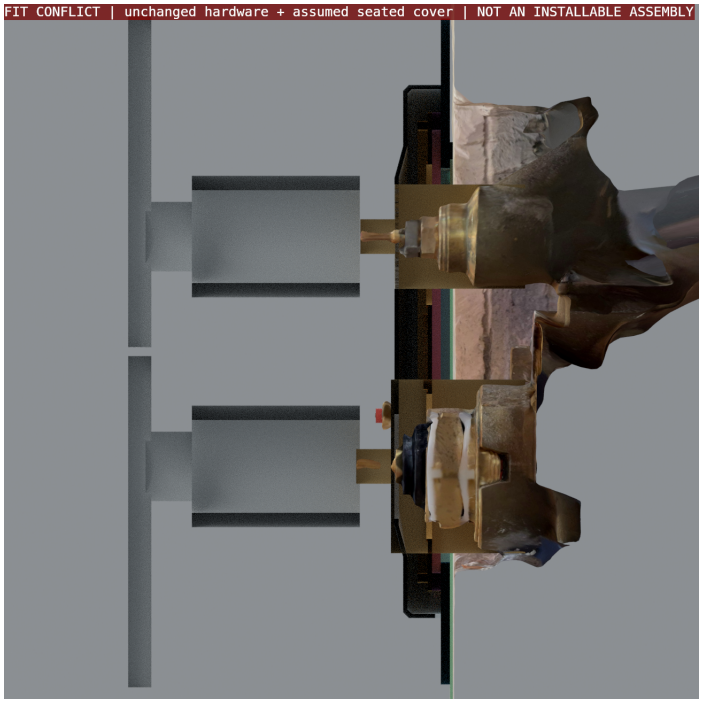
Worst cuts concealed with sound overlap; no rocking; continuous foam support; trim seats; threads engage; drain down; full travel and tool/removal access.

Paper proves no depth clearance. Prototype materials are not approved permanent wet-area materials. Record failures; do not force the fit.

Check the planar template first, then trial the actual layer thickness with the original inner plate, gasket, trim and handles.

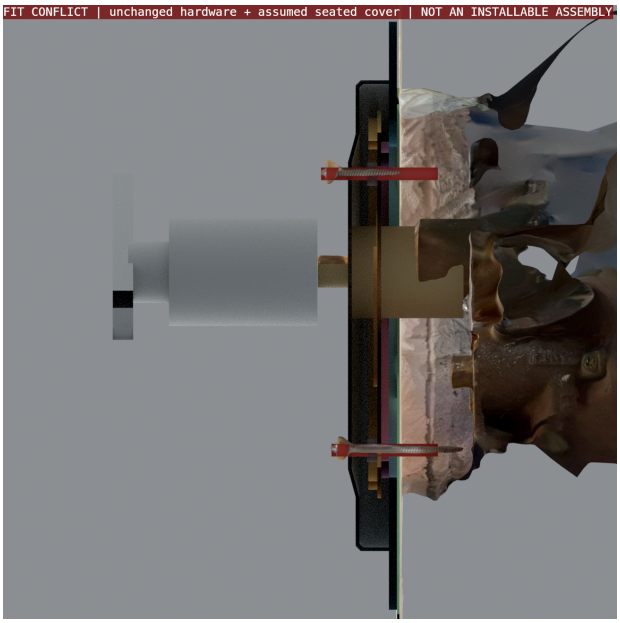
Record product cure conditions, test duration/conditions, observed locations and results. Retain a future removal procedure.

Stop if moisture appears. Investigate supply leakage separately from surface-water entry. A local pass does not certify the concealed shower system.

First check supply/valve behavior with surfaces kept dry; then test controlled water exposure around the assembled trim while observing available access.
