Rebuild a firm surface. Keep shower spray out.

A practical repair plan for the owner and repairer. Work from the rear, keep the existing stone, and remove the plastic form after curing.

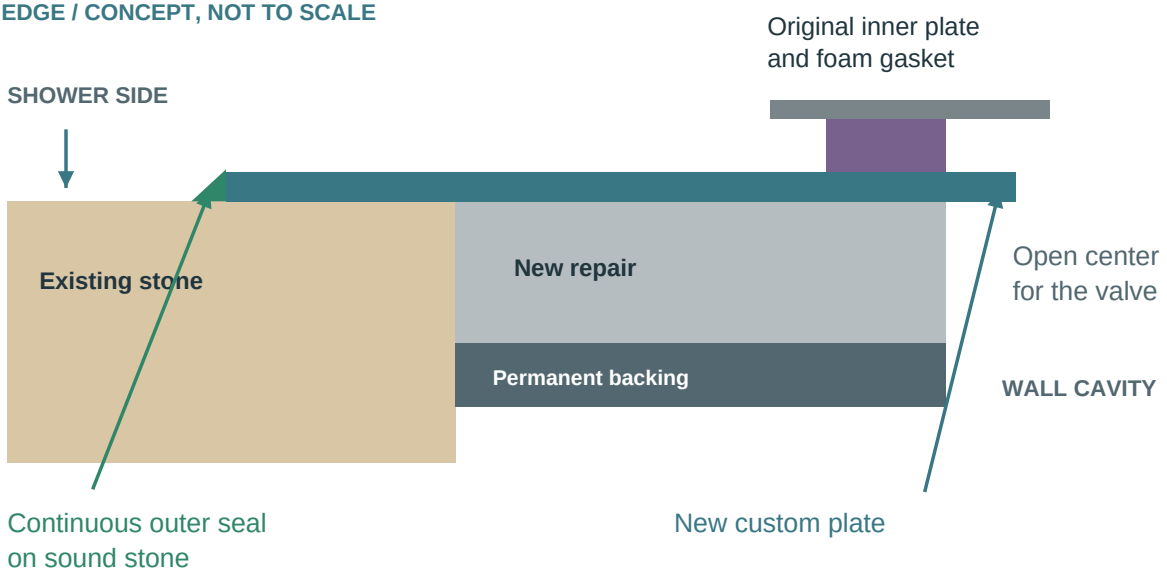
1 SUPPORT

Permanent backing carries the repair after the plastic form is removed.

2 SHAPE

Repair mortar fills missing areas and gives the plate a firm, flat seat.

3 SEAL

The outer plate joint and factory gasket exclude shower spray.

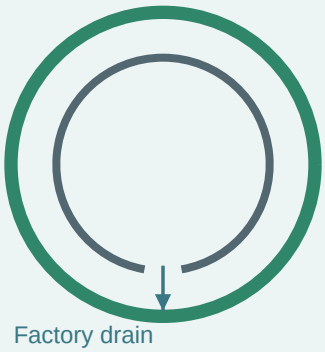
Outer green loop: new plate-to-stone seal

Keep this seal continuous and outside every over-cut. Use a stone-compatible sealant joint on clean, dry surfaces; verify adhesion to the actual metal finish and nonstaining on the stone.

Inner gray circle: factory decorative cover. Keep its bottom drain open so it drains onto the FRONT of the custom plate. Do not copy that gap into the new outer seal.

After the form is removed, the patch must be firm, fully supported and free of release film. The plate should sit without rocking or being forced flat.

Remove ridges on the repair; fill voids with a compatible repair product. Keep the finished support at the intended tile-face plane. Do not grind or cut the existing travertine. Do not use silicone blobs to prop up an unsupported plate.
