01 / Record the current installation

R001 - DRAFT SEQUENCE - NOT INSTALLATION APPROVAL

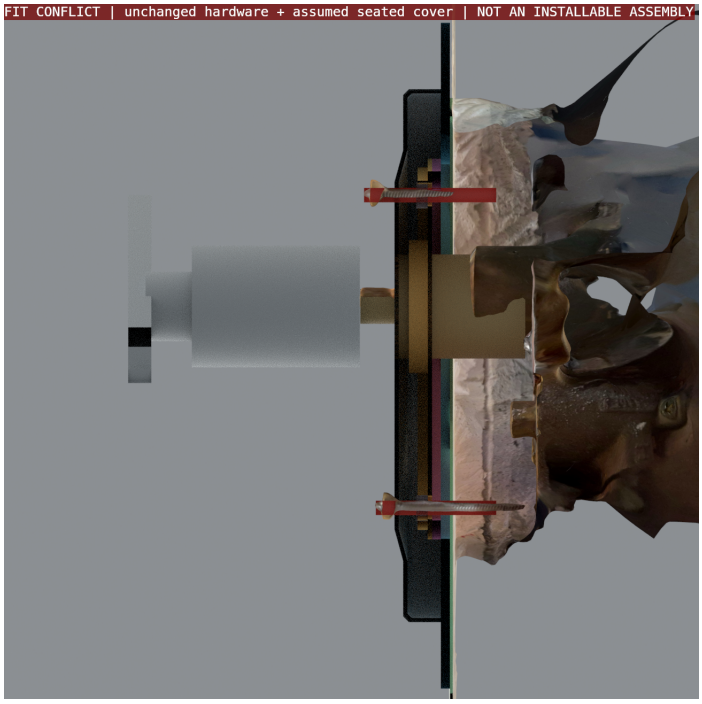
Readings reference the worksheet revision; any newly changed areas are identified.

If a valve moves or repairs hide a cut, the old scan cannot certify current fit.

Take the requested dimensional readings and label the matching locations. Report any future plumbing, stud or wall change before using the model for fit.

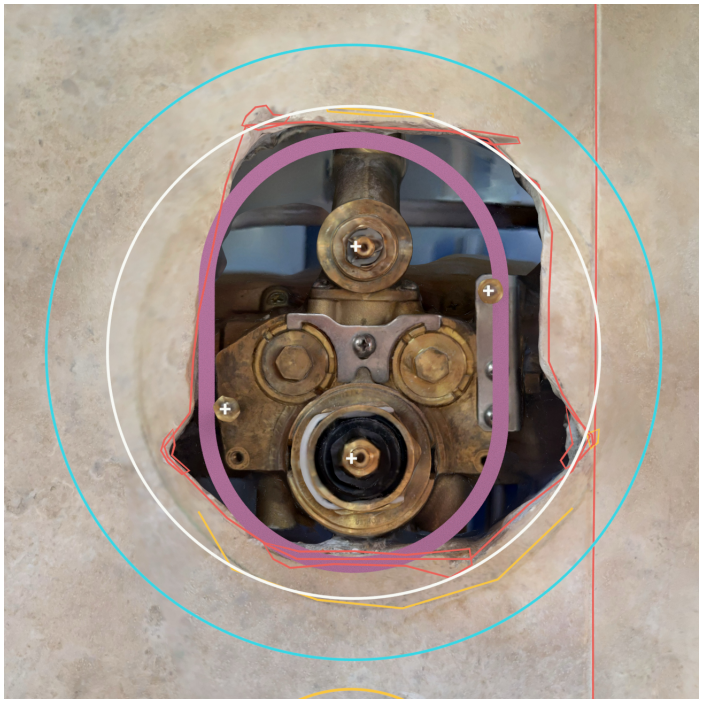
02 / Check plumbing and factory adjustment

Stud rear travel and engagement, Check 10 tip identity/depths, plaster-guard or axis-datum check, and correct adapter/handle seating recorded.

Do not shorten studs, force trim, or loosen pressure-containing parts for a homeowner measurement. No valve relocation target is approved.

Trace reported rear stud contact with wood; verify valve rough-in depth and identify the stem adapters separately. Check available adjustment, final seating and supply/valve leakage before selecting a repair.

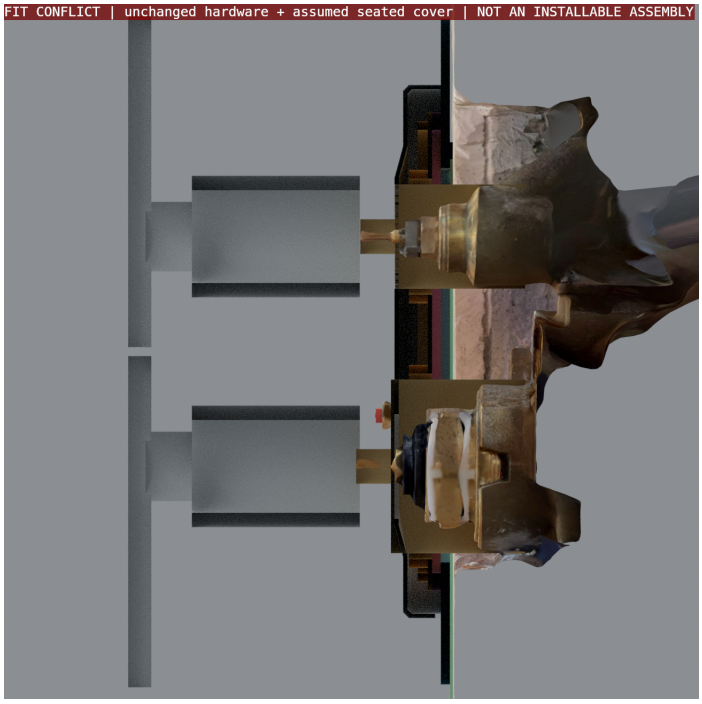
04 / Dry fit the reviewed revision

Worst cuts concealed with sound overlap; no rocking; continuous foam support; trim seats; threads engage; drain down; full travel and tool/removal access.

Paper proves no depth clearance. Prototype materials are not approved permanent wet-area materials. Record failures; do not force the fit.

Check the planar template first, then trial the actual layer thickness with the original inner plate, gasket, trim and handles.

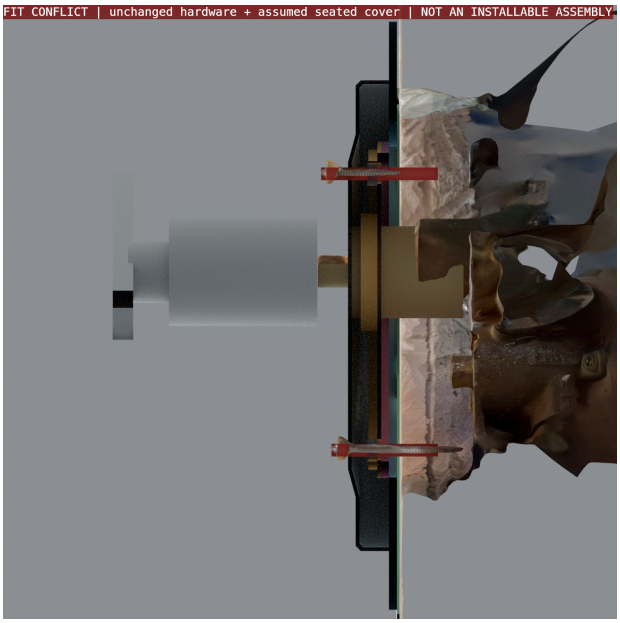
Record product cure conditions, test duration/conditions, observed locations and results. Retain a future removal procedure.

Stop if moisture appears. Investigate supply leakage separately from surface-water entry. A local pass does not certify the concealed shower system.

First check supply/valve behavior with surfaces kept dry; then test controlled water exposure around the assembled trim while observing available access.
