Property Condition Report

Building / المبنى
Marina Vista Residence — Sample

Unit / الوحدة
1807

Inspection type / نوع الفحص
Move-in condition inspection (sample)

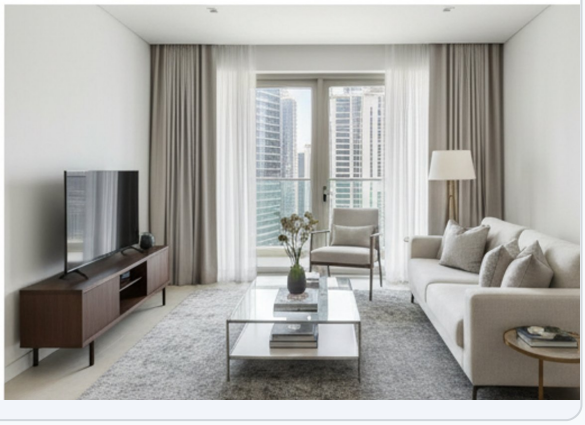
Walls & paintwork Fair / متوسط

Hairline crack approximately 55 cm long beside the balcony opening; no moisture staining observed.

Room Notes: Bright room with good overall presentation. One visible hairline crack requires monitoring.

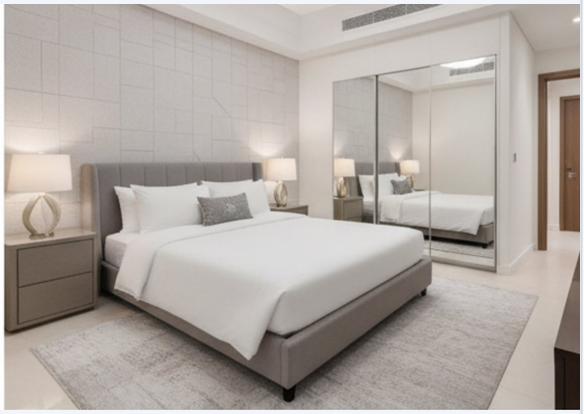
Sockets & isolators Good / جيد

Faceplates secure; electrical function not tested.
