CUTTING & CORING LTD · GPR SCAN REPORT

PROJECT
AKCC-2026-0017

Site	1450 Industrial Way, Burnaby BC	Equipment	GSSI StructureScan Mini XT
Client	Pinnacle Structural Eng.	Slab type	200 mm two-way, post-tensioned
Structure	Level-2 parkade suspended deck	Operator	D. Cunningham
Scan date	2026-05-28	Project no.	AKCC-2026-0017

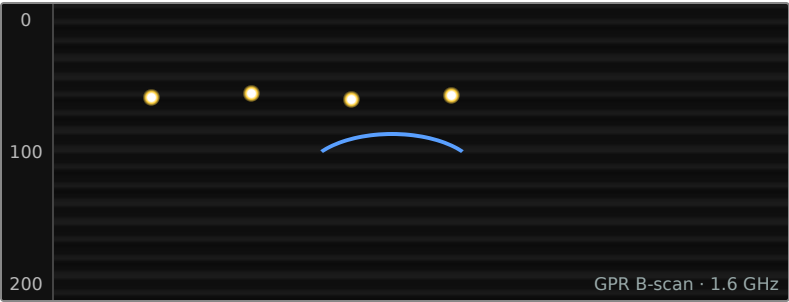
Grid B · Bay 2 column line

CAUTION

Observation. Post-tension tendon crosses on a diagonal within 25 mm of the proposed centre. Relocate the core 75 mm south, clear of the tendon envelope, and re-scan before drilling.

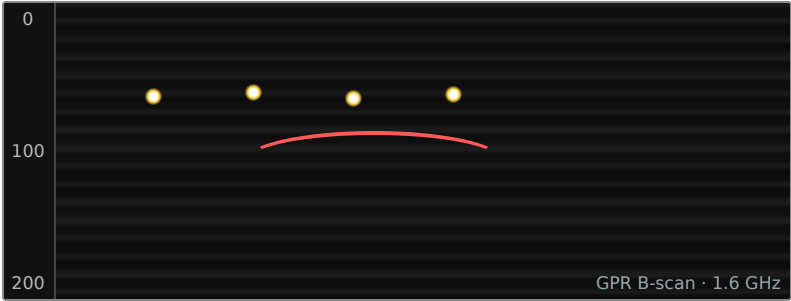
Grid C · Bay 2 wall line

NO-GO

Observation. Energised electrical conduit detected directly beneath the proposed centre at ~110 mm. No-go — do not drill at this location; refer back to the EOR for a redesigned core position.
