Quality Issue #002: CDOM drift

Issue number: 2			
Contact details: chiara.monforte@voiceoftheocean.org; callum.rollo@voiceoftheocean.org			
Version	Date	Comments	Authors
1	2023-07-07	Creation of document	Chiara Monforte and Callum Rollo

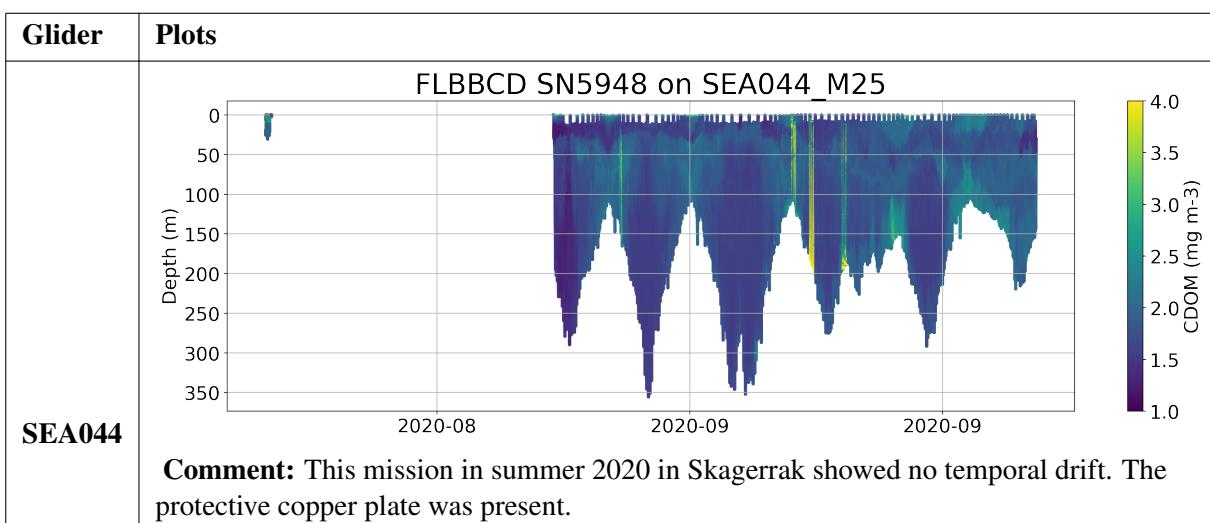
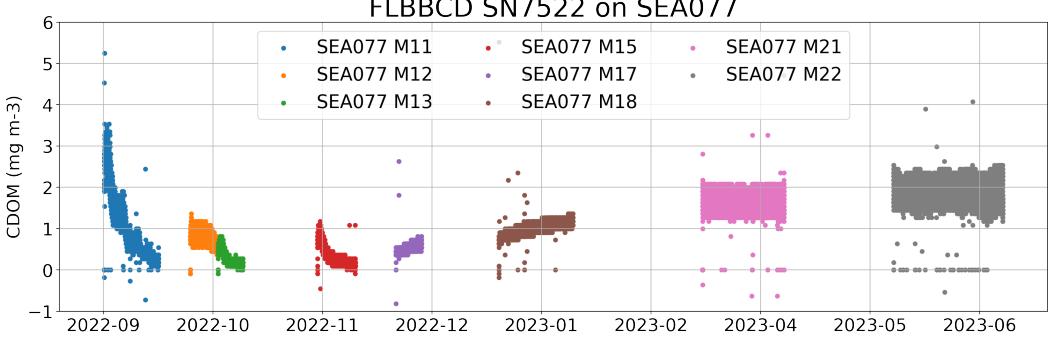
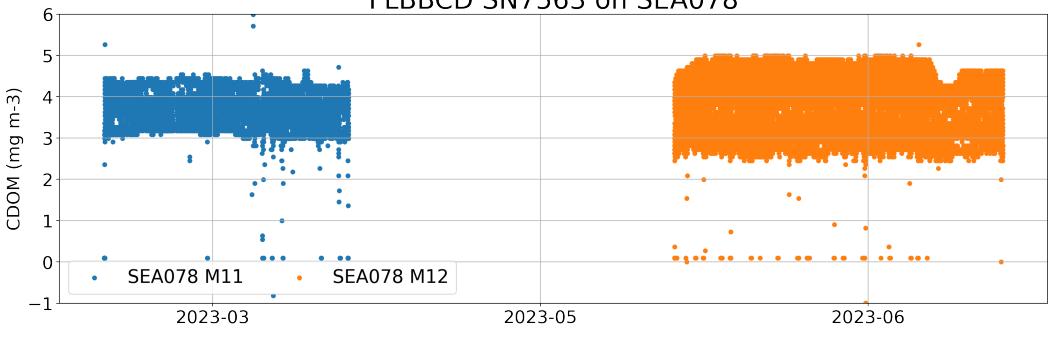
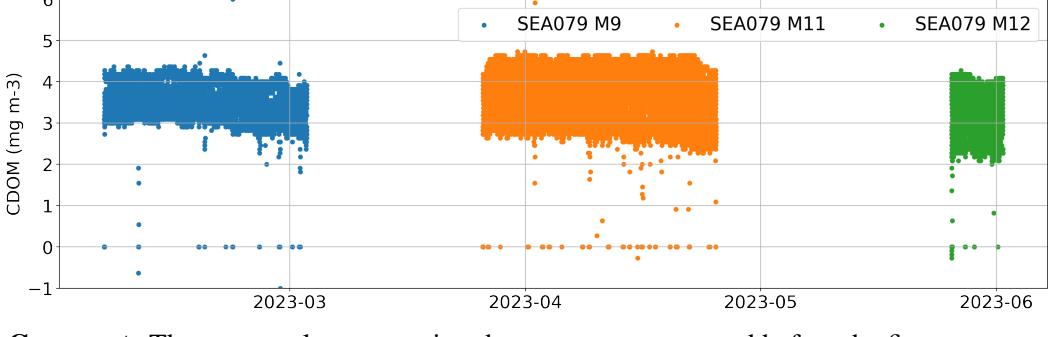
Table 2: CDOM data for each glider to highlight the evolution of the observed issue.

<p>Comment: The first 4 missions (M11-12-13-15) show an evident temporal decrease in CDOM concentration. The protective copper plate on the sensor was removed before the start of mission 17 (in purple in Figure 1). The first two missions after the copper plate is removed (mission 17-18) show a temporal increase instead. Finally, the last two missions (21-22) show no temporal drift. All those missions surveyed anoxic areas.</p>
SEA078	 <p>Comment: The protective copper plate was removed before the first deployment. Data never showed a temporal drift. All those missions surveyed anoxic areas.</p>
SEA079	 <p>Comment: The copper plate protecting the sensor was removed before the first deployment of the glider. Data has never showed a temporal drift. All those missions surveyed anoxic areas.</p>
