SUPPLIER Keystone Device Assembly	PRIMARY EVIDENCE FIR-KDA-1026	INVOICE LINE INV-SUP-010-2026-10-L004	REVIEW DATE 2026-11-09
BUILT 317,000	ACTUAL SCRAP 7,000	ALLOWED SCRAP 4,755	EXCESS 2,245

NONCONFORMANCE STATEMENT

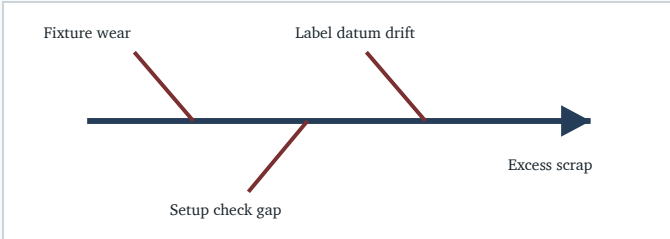
Figure 1. Cause-to-loss relationship

Fixture wear and an incomplete clip-seating setup check caused the major assembly defects; label datum drift caused a smaller secondary loss.

Action	Owner	Due
Replace clip-seating fixture wear block	Keystone Device Assembly Quality	Complete
Add first-piece clip height verification	Keystone Device Assembly Quality	30 days
Trend label datum capability for the next three lots	Keystone Device Assembly Quality	30 days
