SUPPLIER BluePeak Biologics	PRIMARY EVIDENCE UTL-BPB-1026	INVOICE LINE INV-SUP-009-2026-Q4-L004	REVIEW DATE 2027-01-08
AFFECTED RUN BP-1026-03	EVENT DATE 2026-12-19	CLASSIFICATION Major	CLAIMED FEE \$111,000.00

EVENT DESCRIPTION AND CONTAINMENT

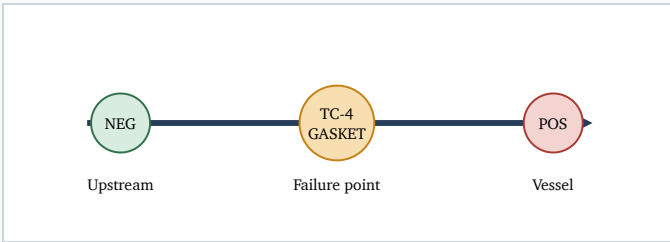
Figure 1. Contamination localization

- Positive sample localized downstream of transfer connection TC-4
- Retained upstream sample remained negative
- Gasket inspection found a visible compression fold
- Maintenance closeout omitted the required post-assembly pressure-hold result

A supplier-maintained transfer-hose connection was reassembled with a pinched gasket after preventive maintenance, compromising the closed path.

Action	Owner	Due
Replace TC-4 gasket and affected hose set	BluePeak Biologics Quality	Complete
Add witnessed pressure-hold verification after hose maintenance	BluePeak Biologics Quality	30 days
Retrain maintenance technicians on gasket installation and closeout	BluePeak Biologics Quality	30 days
