SUPPLIER Keystone Device Assembly	PRIMARY EVIDENCE FIR-KDA-1026	INVOICE LINE INV-SUP-010-2026-10-L004	REVIEW DATE 2026-11-09
BUILT 317,000	ACTUAL SCRAP 7,000	ALLOWED SCRAP 4,755	EXCESS 2,245

NONCONFORMANCE STATEMENT

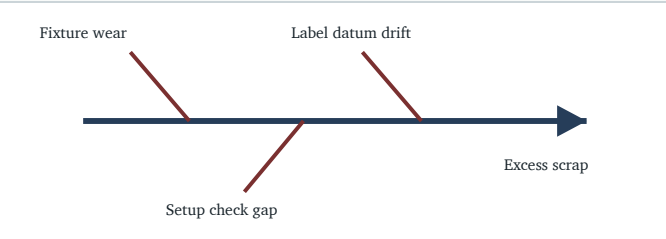
Figure 1. Cause-to-loss relationship

Code	Severity	Quantity
COS-12	Minor	2,400
ASM-07	Major	1,900
NSH-03	Major	1,600
LBL-04	Minor	1,100

Fixture wear and an incomplete clip-seating setup check caused the major assembly defects; label datum drift caused a smaller secondary loss.

Action	Owner	Due
Replace clip-seating fixture wear block	Keystone Device Assembly Quality	Complete
Add first-piece clip height verification	Keystone Device Assembly Quality	30 days
Trend label datum capability for the next three lots	Keystone Device Assembly Quality	30 days
